Annex No 1.1 – Landing approach profile of Tu-154M aircraft tail number 101 at SMOLEŃSK  
NORTH aerodrome on 10.04.2010 (from 3500 m)

## Description and analysis of the operation of on-board systems of Tu-154M aircraft No 101

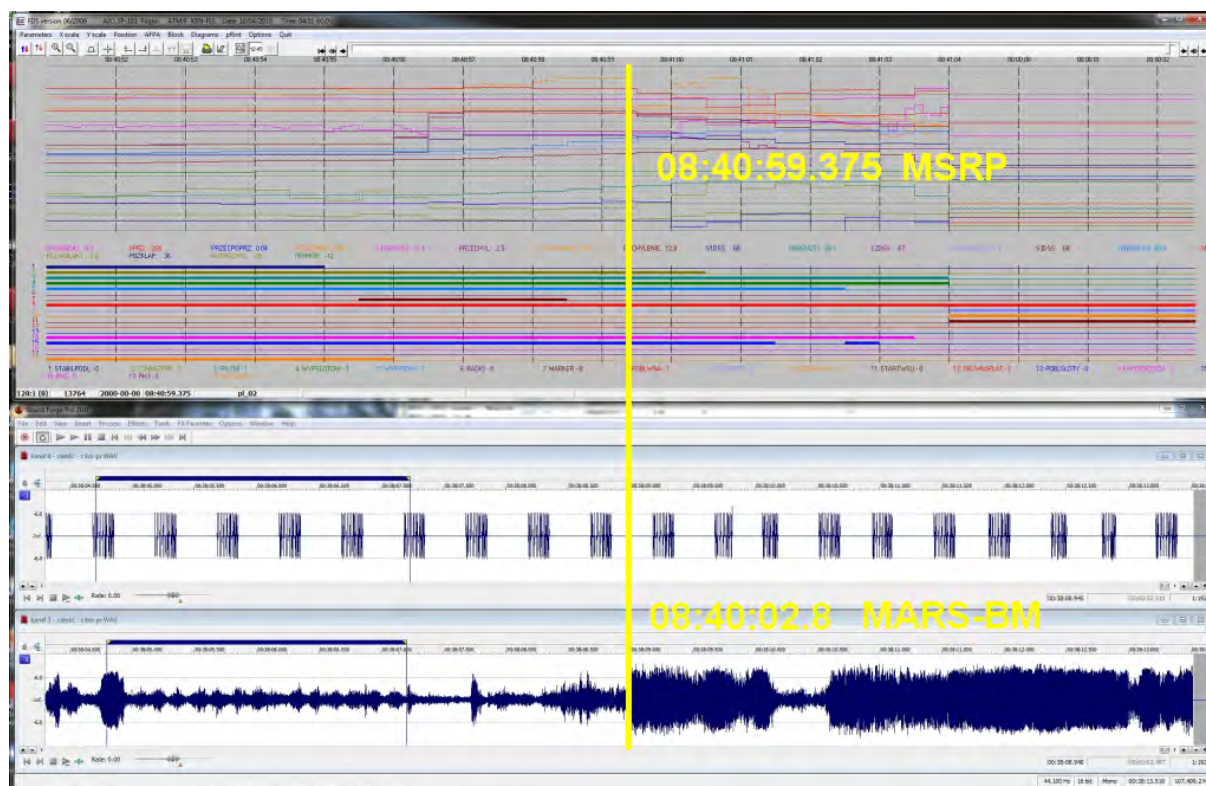
The above data shows that MSRP time is delayed by 3.425 s compared with MARS-BM time. A delay of 3 s was adopted for further analyses.

Fig. 6. Dependence of MSRP and MARS-BM time on birch impact

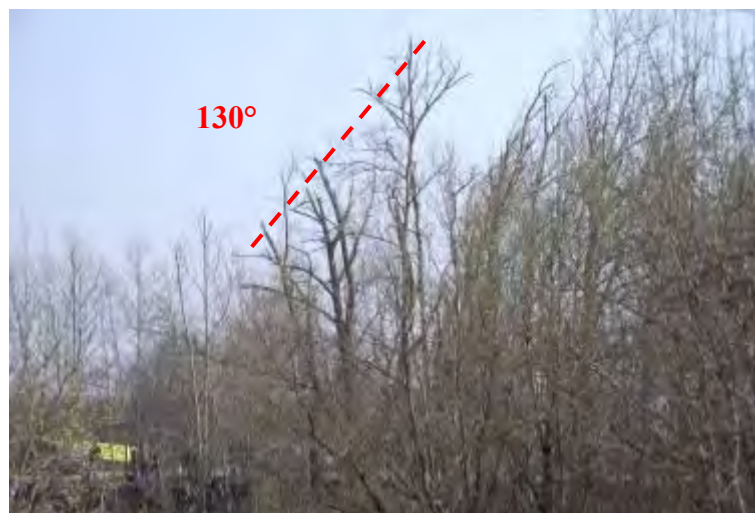
**50 m** later, the plane's roll increased to  $-120^\circ$  as the fuselage, wings, and tailplane impacted with two tall trees causing their limbs and branches to break. At this moment, the left elevator separated. With a roll reaching  $-130^\circ$ , the plane collided with the last group of trees. The fuselage pitch was approx.  $16^\circ$  and started decreasing quickly in the following flight phase. That point is marked as '6' in fig.1 and it corresponds with the point where the ATM-QAR flight record broke off. In the final phase of the flight, the plane travelled with its nose pointing slightly down.

Fig. 11. Damage to the last group of trees before the impact with the ground

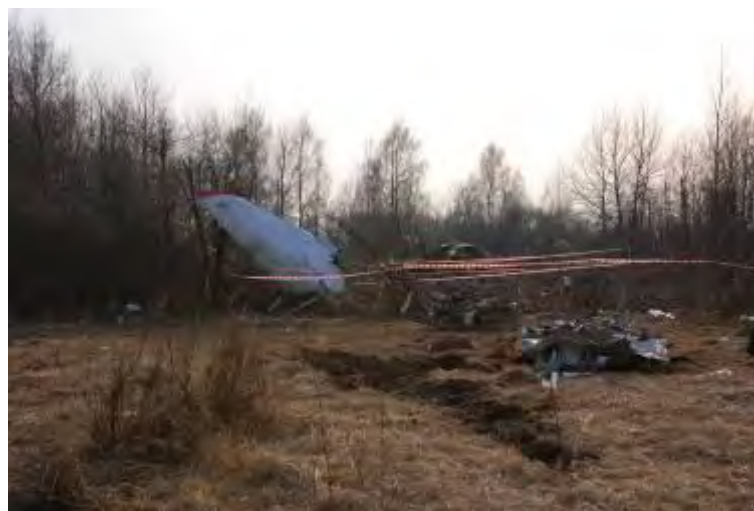
Fig. 12. A furrow left by the left elevator

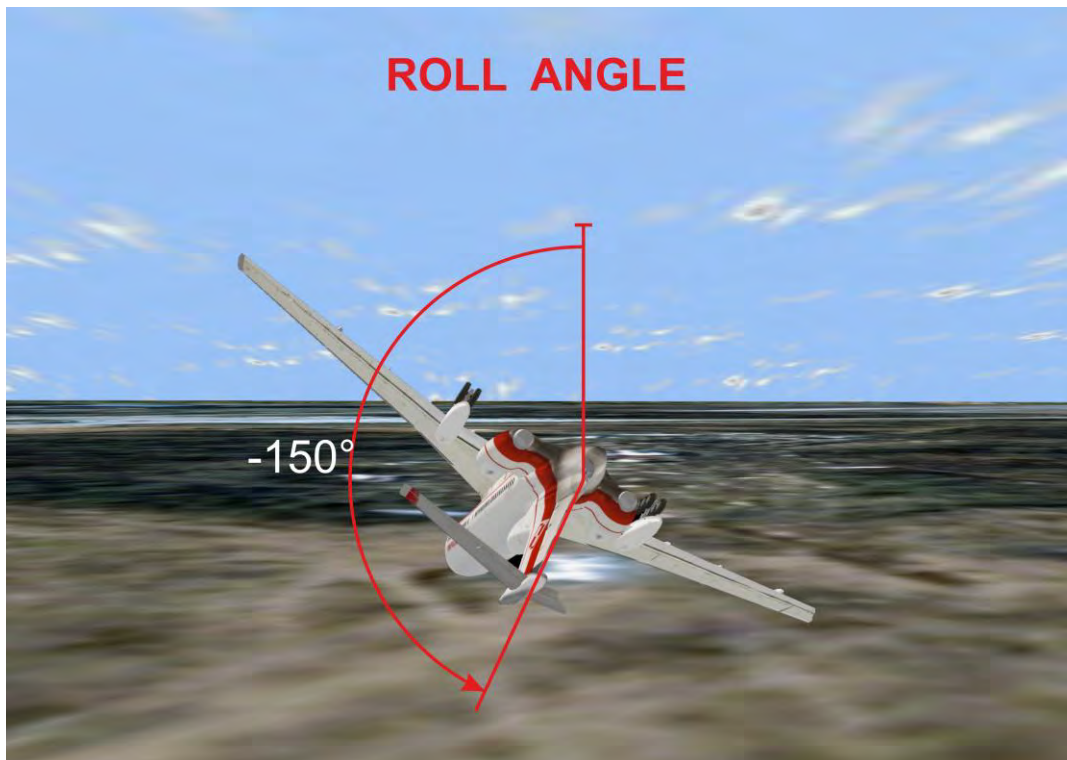
Eventually, the plane collided with the ground with the stump of the left wing first with a roll of approximately  $-150^\circ$  (fig. 15), small negative pitch of about  $-6^\circ$  (fig. 16), on a magnetic course of about  $240^\circ$  (from the moment of the left wing loss, the course deviated by approximately  $-20^\circ$  – fig. 17).

Fig. 15. Roll angle at impact with the ground

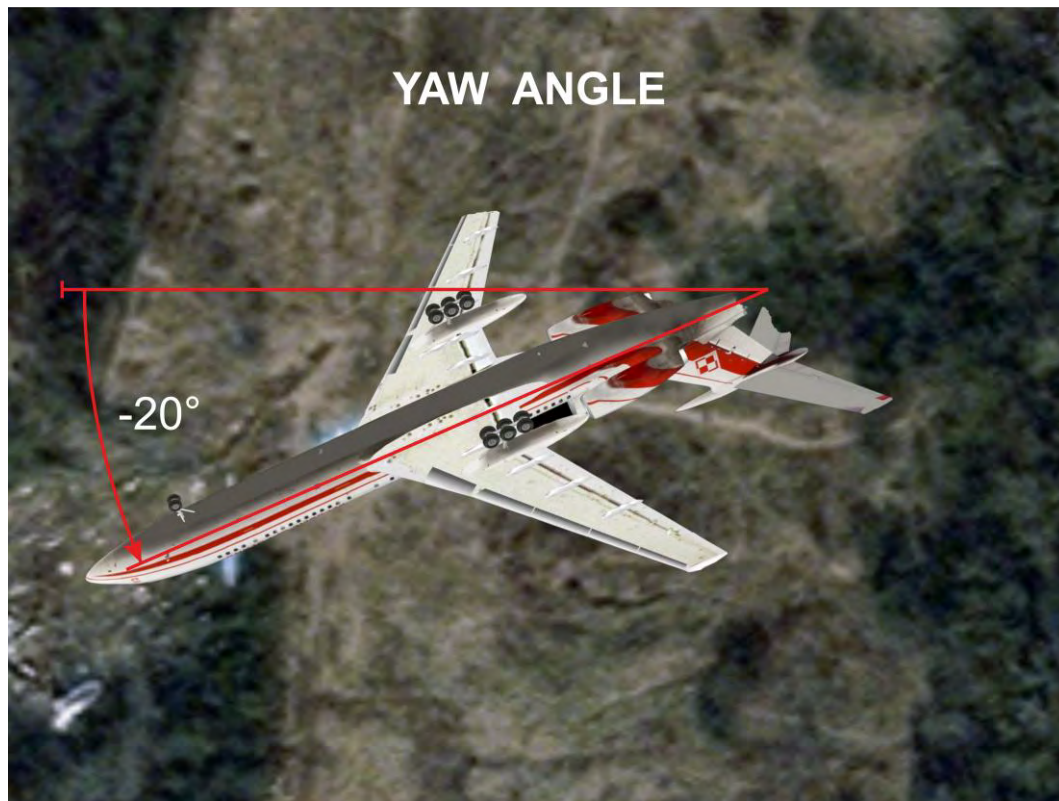
Fig. 17. Yaw angle at impact with the ground
