# **Final Report**

**from the examination of the aviation accident no  
192/2010/11**

**involving the Tu-154M airplane, tail number 101,  
which occurred on April 10<sup>th</sup>, 2010**

**in the area of the SMOLENSK NORTH airfield**

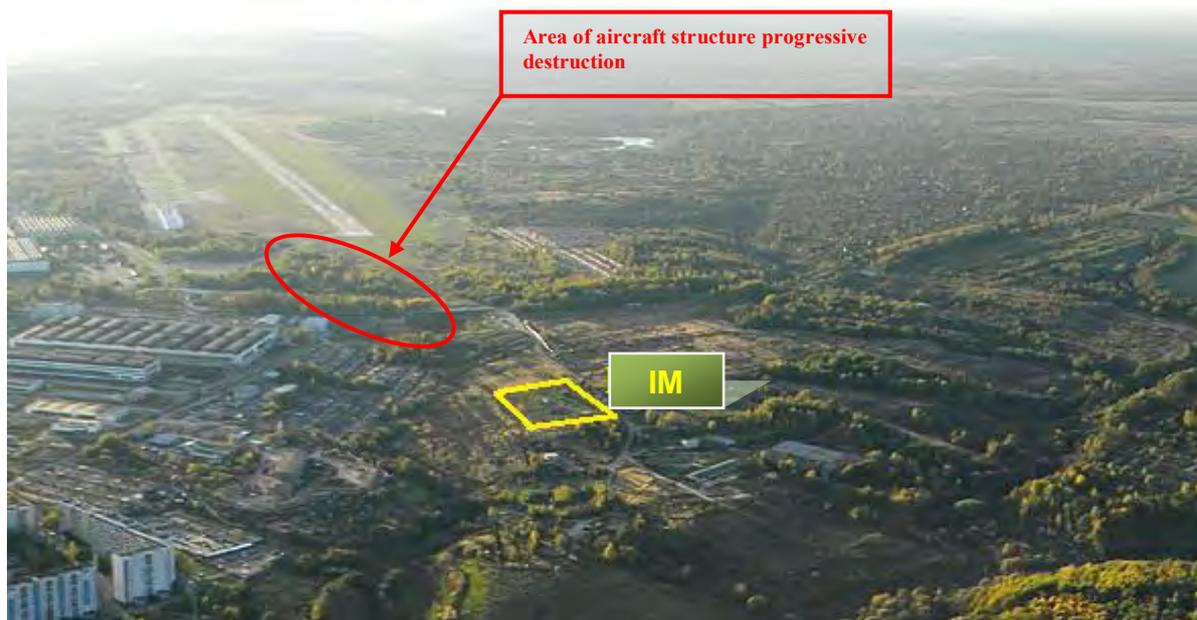
Geographical co-ordinates (acc.to WGS-84)	N54°49'28,09"; E32°03'7,26"
Height above sea level	253 m
Deflection from RWY centreline	105 m left (southward)

Fig. 8. Place where aircraft struck obstacles and the ground

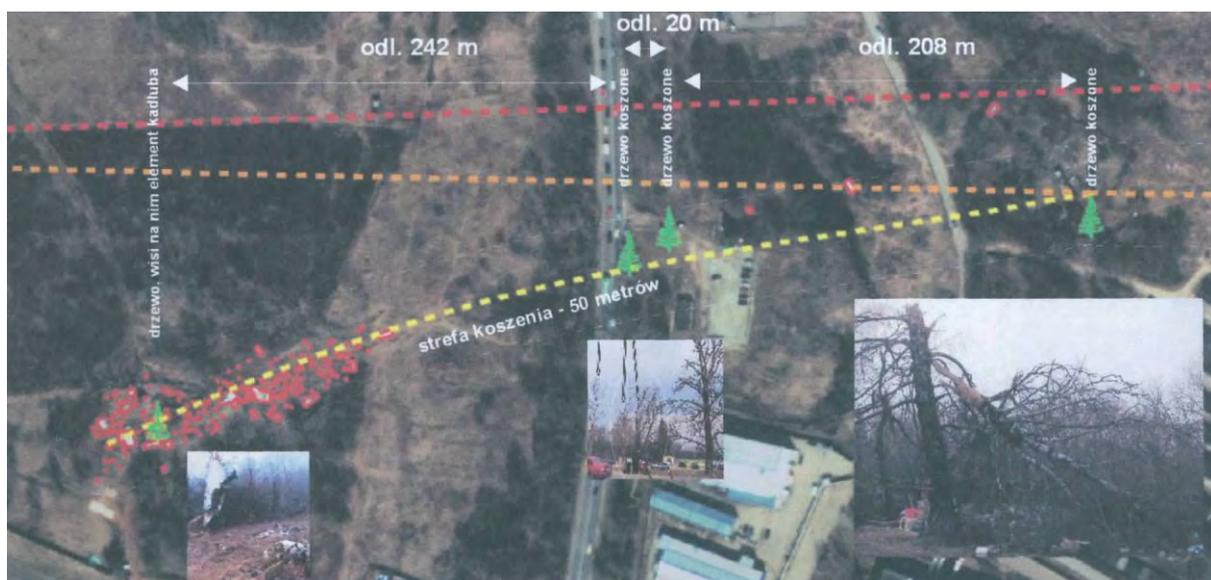
Fig. 9. Place of impact, characteristic measurements depicted.<sup>39</sup>

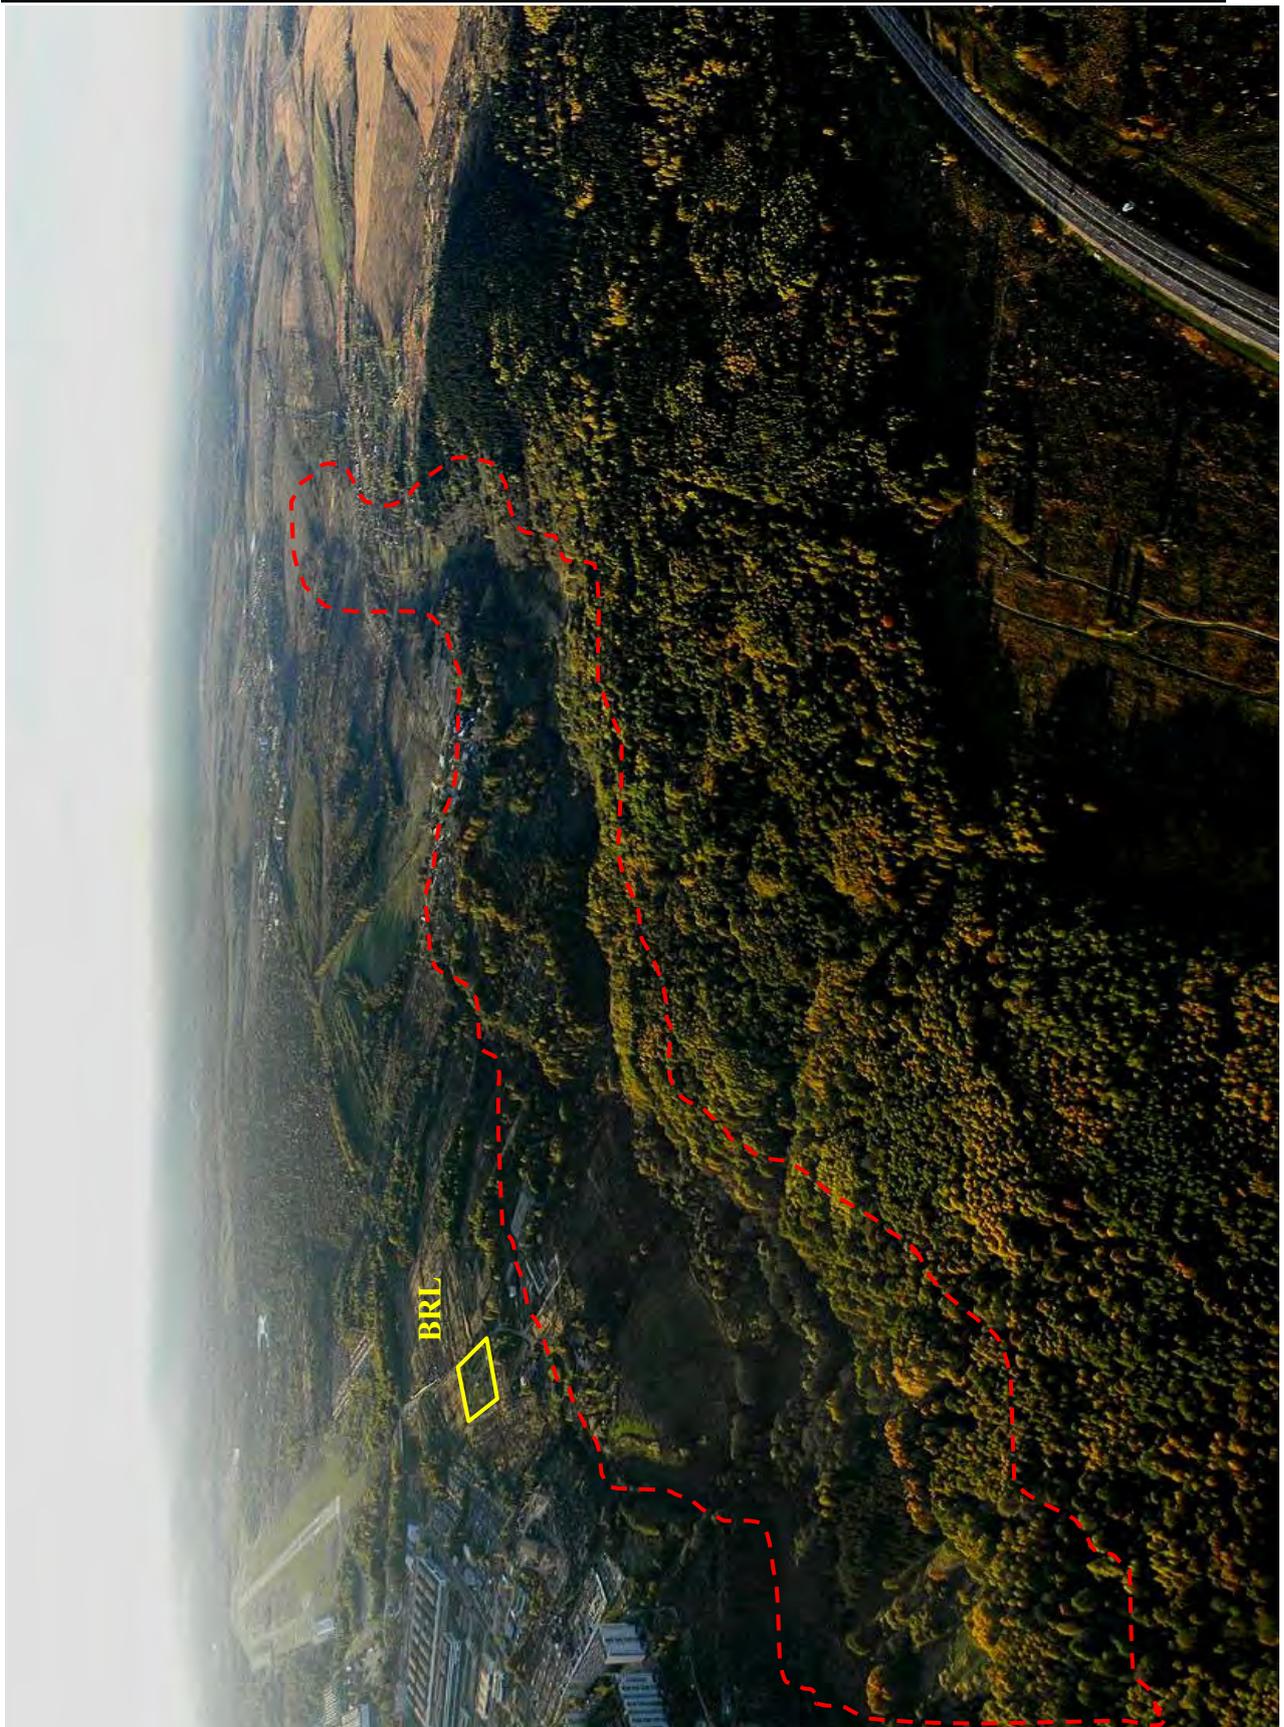
Photo 19. IM positioning and terrain relief in the area of descent to RWY 26 at SMOLENSK NORTH (visible terrain depression and a ravine with a watercourse in the area of IM)

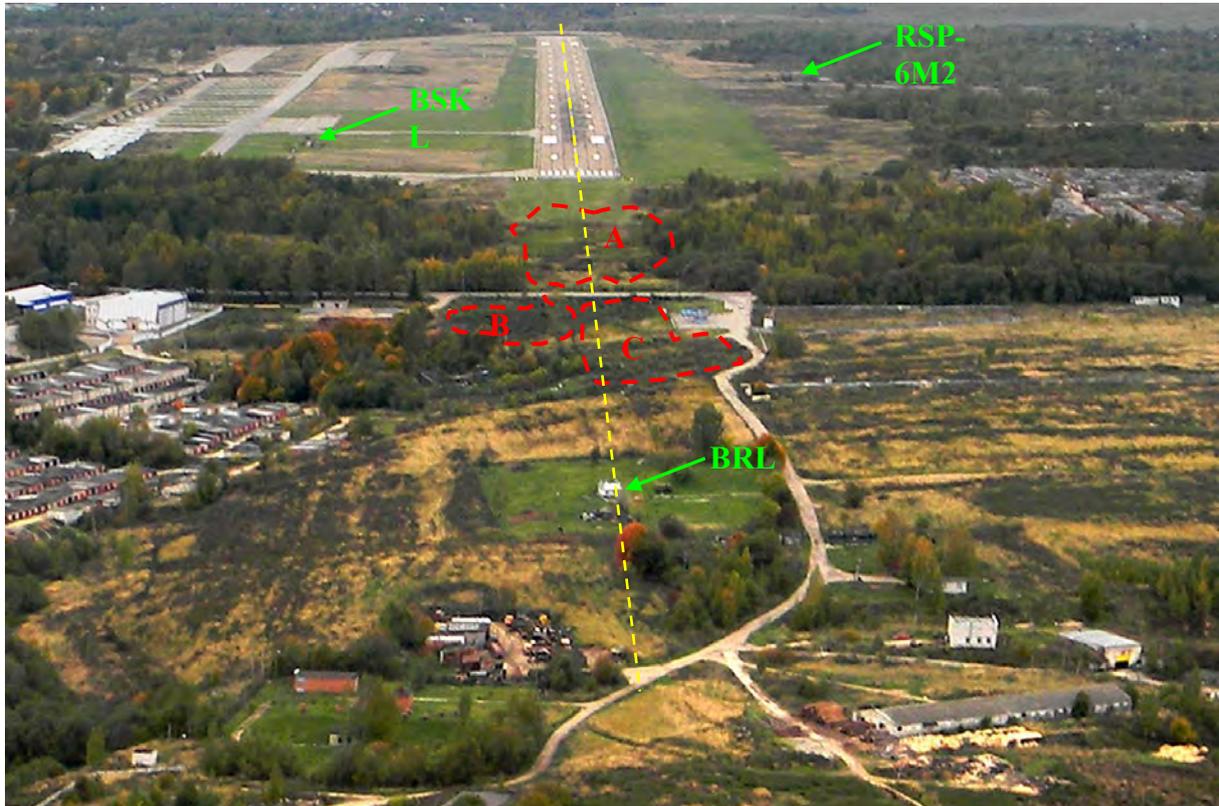
After 10.04.2010, there was felling of trees around the glide path to SMOLEŃSK NORTH. In Fig.4, place of felling of view-obscuring trees are marked; those were the trees which cluttered the radar screen and obstructed the sight of RWY 26 approach lights. Following drawings depict differences in tree stands between 10.04.2010 r. (Fig.Fig. - Fig.8) and 30.06.2010.

Fig.20. SMOLEŃSK NORTH – areas where trees and shrubs were removed (red) on RWY 26 centerline (yellow) (photographed on 30.06.2010)

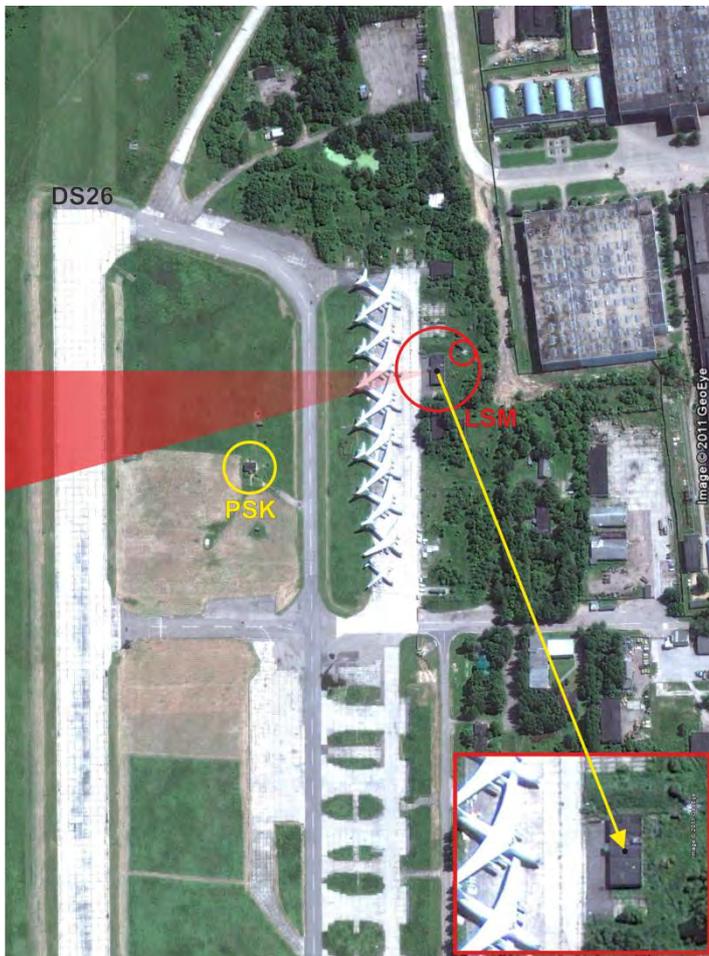
The cloud base and visibility, measured at the atmospheric station on 10.04.2010 did not reflect real lateral and vertical visibility values that were measured in the Near Control Zone and on the landing direction. According to Russian regulations, measuring should be taken at the Near Control Zone as well as Outer beacon and Inner beacon (Instruction NAMS 86 items 21-23).

Fig.18 SMOLENSK NORTH aerodrome – location of the atmospheric station  
**LSM** – aerodrome atmospheric station                      **PSK** – ancillary control post
