Annex No 1.1 – Landing approach profile of Tu-154M aircraft tail number 101 at SMOLEŃSK  
NORTH aerodrome on 10.04.2010 (from 3500 m)

## Description and analysis of the operation of on-board systems of Tu-154M aircraft No 101

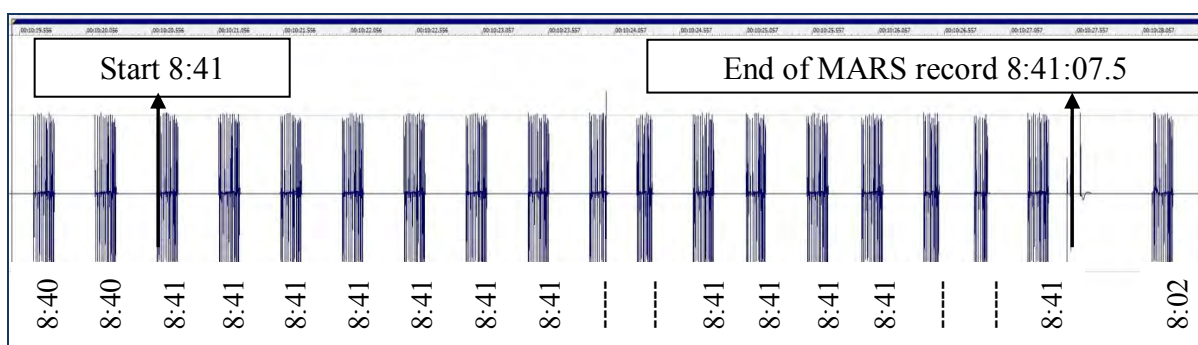
Fig. 5. View of the last 16 recorded time markers at 8:41

An analysis of the record on Track 4 shows that before the change of hour at the start of recording 12 identical time markers were recorded with encoded hour 8:02, which means that recording started no later than 0.5 s after 08:02:53.5. The end of the recording was identified in the same manner – it was determined that it was the 16th time signal with the same structure recorded at the end of the recording<sup>5</sup> (Fig. 5). On that basis, it was determined that the end of recording by the MARS-BM recorder occurred no later than 0.5 s after 08:41:07.5.

<sup>5</sup> Four incorrect pulse strings in the final stage of the recording were caused by vibrations resulting from the aircraft's collision with trees.

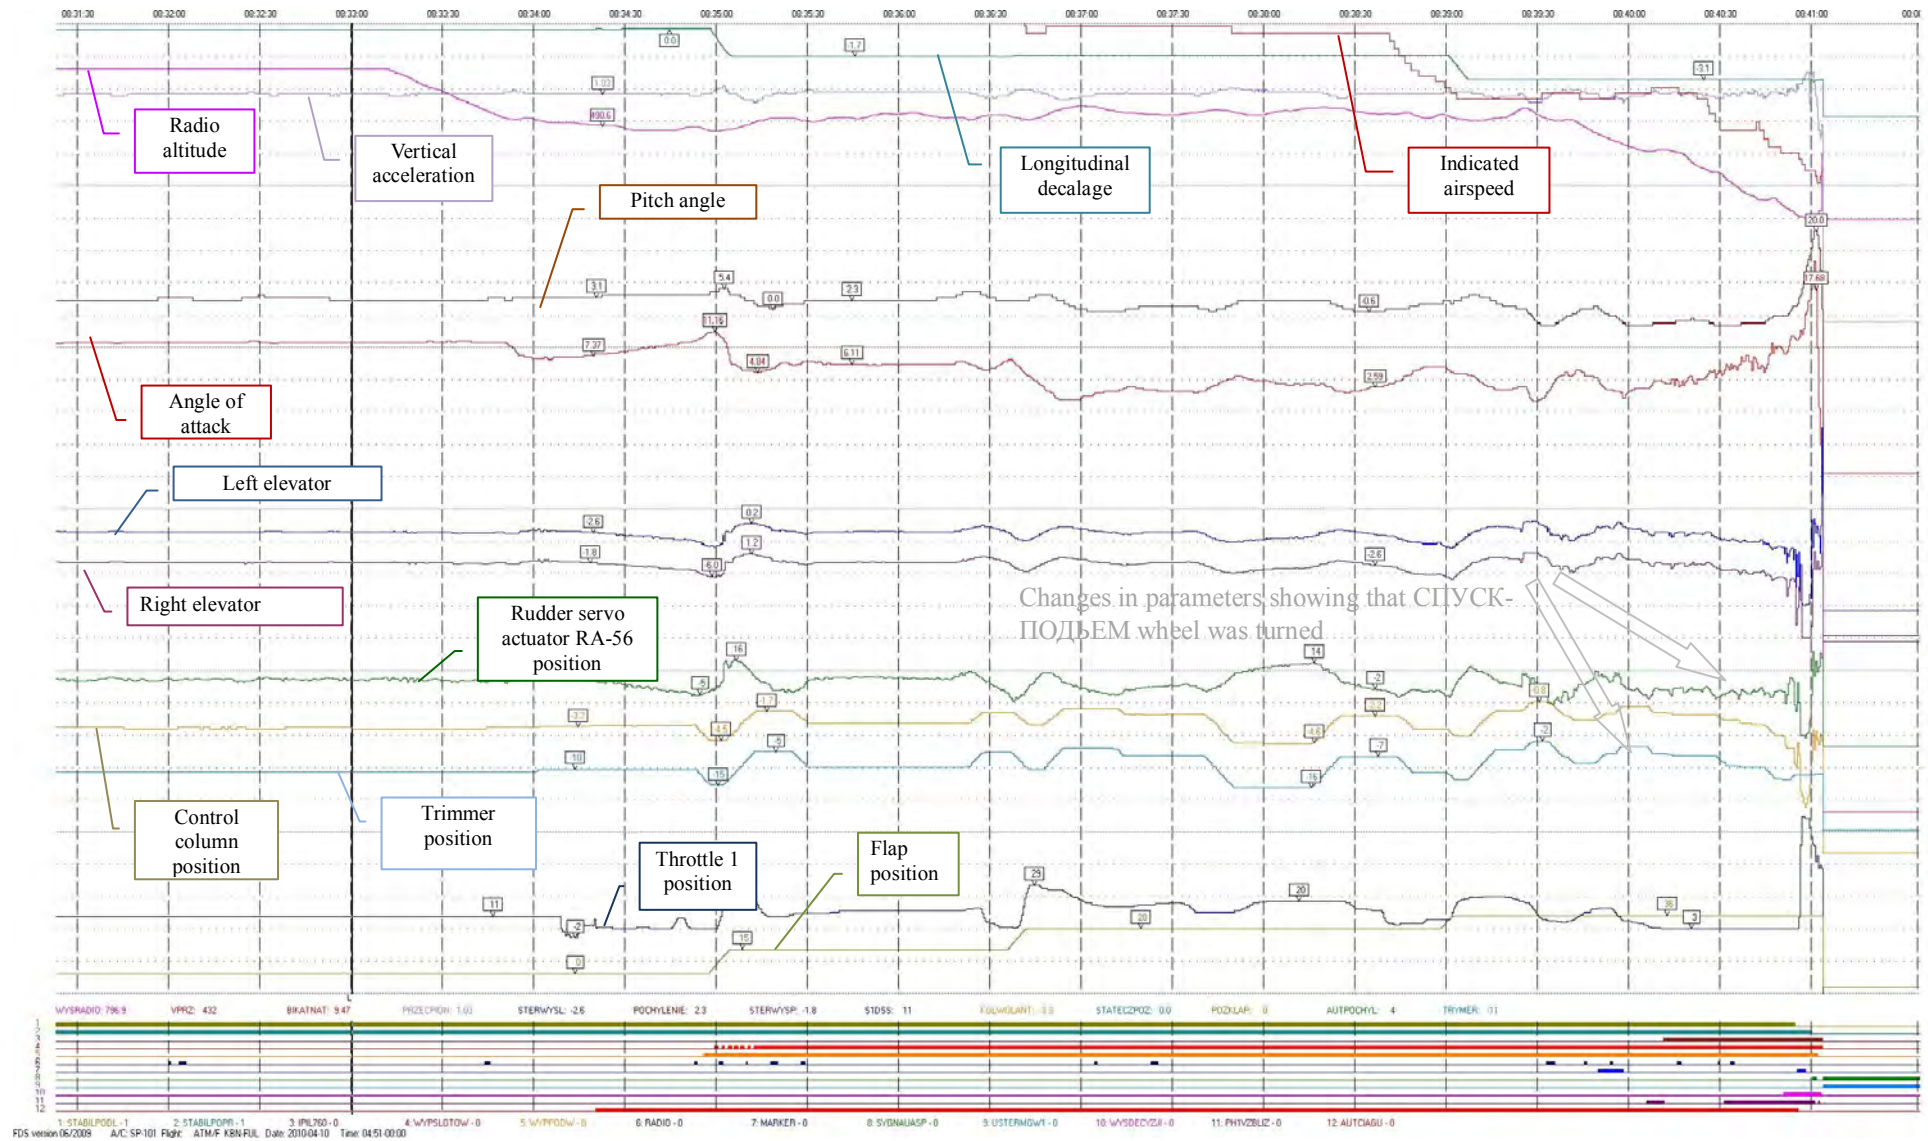
Fig. 14. Selected parameters during landing approach – pitch channel

- 1) No anomalies were found in the operation of the ABSU automatic control system. The movements of actuator shafts changing the position of elevators, ailerons, and rudder were fluid and did not extend to reach extreme values.

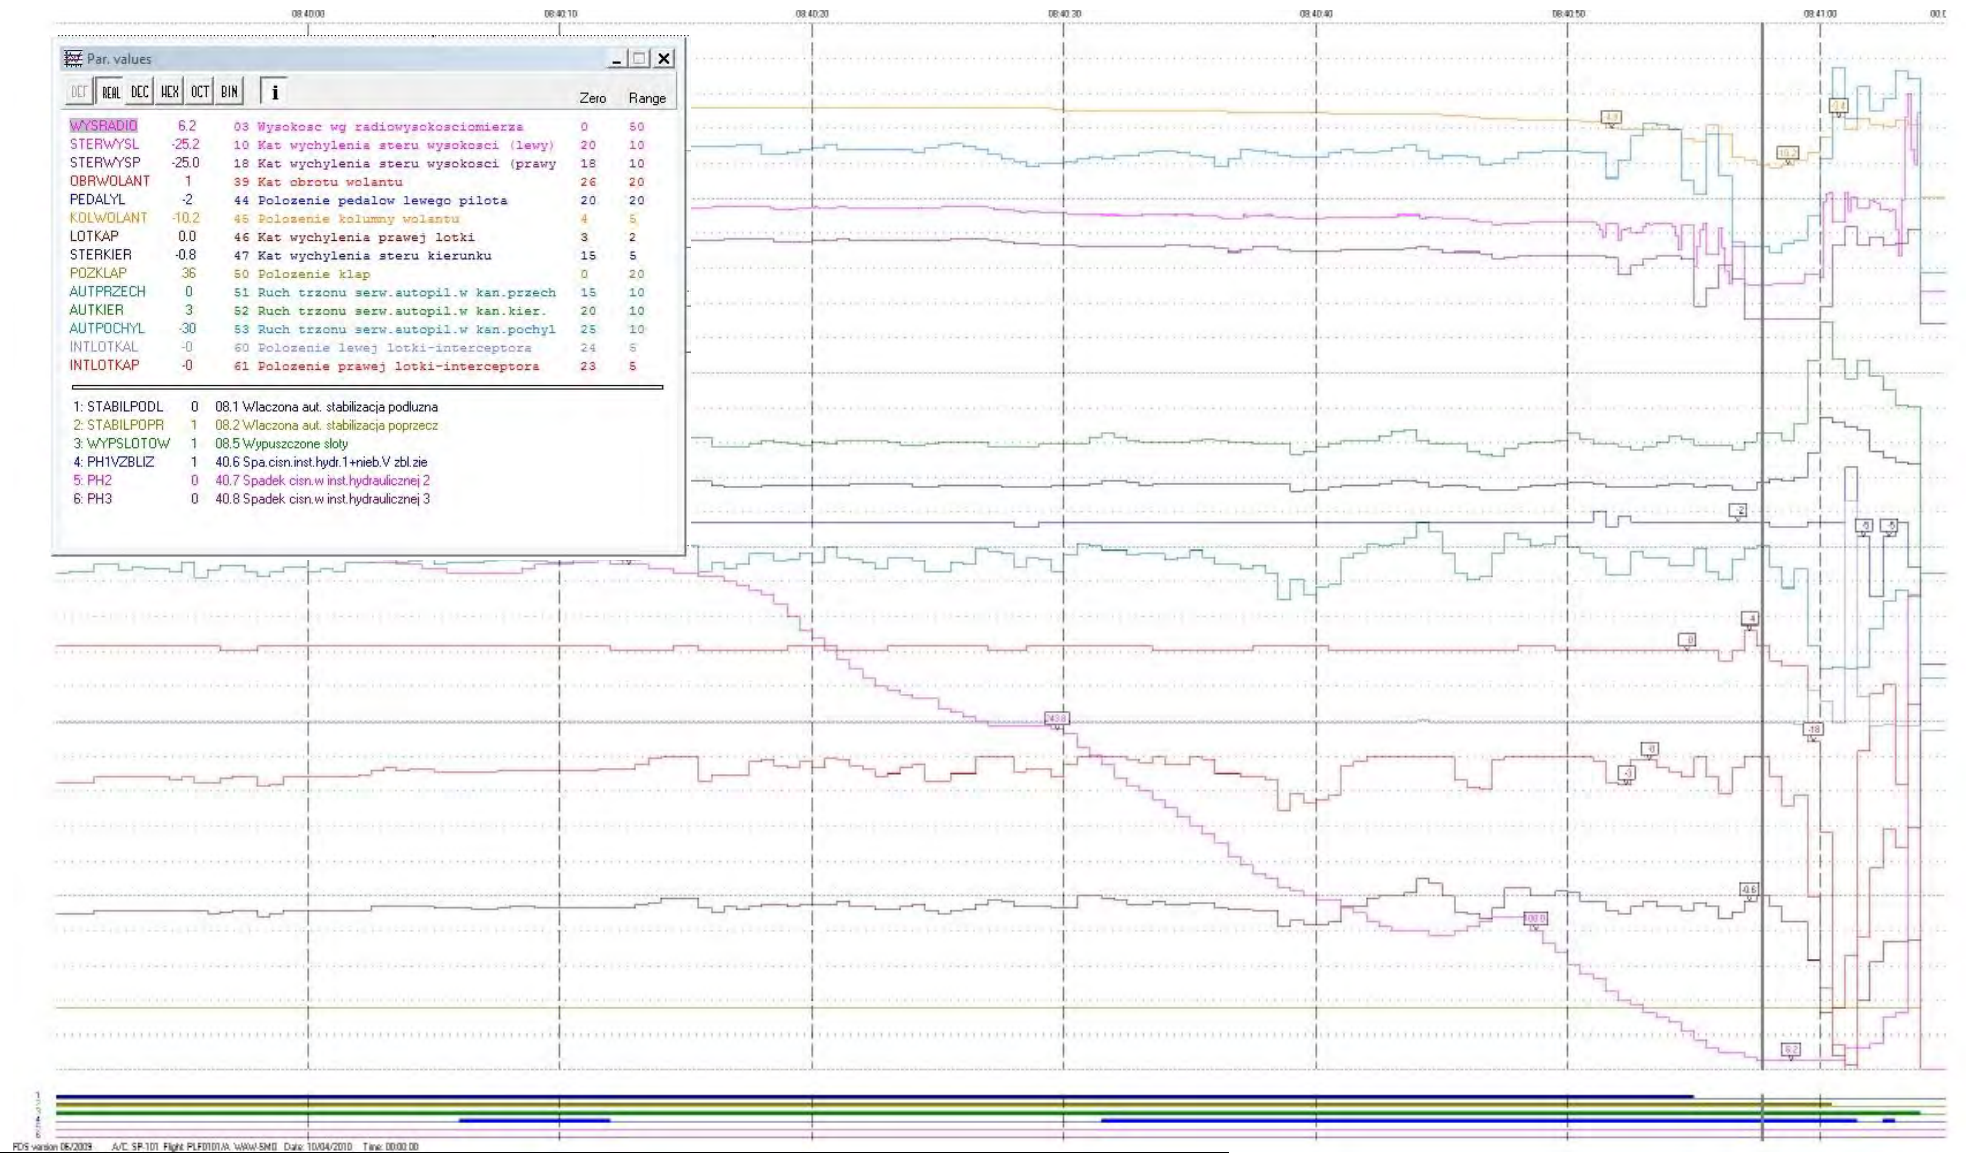
- 1) In the time interval from the takeoff to 0841:03 no signals appeared in the PH1VZBLIZ, PH2 and PH3 channels indicating a failure of any of the three hydraulic systems. This is in agreement with the MARS-BM records, in which there is flight engineer call out on a hydraulic system failure.

- 3) The change of parameters in POZKLAP channel was compared. It was found out that throughout the 0840:59–08:41:03 time interval the flap position did not change.

- 4) The change of parameters in WYPSLOTOW channel was compared. It was found out that throughout the 0840:59–08:41:03 time interval the slats were retracted.

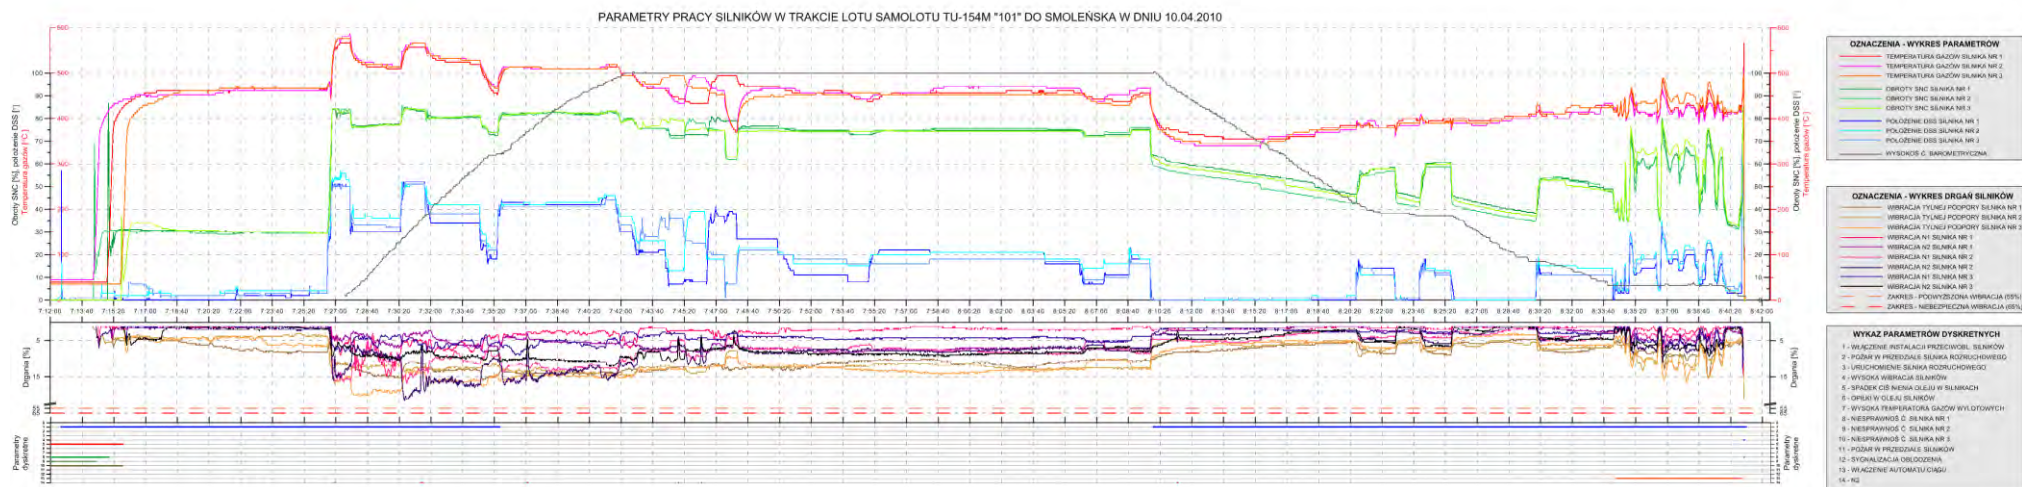
Based on an analysis of selected parameters read from the ATM-QAR recorder, it was found out that engine operation parameters were in compliance with the applicable technical specifications (TS) from the start-up, throughout the flight until the accident. The speeds of each engine changed in line with changes in the position of the corresponding throttle levers. Gas temperatures downstream of the turbine and speeds of low pressure compressors (LPCs) of all engines running within the same throttle lever setting ranges were at the same level and took rated values in compliance with the applicable TS. An analysis of the motor operation parameters showed that as the flight conditions changed – change of height and temperature – the engines operated in a stable manner within the ranges in compliance with the TS (“Двигатель Д-30КУ 2 серии Руководство по технической эксплуатации”, “Ту-154М. Руководство по летной эксплуатации”), which is indicative of correct operation of the engine automatic control systems.

The abrupt changes in vibration values in the form of instantaneous peaks, which can be seen on charts representing the vibrations of high pressure rotors of engines 1, 2, 3 (measures by the AVM-219 system) are attributable to the measurement of the second harmonic of “N2” high-pressure rotors, performed cyclically by the crew during the flight (2XN2) switch. In this measurement, the on/off 2n2 instruction is recorded and the „N2” signal recorded for all three engines is replaced by the 2n2 signal.

An analysis of the record of discrete parameters related to the operation of the power plant from the start-up of the engines to 0841:03.5, i.e. 0.5 s before the end of the reliable record on the ATM-QAR recorder, showed the absence of any signals of emergency conditions such as:

which testifies to correct operation of the engines during the flight. No “fire in starter motor compartment” signal was recorded either. The information shown in the record of discrete parameters concerning the failure of engines 1, 2, 3 before their start-up and the “engine oil

hence it can be concluded beyond any doubt that there was nothing to cause **incorrect operation of the power plant in flight.**

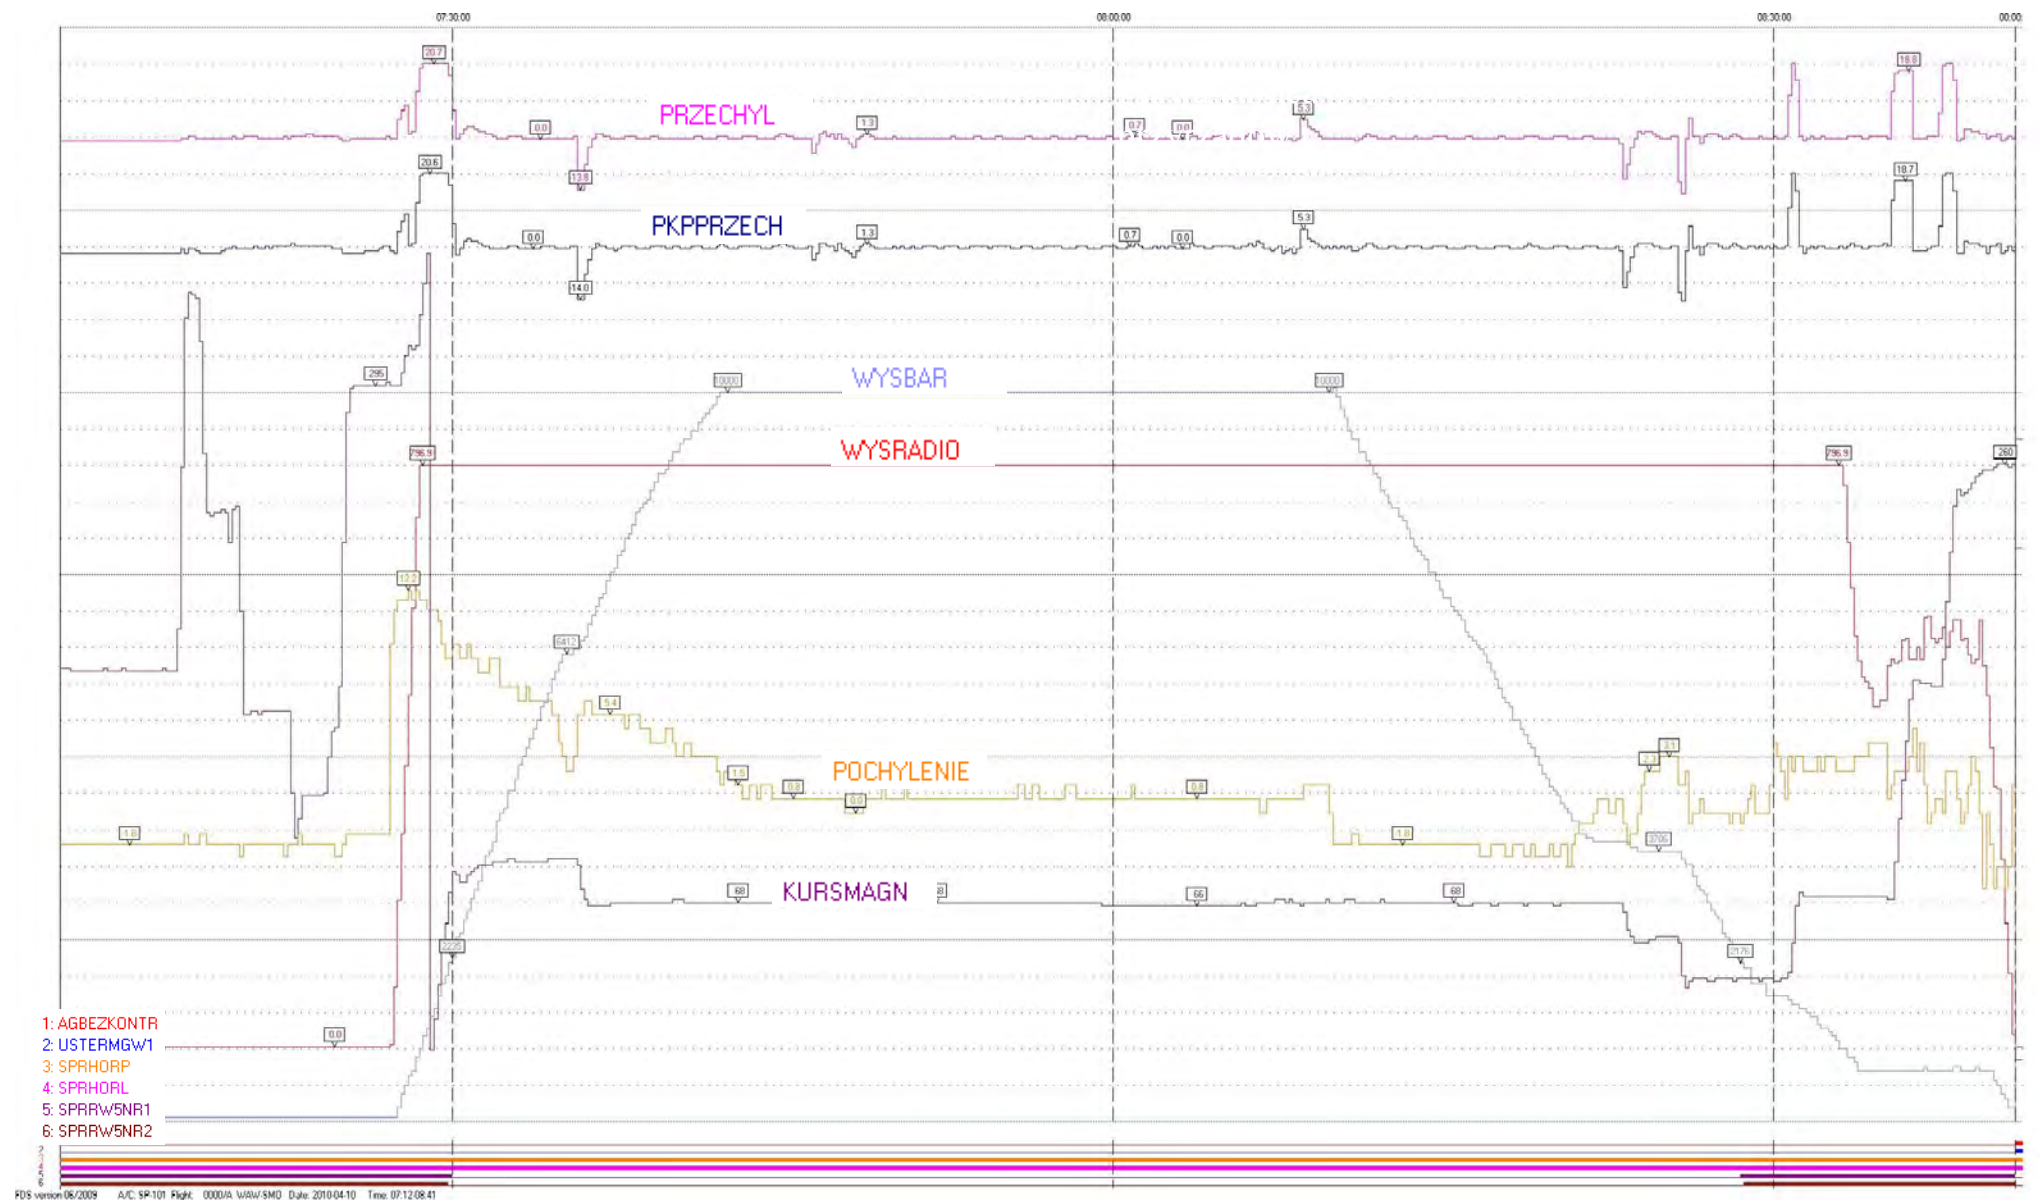
Fig. 27. Flight parameters for selected on-board instruments

The analysis did not reveal any emergency conditions of systems or instrument failures. The manner in which all parameters developed is not indicative of any malfunctioning of units, systems and equipment on board throughout the flight until the moment the left wing of the aircraft aircraft collided with the tree with a diameter of about 30-40 cm.

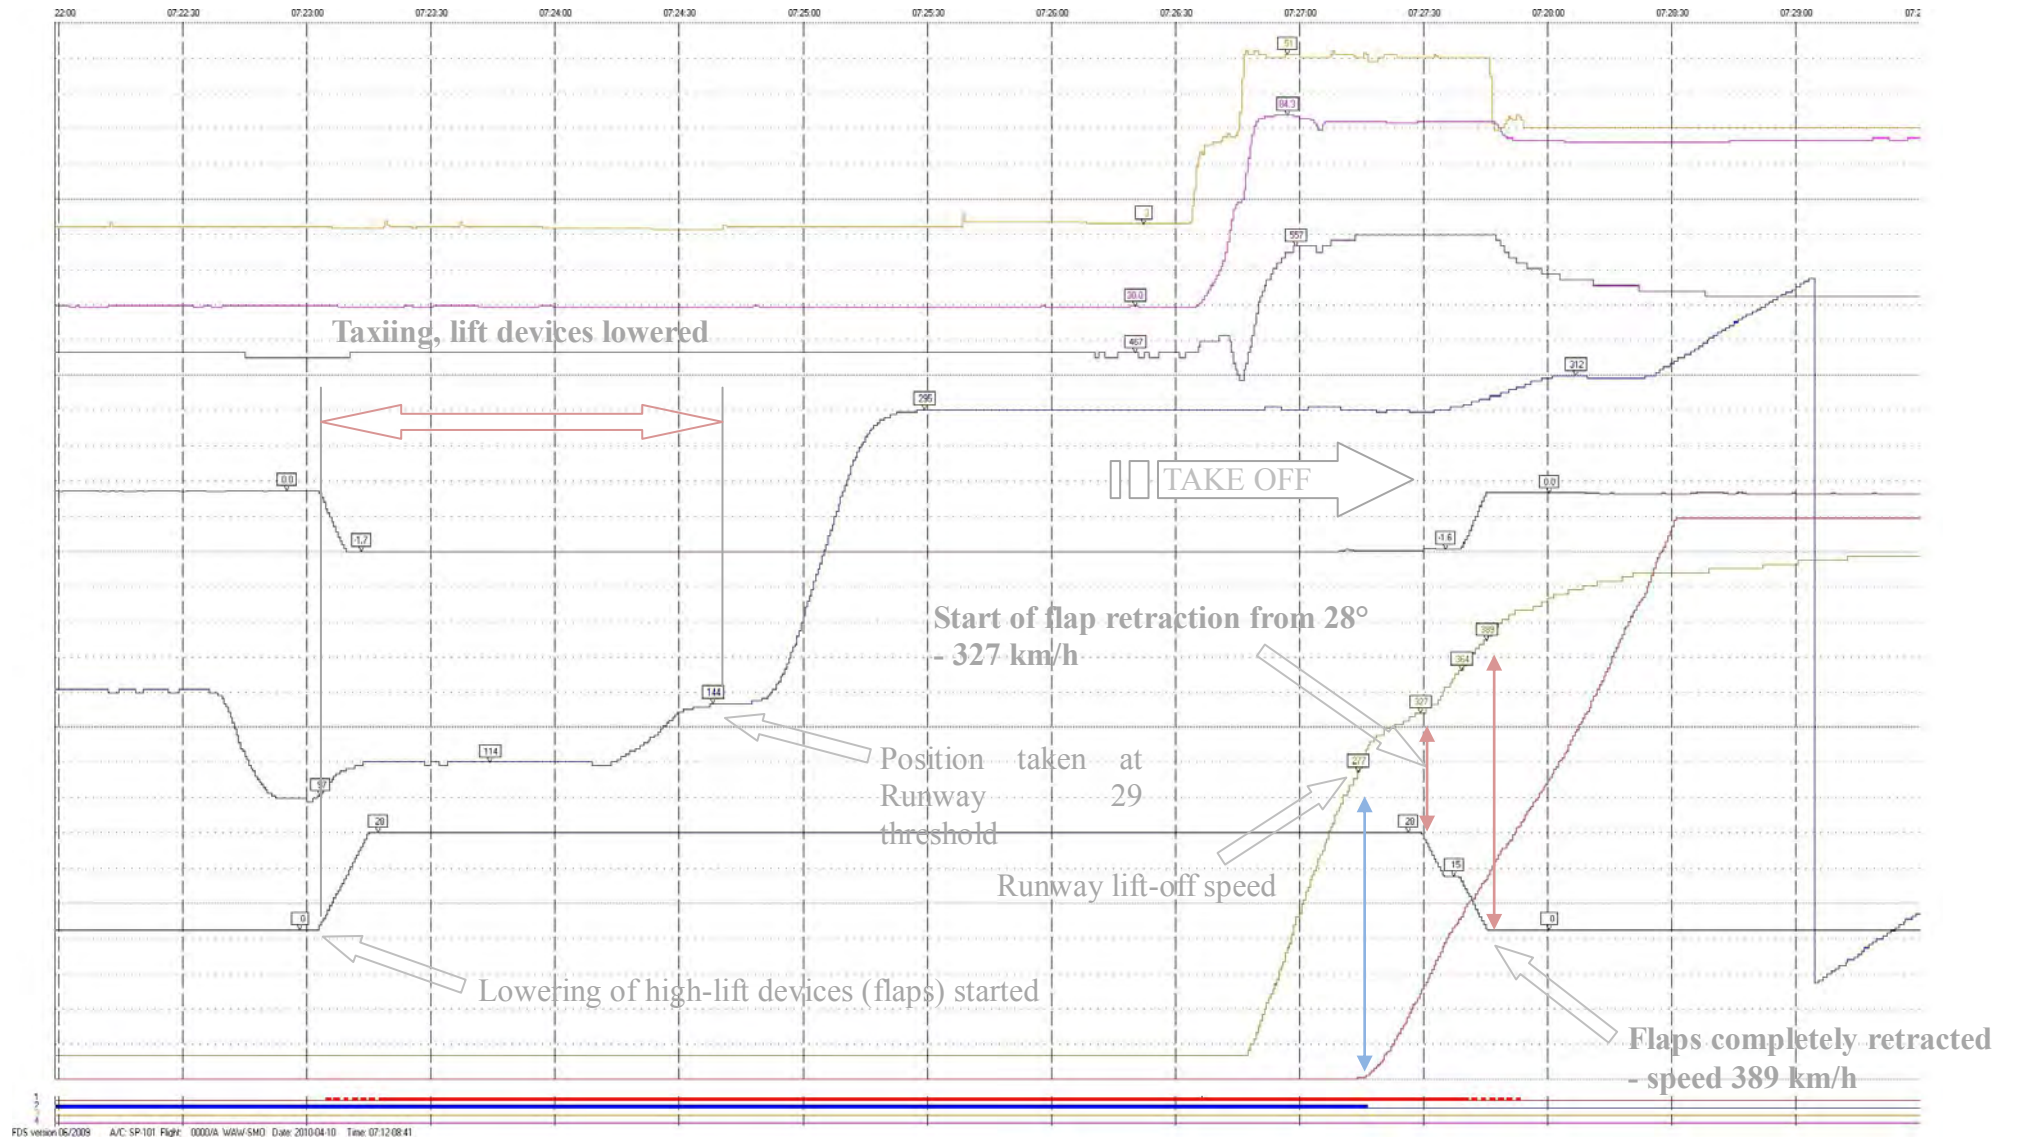
Fig. 28. Selected parameters of the taxiing and takeoff stage

<b>AFPA C5-1</b>			
No	No of procedure	Description of procedure	Duration and values of additional parameters
1.	AL35A	Taxiing, lift devices lowered Fig. 28	Duration: 07:23:04-07:23:07 POZKLAP: 4 WYPSLOTOW: 1

2.	AL35A	Taxiing, lift devices lowered Fig. 28	Duration: 07:24:53-07:25:17 POZKLAP: 28 WYPSLOTOW: 1
3.	AL29A	Retraction of flaps from 28 below $V_p$ < 330 km/h Fig. 28	Duration: 07:27:29-07:27:30 VPRZ: 327 POZKLAP: 27

4.	AL09A	Retraction of flaps at $V_p$ < 410 km/h Fig. 28	Duration: 07:27:45-07:27:46 POZKLAP: 0 VPRZ: 389
5.	AL31A	Flight at $V > 460$ km/h below FL100 /acc to ICAO/ Fig. 29	Duration: 07:29:12-07:30:53 VPRZ: 493 WYSBAR: 3000 WYSRADIO: 796.9
<b>08:40:59.375 – collision with tree</b>

All the exceeded limitations mentioned in Sections 1-5 and 12-13 were not due to incorrect operation of the aircraft, but resulted from incorrect use of the aircraft by the crew.

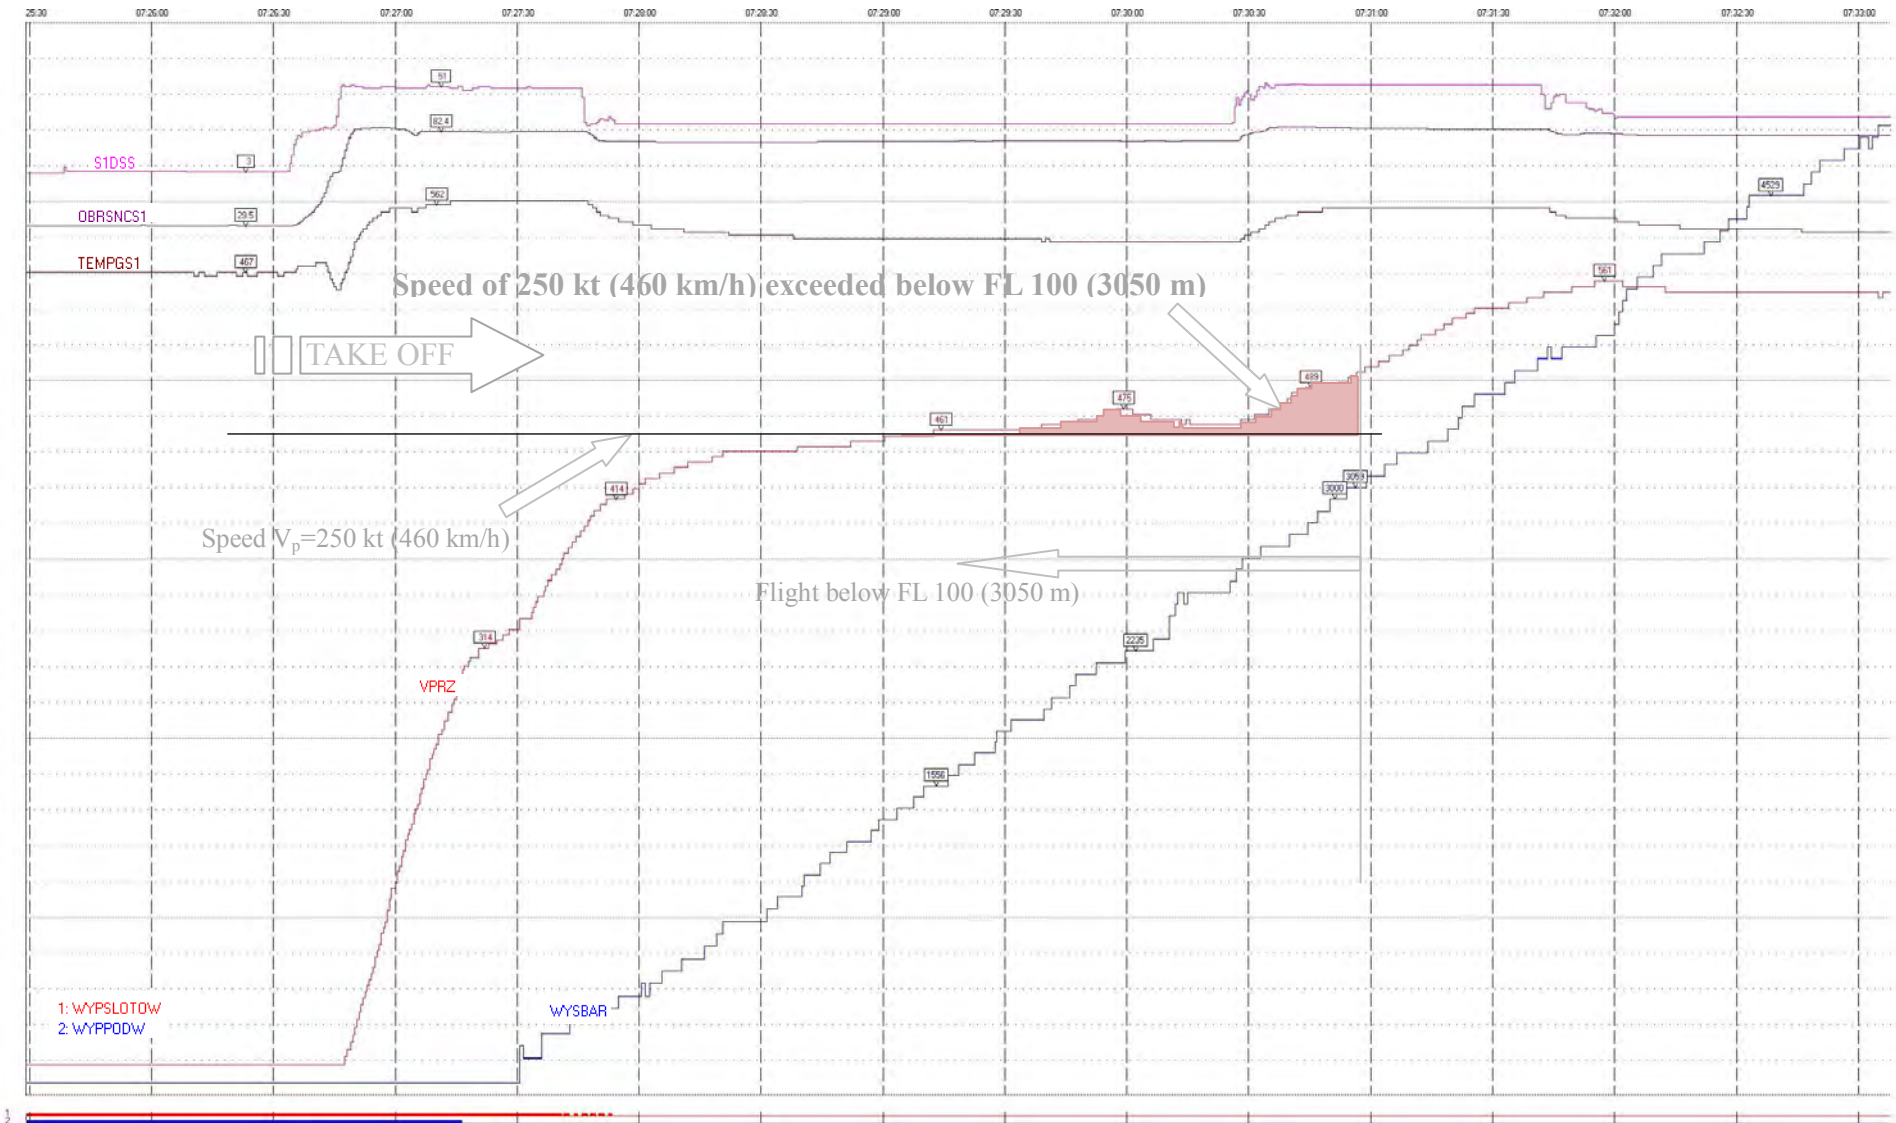
Fig. 29. Exceeding the speed of 250 kt (460 km/h) during flight below FL 100 (3050 m)

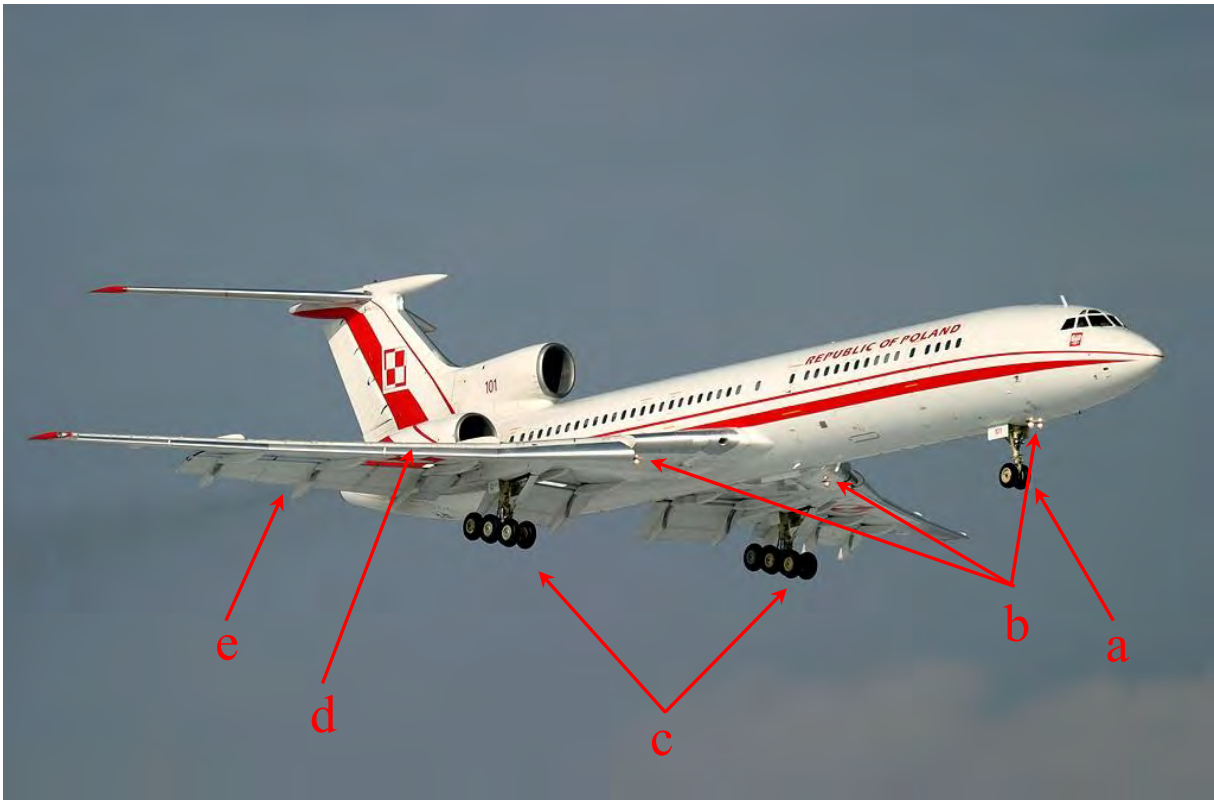
At the time of collision (contact) with the first ground obstacle (the tip of a birch in the vicinity of the inner marker), the configuration of the aircraft Tu-154M, tail number 101, was as presented in Fig. 5.

Fig. 5. Aircraft Tu-154M, tail number 101, in the landing configuration This is confirmed by the extended:  
a – Front landing gear;  
b – Spotlights;  
c – Main landing gear;  
d – Slats;  
e – Flaps.

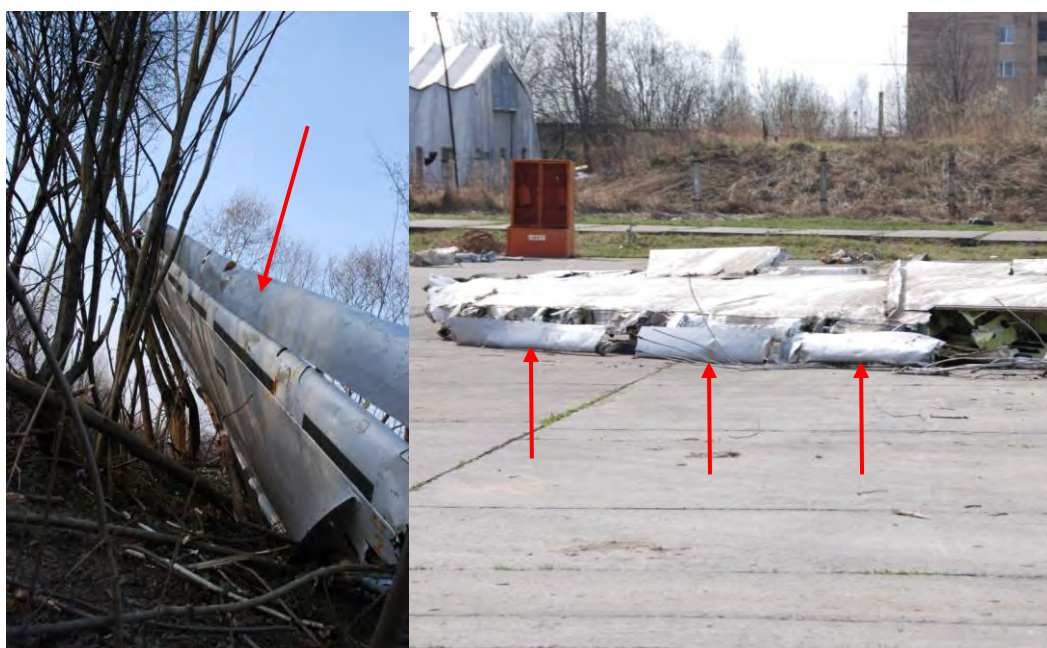
Fig. 7. The slats of the left and right wing of the aircraft in the extended position

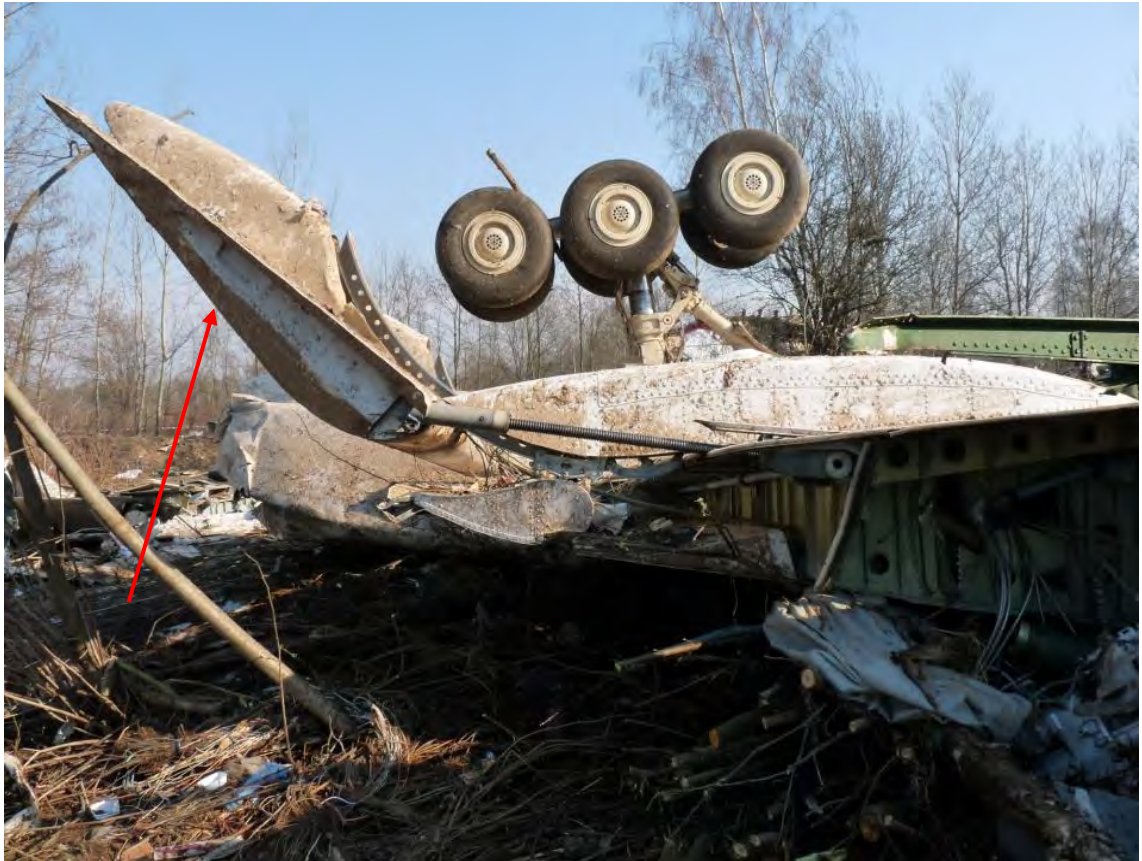
Fig. 8. Flaps in the displaced position

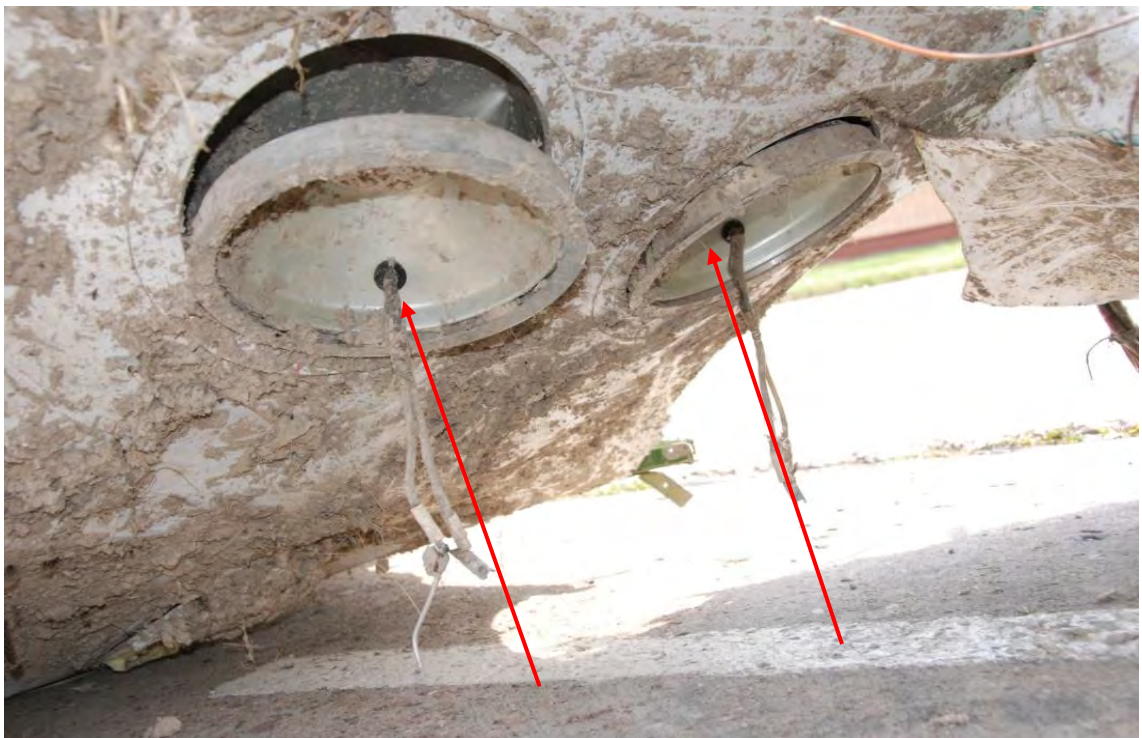
Fig. 9. The front spot lights in the extended position

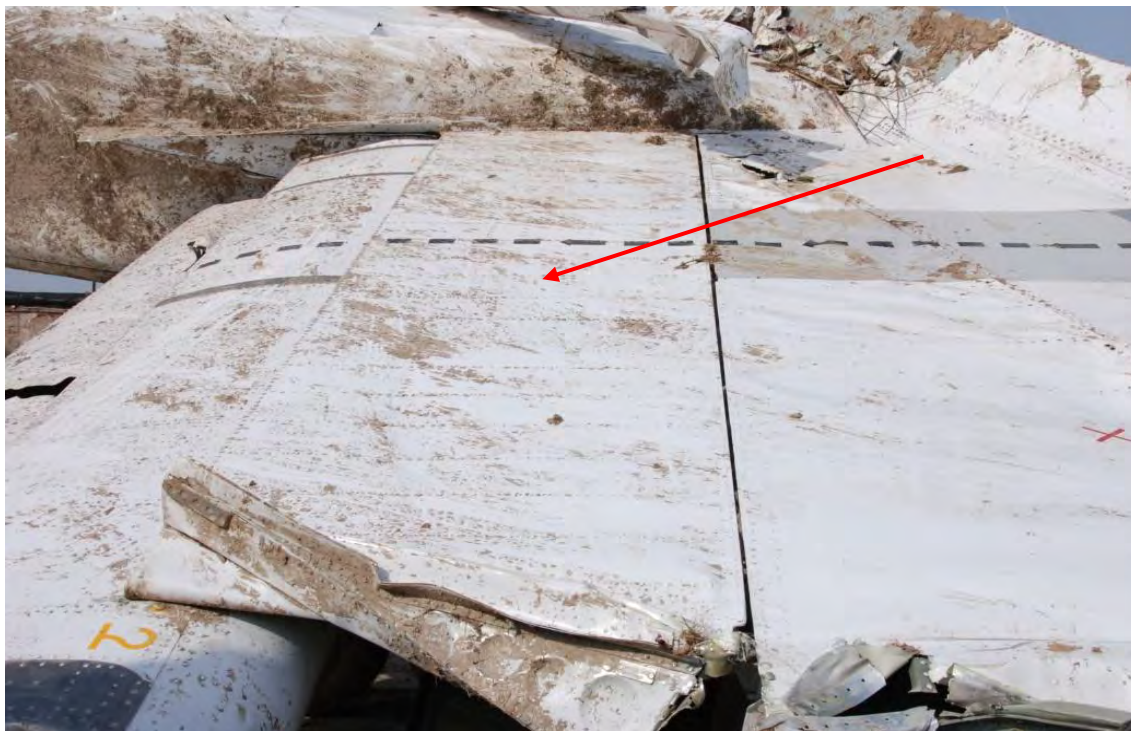
Fig. 10. The spoilers in the retracted position

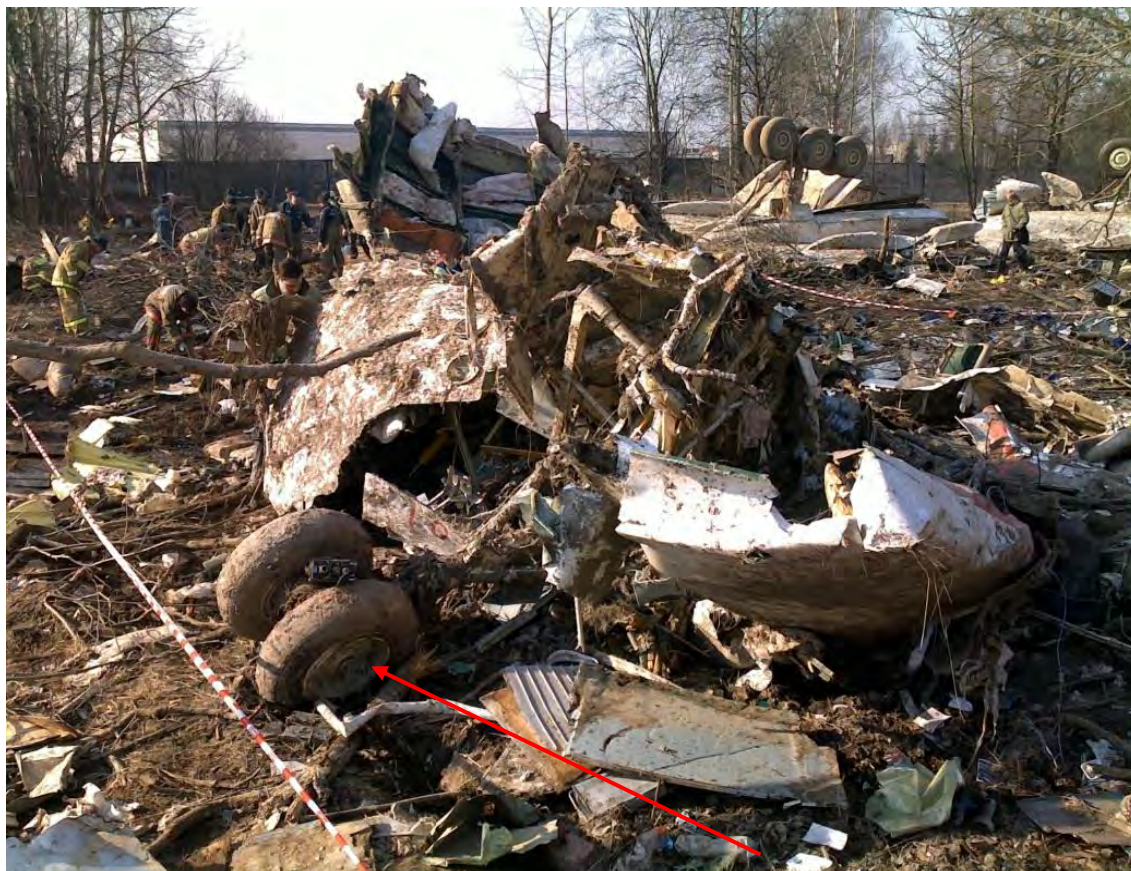
Fig. 11. The nose gear leg in the extended position

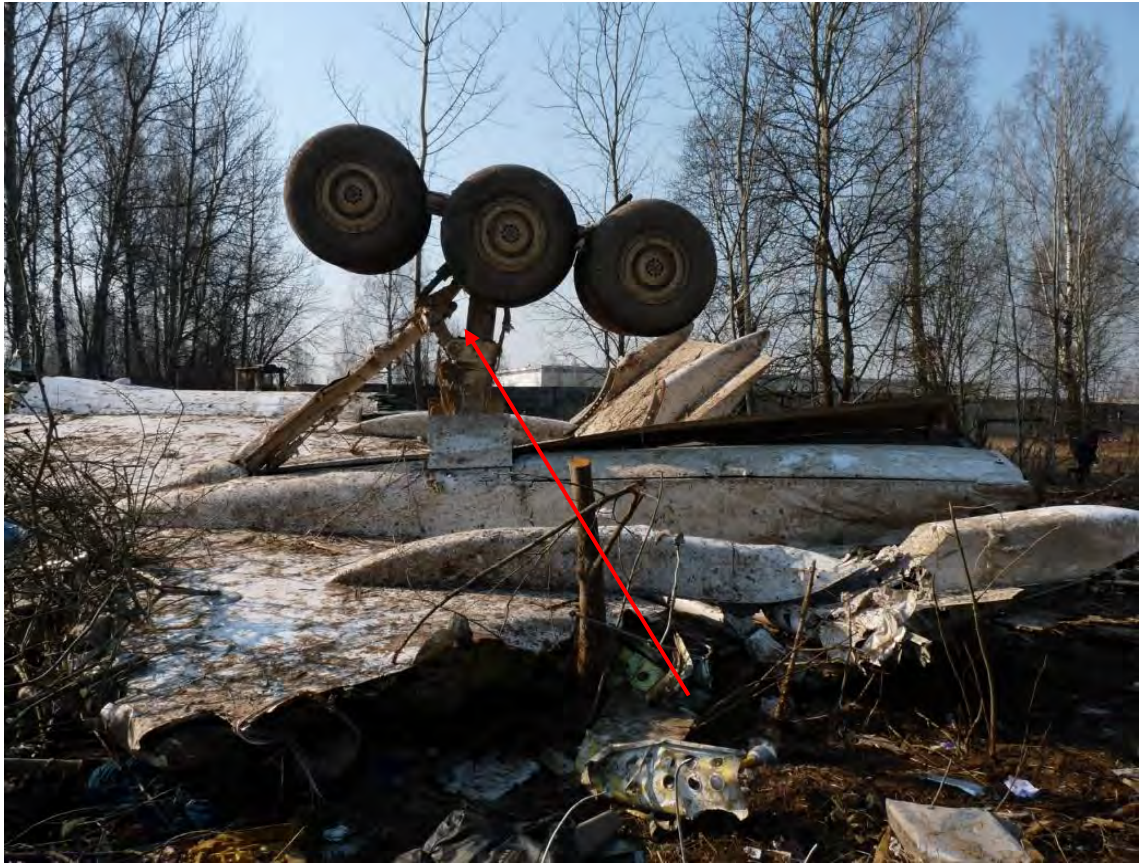
Fig. 12. The right main landing gear in the extended position

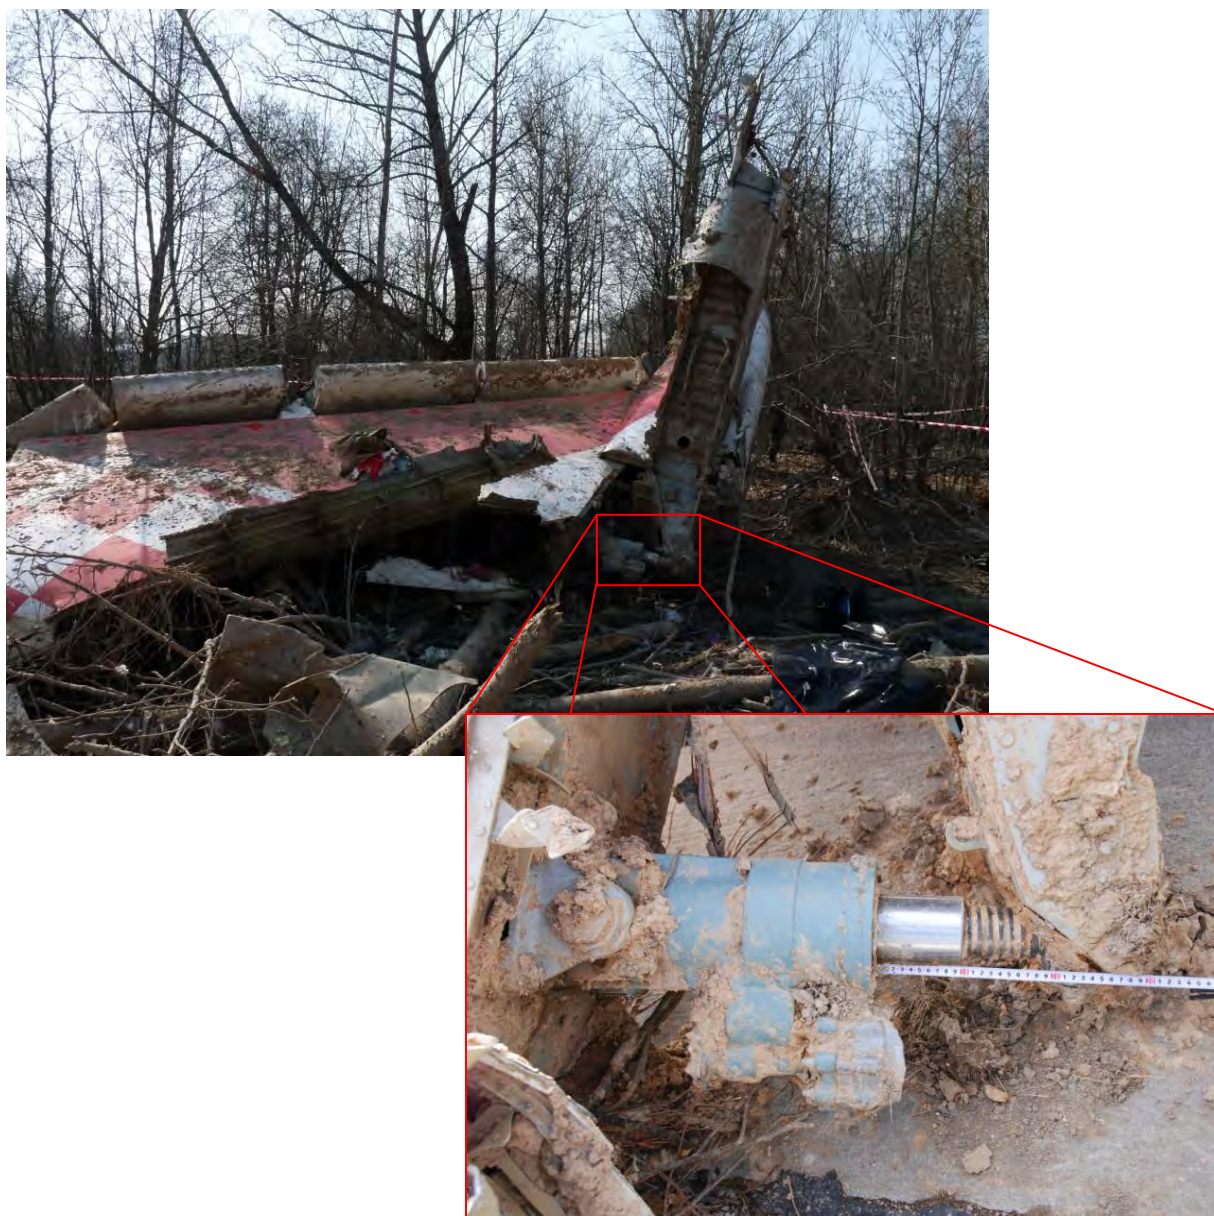
Fig. 14. The tail plane set at  $-3^\circ$

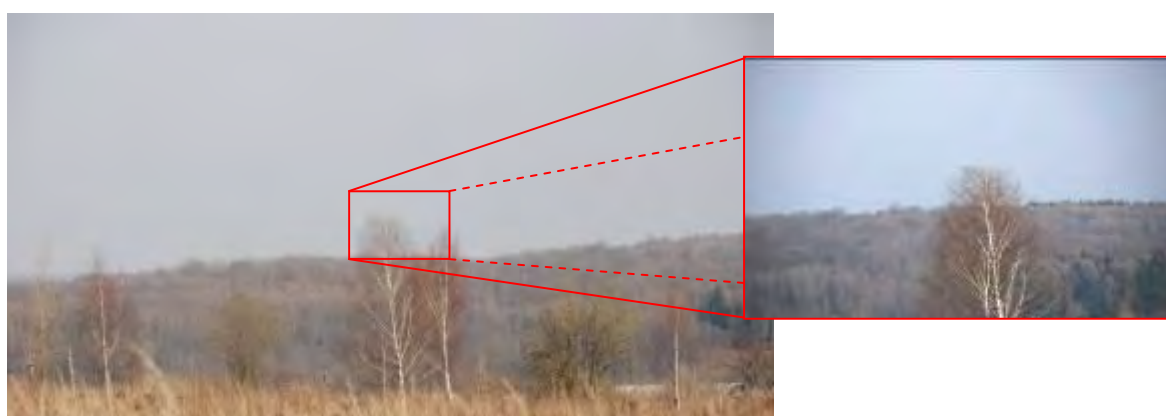
Fig. 3. Birch tree in the vicinity of inner NDB (item 2 – fig. 1 and item 1 - fig. 2) sheared by the right wing edge
