Annex No 1.1 – Landing approach profile of Tu-154M aircraft tail number 101 at SMOLEŃSK  
NORTH aerodrome on 10.04.2010 (from 3500 m)

## Description and analysis of the operation of on-board systems of Tu-154M aircraft No 101

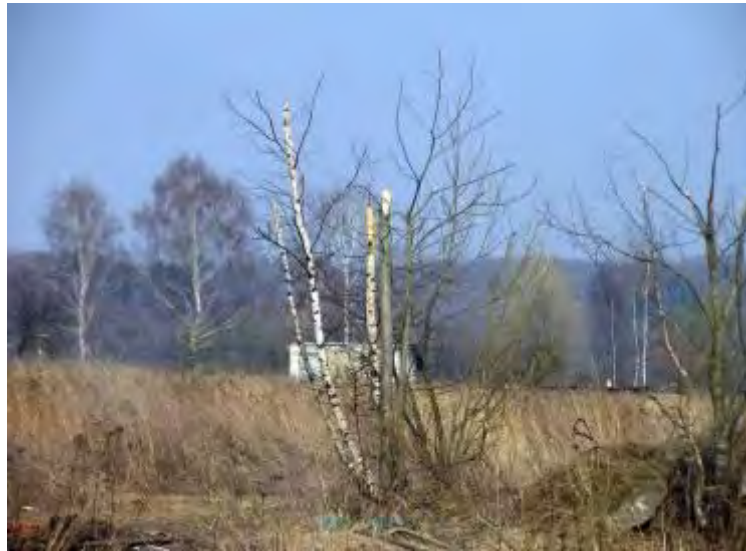
**167 m** and **180 m** away from the first collision with the terrain obstacles, impacts with trees and bushes followed (fig. 4). Those were clusters of young birch trees, which were sheared at about **4 m** above ground by the left wing edge of attack (slat). Even though the

Fig. 4. Cluster of young birches (item 3 fig. 2) sheared by the slat

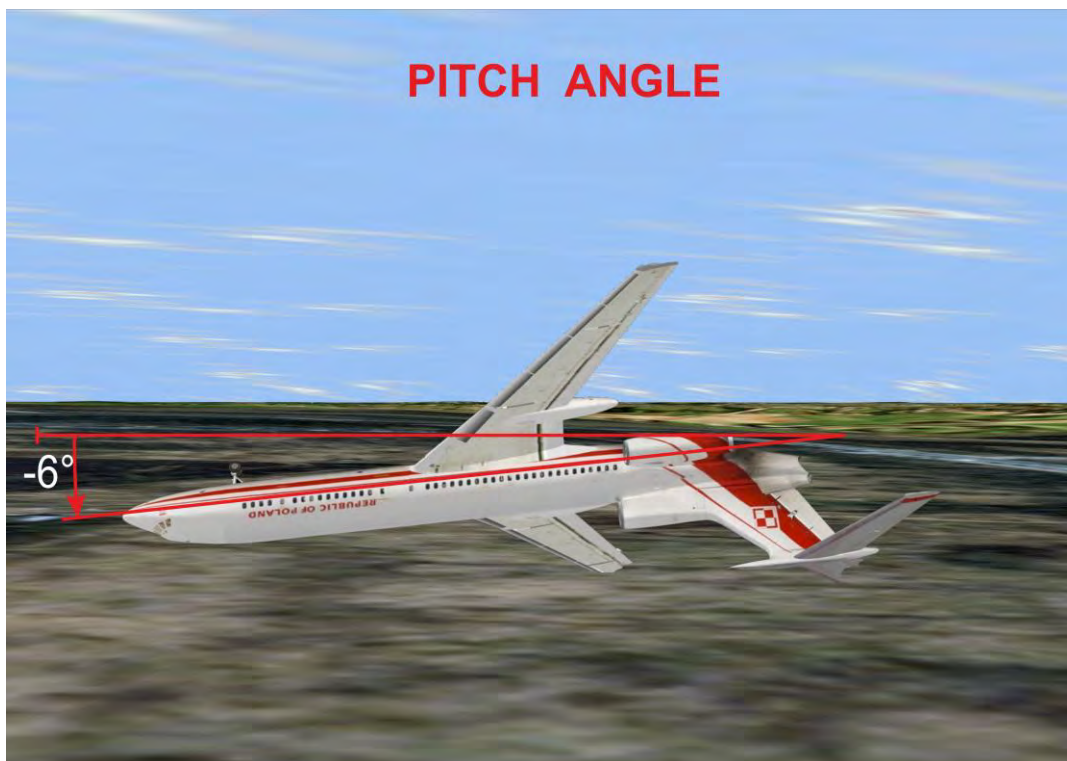
Eventually, the plane collided with the ground with the stump of the left wing first with a roll of approximately  $-150^\circ$  (fig. 15), small negative pitch of about  $-6^\circ$  (fig. 16), on a magnetic course of about  $240^\circ$  (from the moment of the left wing loss, the course deviated by approximately  $-20^\circ$  – fig. 17).

Fig. 16. Pitch angle at the impact with the ground

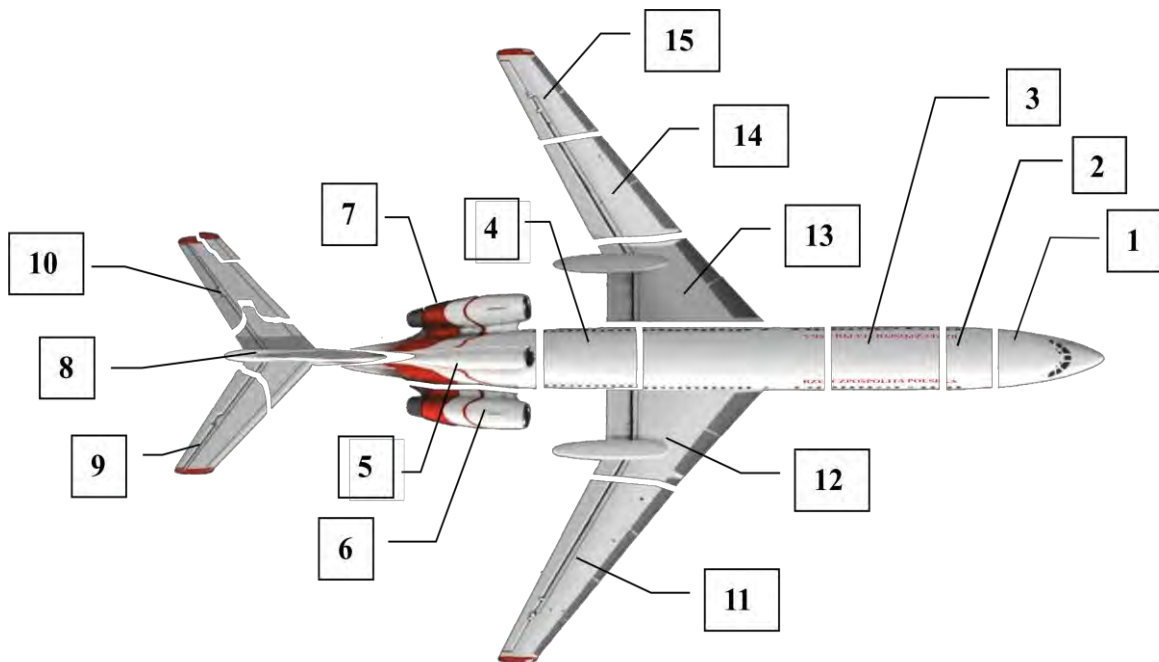
In consequence of the impact, the aircraft was fragmented as shown in Fig. 6.

Fig 6. Graphics presenting the preserved fragments of the aircraft

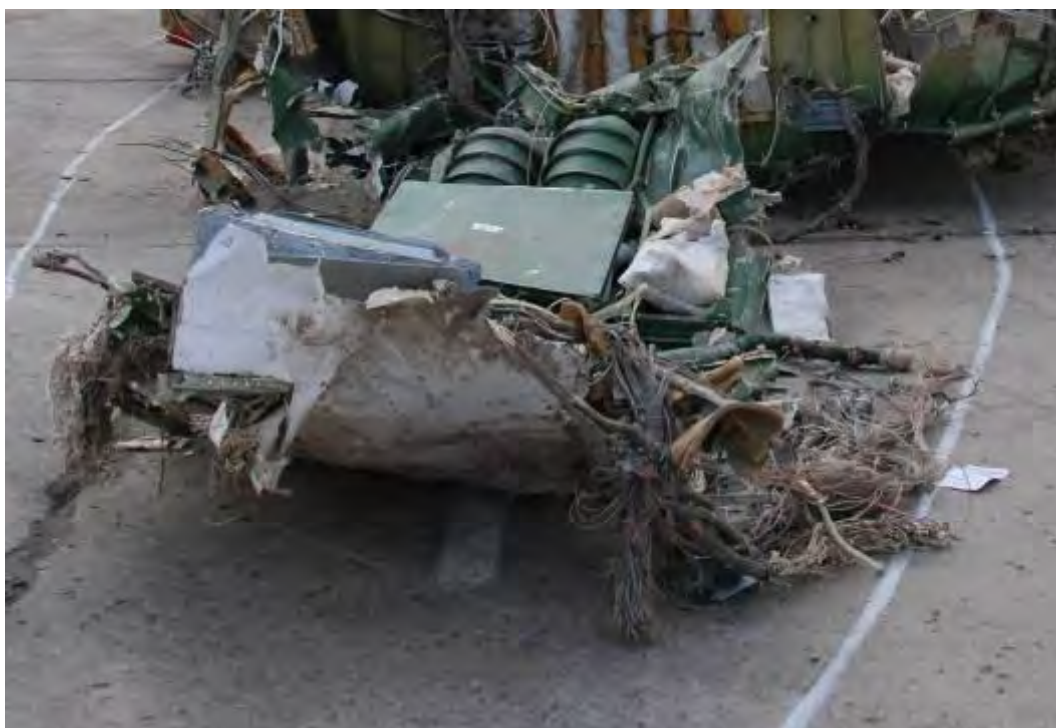
- a) The crushed front lower section from the nose to frame 13 (fig. 7). The whole front section of the aircraft, including the radar cover, cockpit and equipment found in this section of the fuselage were crushed and torn into small fragments. Casings and glass elements of onboard instruments found in the cockpit were extensively dented and broken. Most of them remained attached to the crushed fragments of instrument panels.

Fig. 7. The remnants of the aircraft's front section

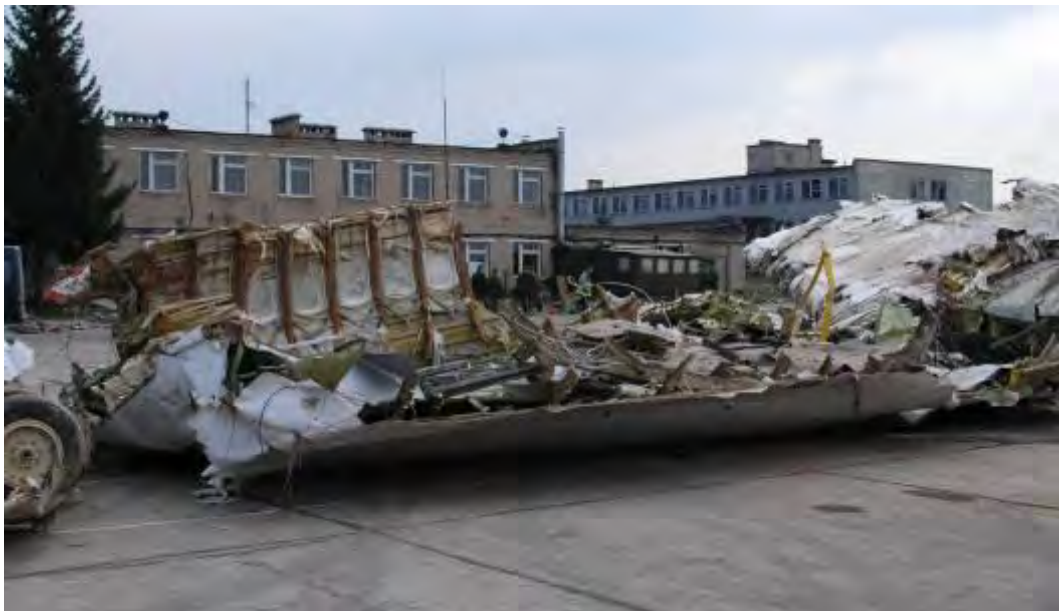
- c) The fragment of the lower section, deck and right aircraft's side from frame 21 to frame 31. (Fig. 9). The preserved elements are the deck with torn off equipment fixings, lower skin panels of the fuselage, and a fragment of the outer skin panel from the right aircraft's side.

Fig. 9. Front fuselage section - the first lounge

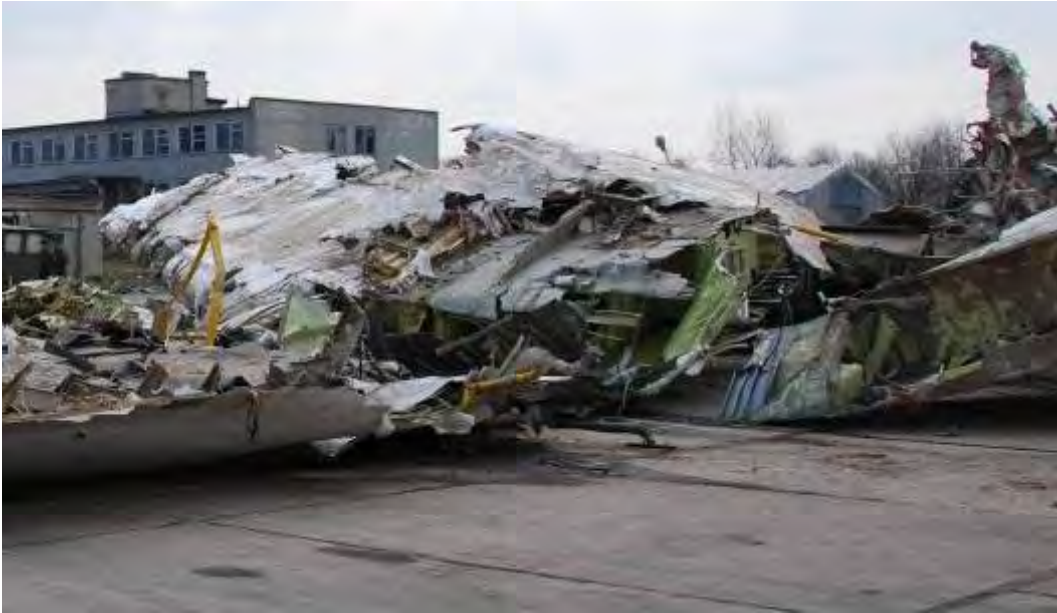
- d) Lower part of the middle section from fuselage frame 41 to frame 49 with the torn middle wing. The middle wing was torn asymmetrically. Together with its right part extending up to 17<sup>th</sup> wing frame (beyond the fixing of the detachable section) two

frames in the left part of the middle wing were torn off (fig. 10). The torn fuel tanks 1 and 4 in the middle wing contained remains of aircraft fuel.

Fig. 10. The middle fuselage section in the middle wing area

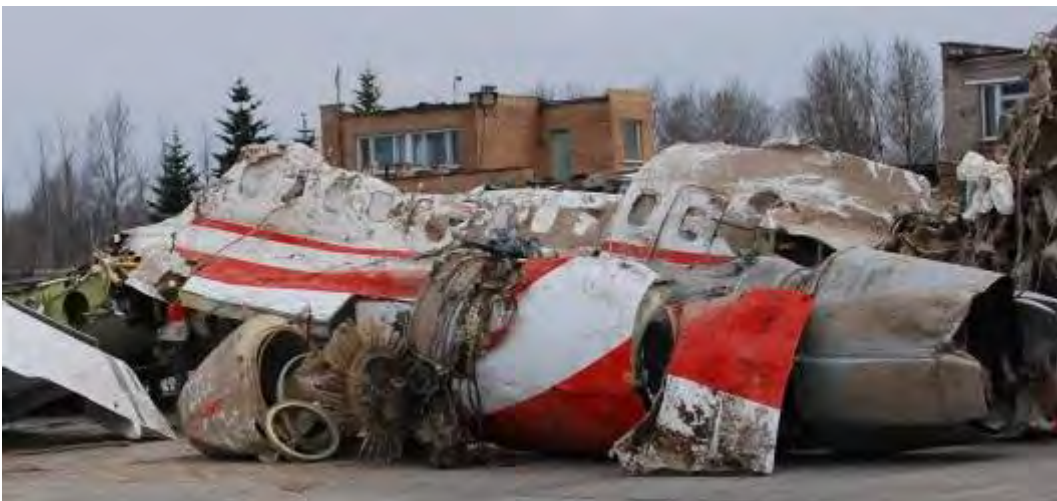
- e) The lower portion of the rear section with a crushed left aircraft's side from frame 52 to frame 62 (fig. 11). This fragment included the bent deck from the passenger compartment, lower fuselage skin panels, and fragments of the left aircraft's side skin panels. The right aircraft's side was torn away from the remaining part of this fuselage fragment at the level of the passenger compartment deck;

Fig. 11. The tail part of the fuselage - passenger compartment

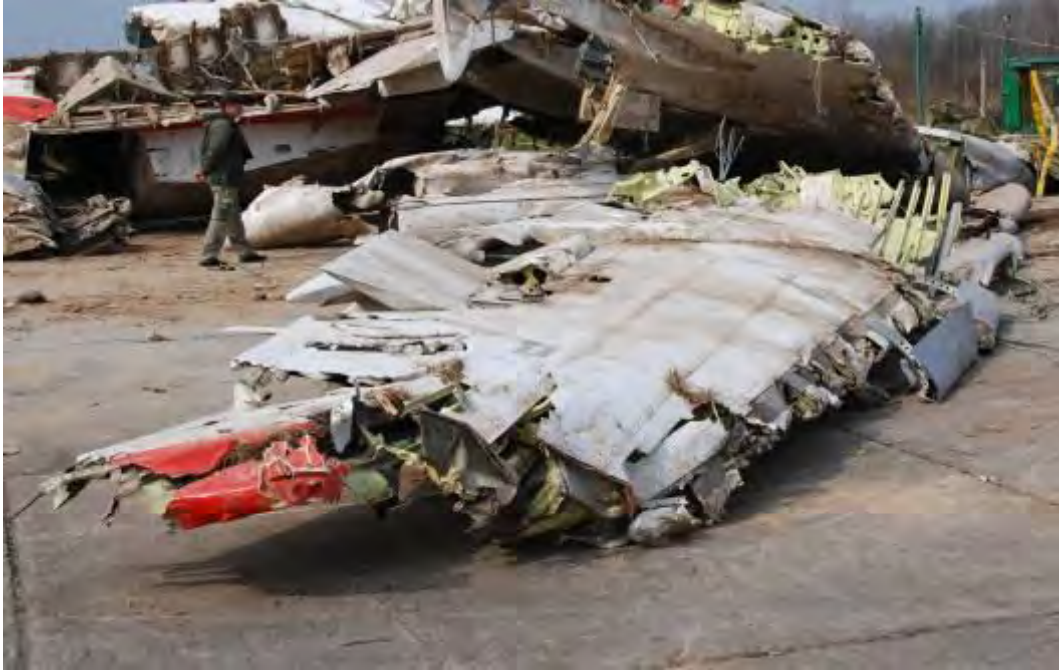
- a) The right outer part from rib 20 to rib 44 (fig. 33). Numerous oval dents can be seen on the leading edge and extended slats. Broken slat jack screws. Numerous tears in the skin panels.

Fig. 13. The right part of the wing

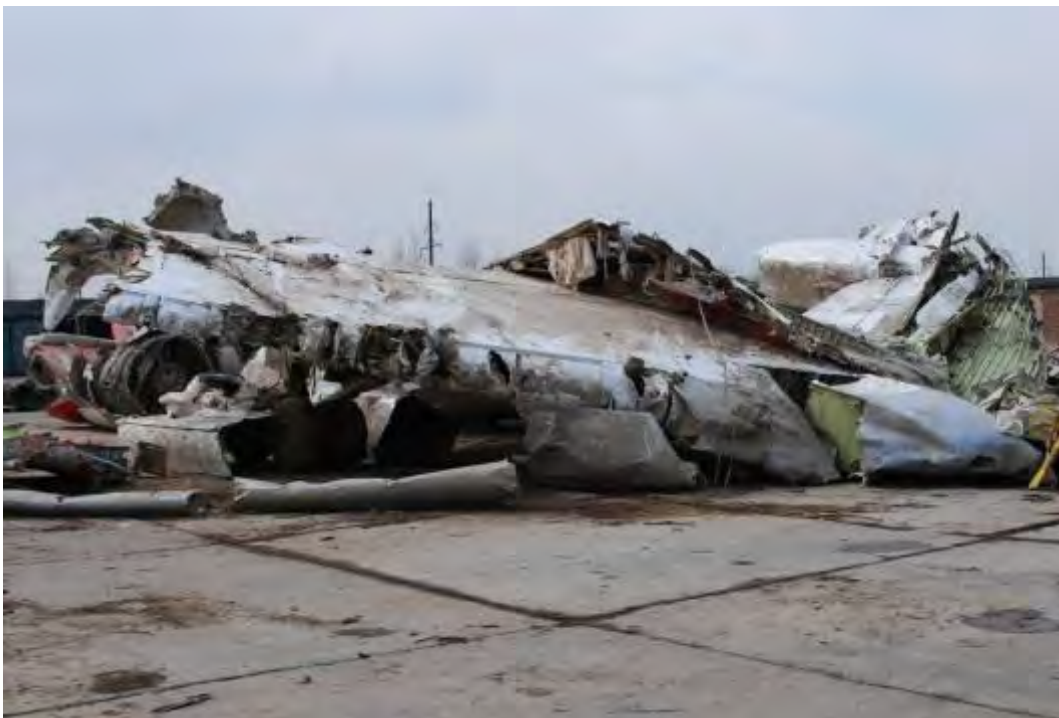
- b) The right part with the middle wing from frame 2 (left aerofoil) to frame 17 (right aerofoil) (Fig. 14 and 15) - the middle wing was torn asymmetrically. The slats were torn away from the wing structure. The dents and tears on skin sections at the wing leading edge extended to the front spar;

Fig. 14. The leading edge at the root section of the right wing

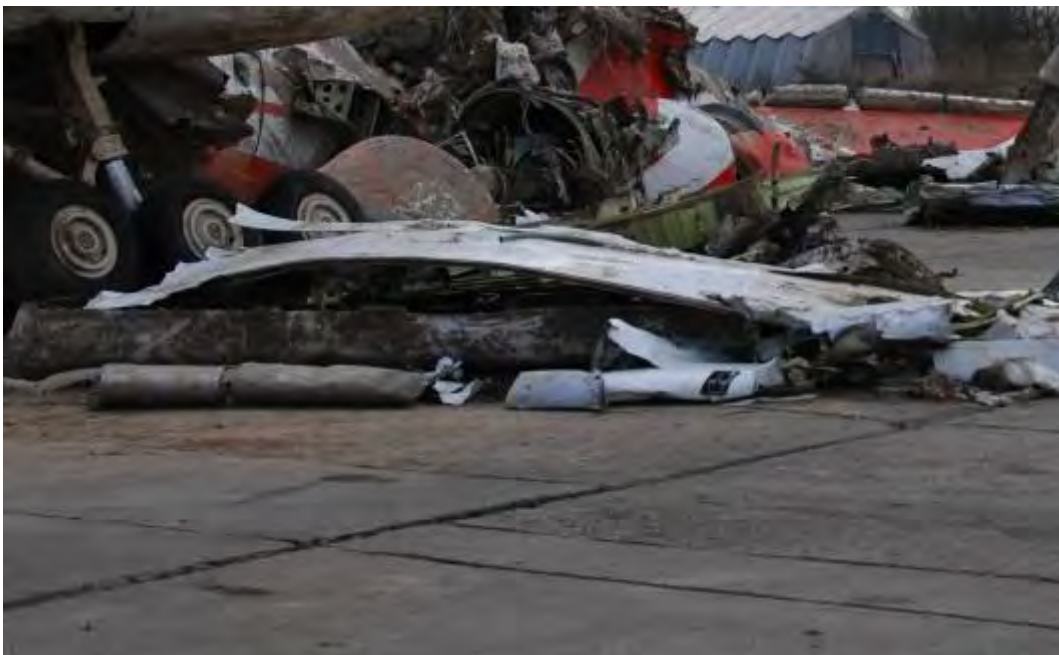
- d) The left part from rib 18 to rib 24 (fig. 18). The fragment is significantly distorted (twisted spars, torn skin panels). All slat jack screws are torn off;

Fig 18. The middle section of the left wing

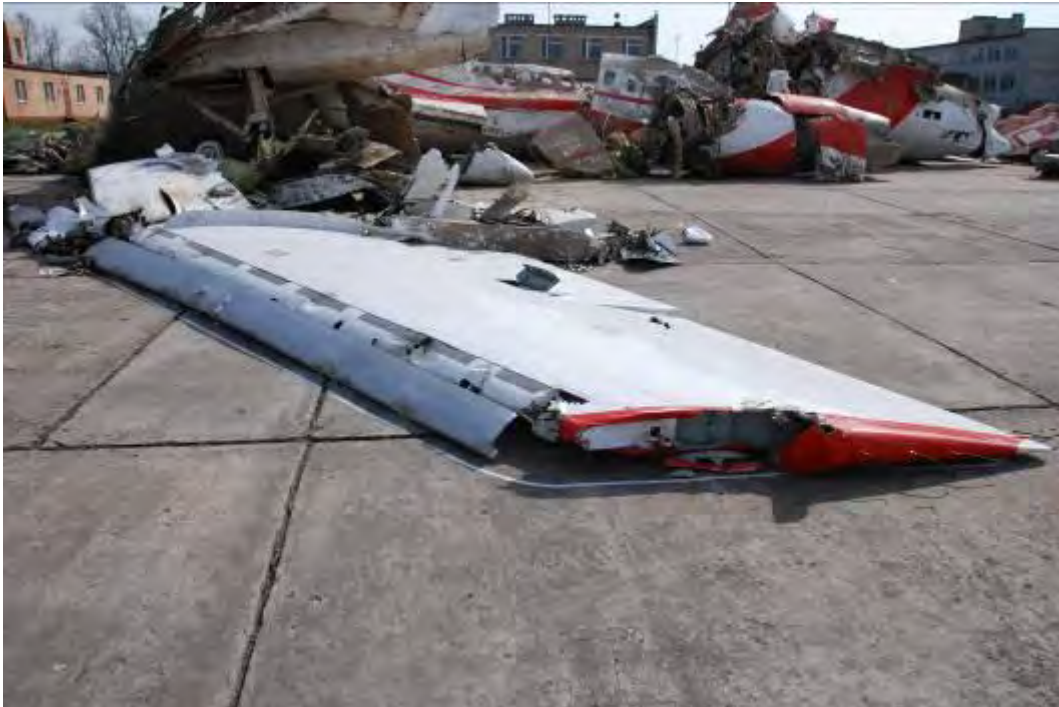
Fig. 19. The left wing tip

- e) The outer section of the left wing from rib 28 to the wing tip (fig. 19) - the fragment was torn off on impacting a large birch tree. Relatively well preserved fragment of the

wing. Small oval dents can be seen on the leading edge (slat). The front section of the wing tip fairing was torn off.

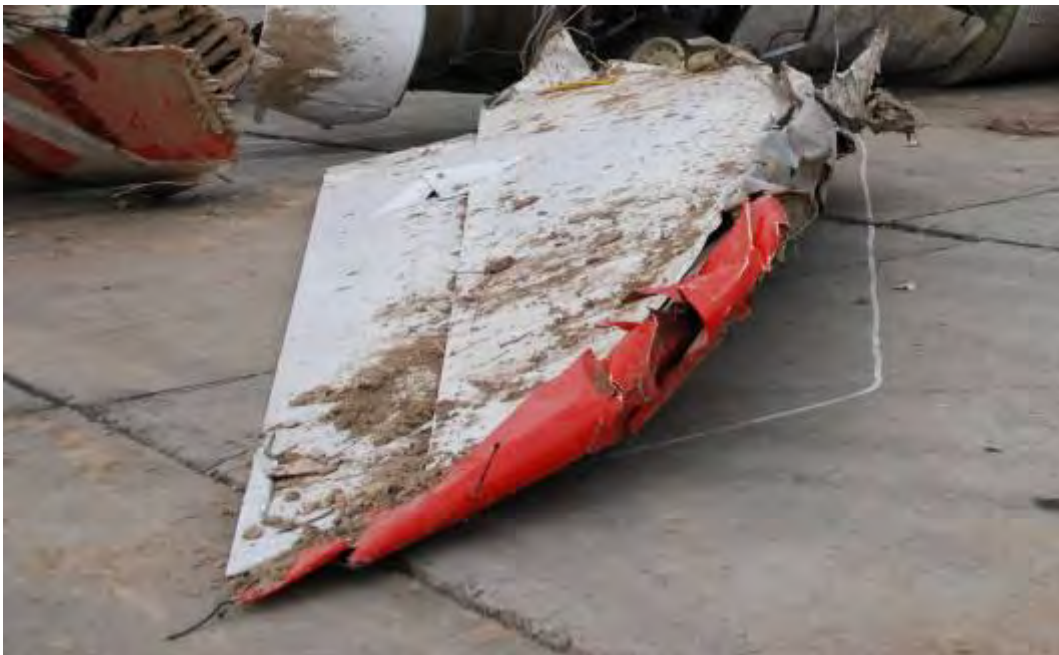
Fig. 20. The right section of the tailplane with the elevator

The right section of the tailplane was torn off at a distance of 1 m from its fasteners on the fin. Numerous dents on the leading edge and twisted structure of the tailplane (fig. 20).

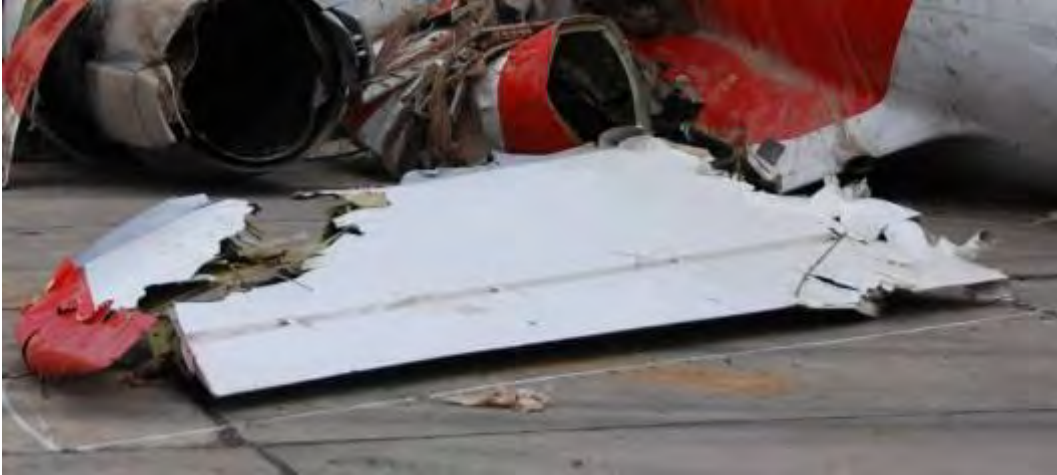
Fig. 21. The left section of the tailplane with the elevator

The left section of the tail plane was torn off at a distance of 1,5 m from its fasteners on the fin. A fragment (outer corner piece) was torn off, leaving a ragged tear edge. Numerous oval dents can be seen on the leading edge (fig. 21). The left stabilizer had already separated from the plane before the aircraft crashed into the ground.

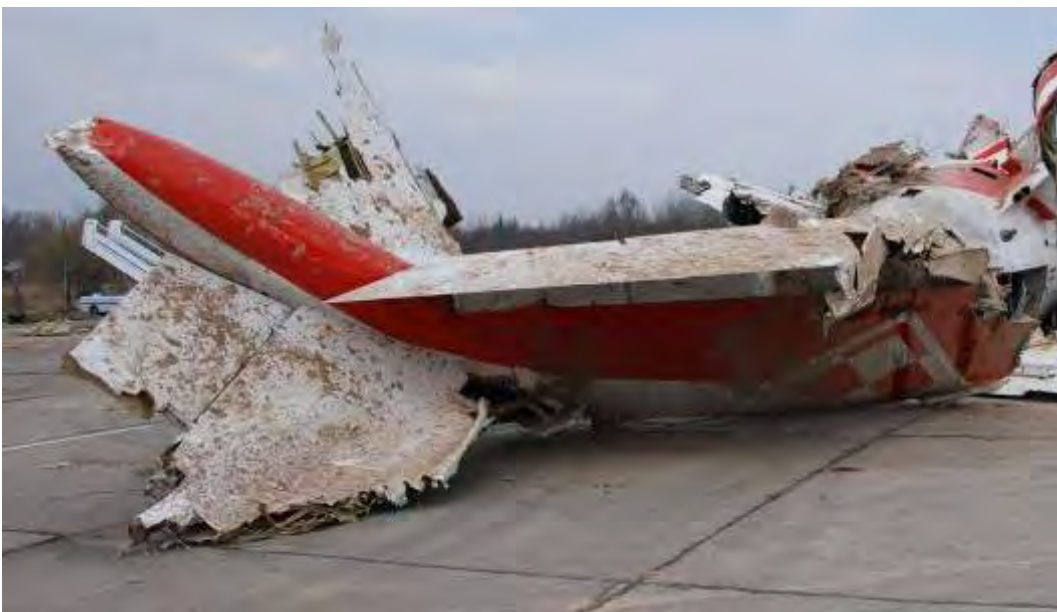
Fig. 22. The fin

The fin was torn away at its root from the fuselage tail part. The front part of the fairing of the tailplane control mechanism was crushed. The tailplane control mechanism was heavily soiled with mud. The displacement of the mechanism shaft corresponds to the tailplane's position at  $-3^{\circ}$ . The skin panels torn away from the leading edge of the fin. The rudder is still fastened to the fin and displaced to the left by an angle of about  $20^{\circ}$  (fig. 22).

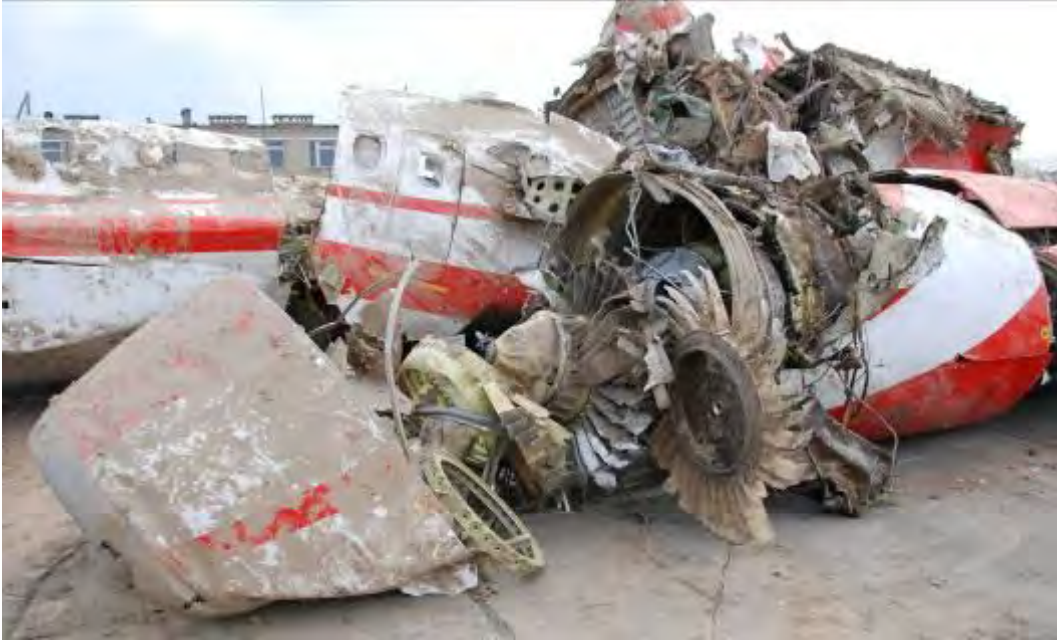
Fig. 23. The left engine

Engine 1 (left) torn away from the aircraft's structure. The low pressure compressor disks separated from the engine. The rotor blades bent in the direction opposite to that of the rotation (fig. 23).

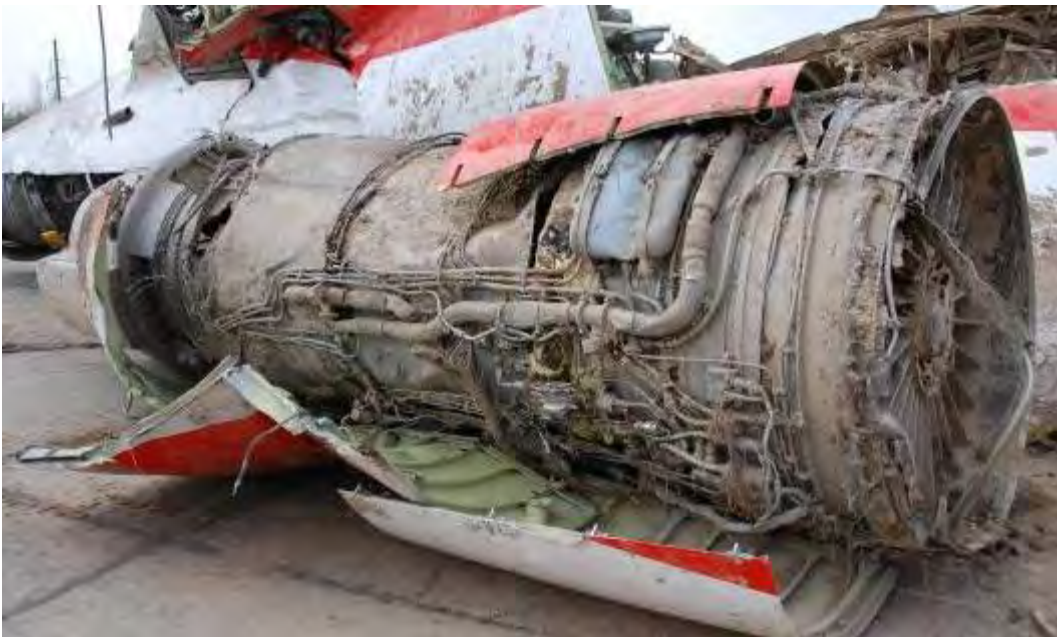
Fig. 24. The right engine

Engine 3 (right) torn off the aircraft's structure and heavily soiled with mud (fig. 24). The rotor blades bent in the direction opposite to that of the rotation.

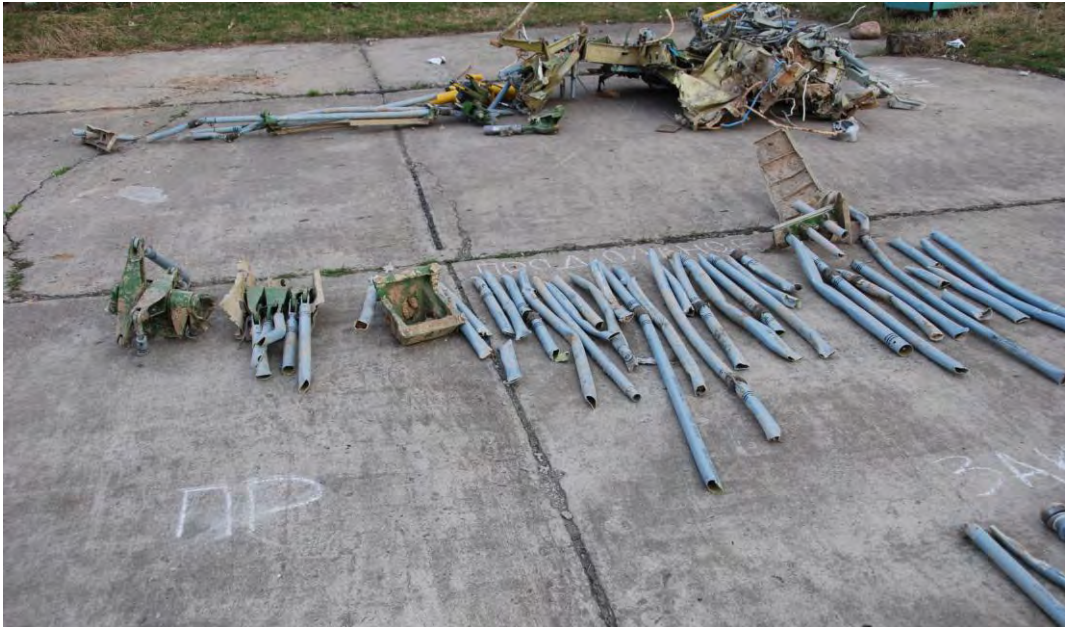
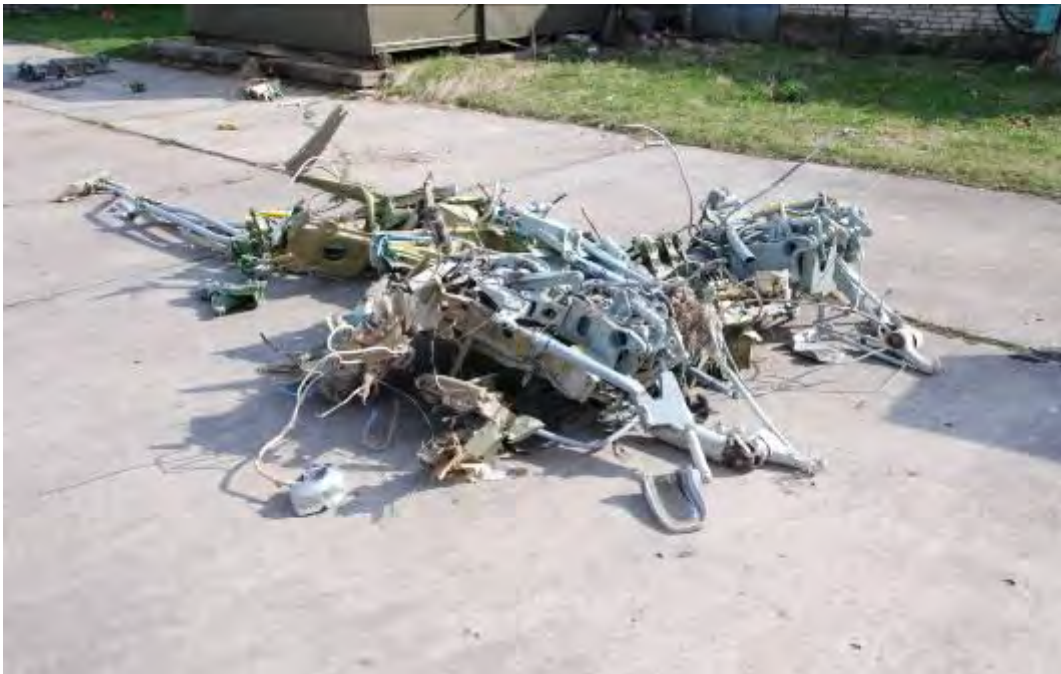
Fragments of control wheels and distorted pedals together with the gear located under the cockpit deck were preserved. The elevator, aileron and rudder control rods have numerous tears both at the riveting joints with the tip elements, and on the straight sections (fig. 25 and 26). Control cables torn apart.

Fig. 25. The control rods of the aircraft

Fig. 26. The remains of the aircraft's controls - the elements installed in the cockpit and under the cockpit deck.

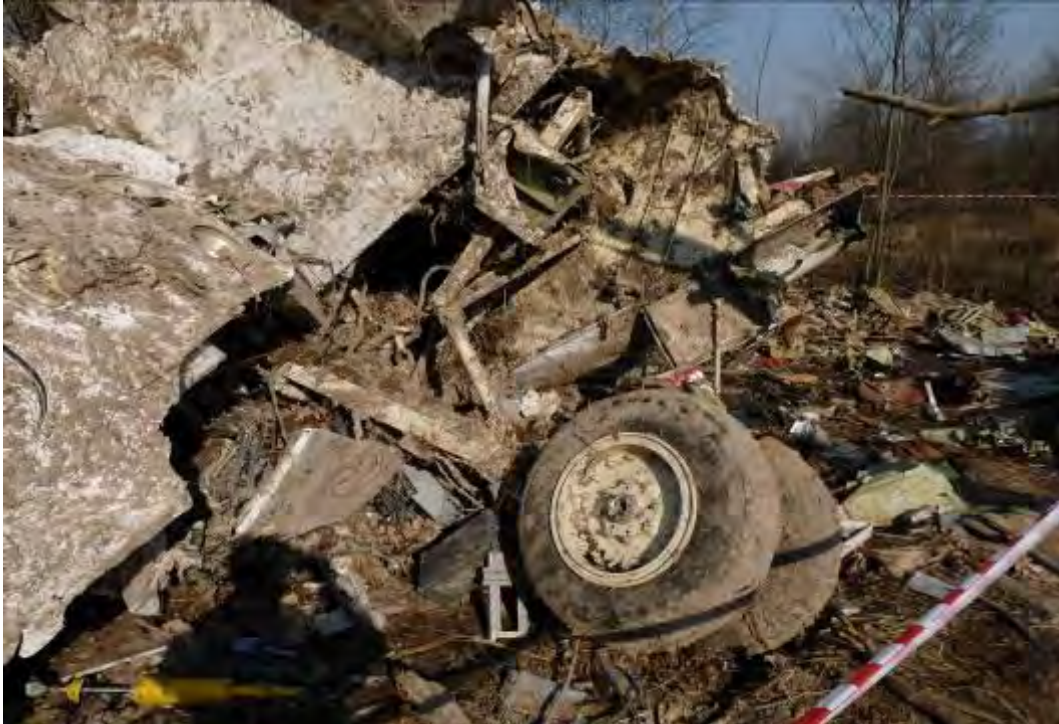
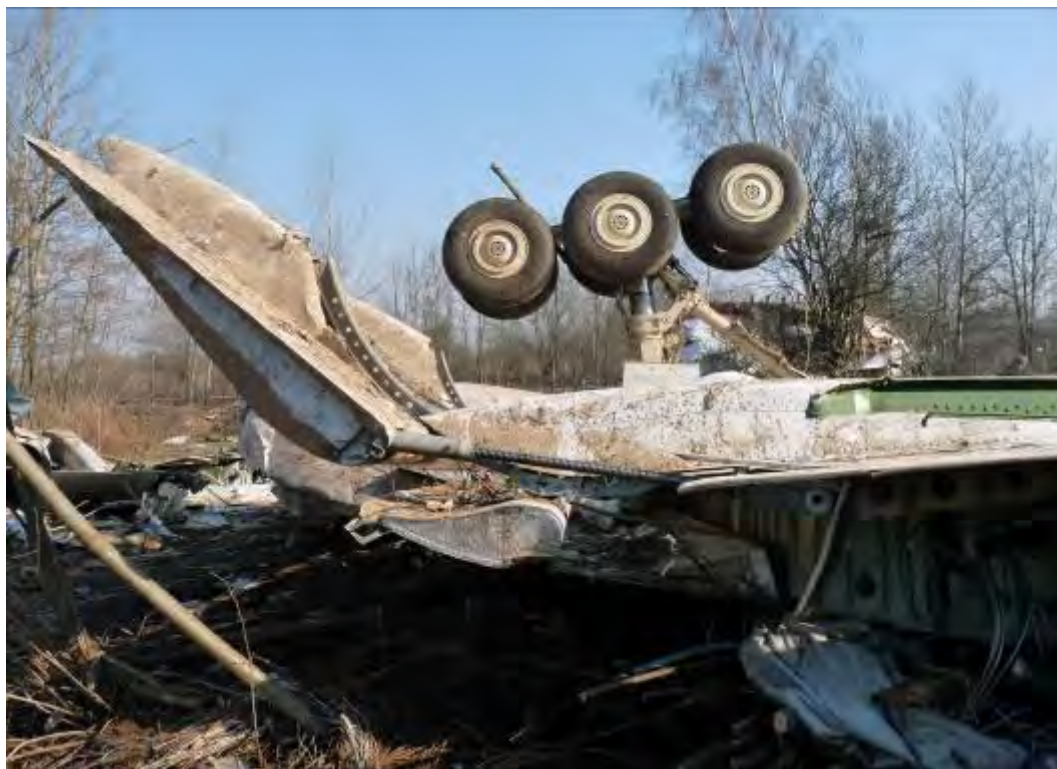
The nose gear leg with impact traces is still attached to a fragment of the nose part of the fuselage. The angle brace of the undercarriage strut is slightly bent. The main landing gear legs bear slight impact traces left by tree branches, especially on the strut fairing. The landing gear is in the extended position and locked. No visible traces of damage have been found on the nose and main landing gear wheels (fig. 27-29).

Fig. 27 The nose landing gear

Fig. 28 The left main landing gear

Fig. 29 The right main landing gear

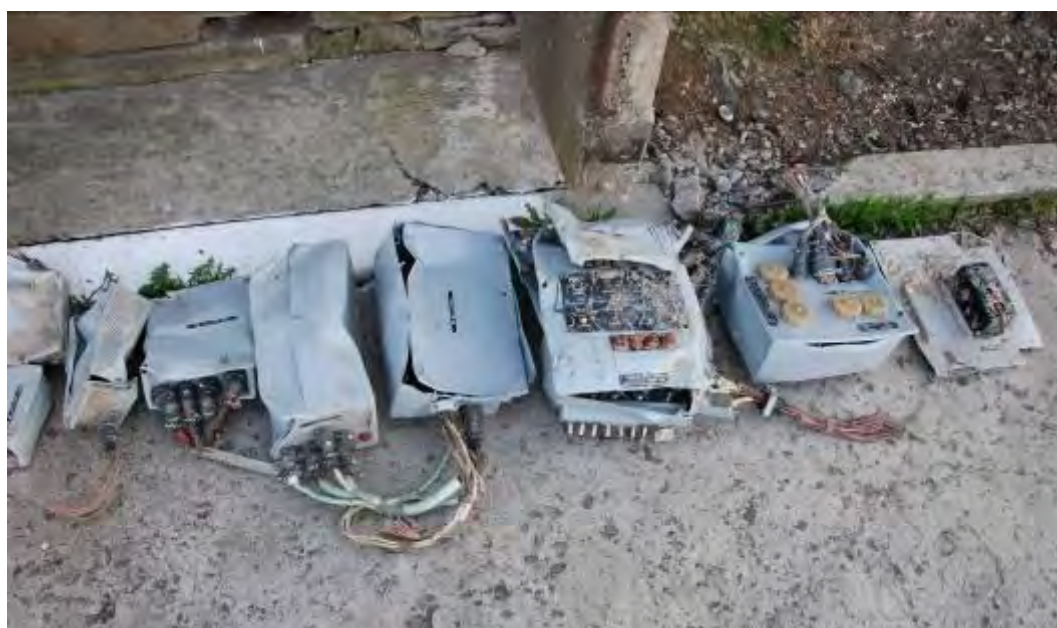
Fig. 30. The control boxes of the electrical system

Wiring harnesses are torn apart. The control boxes are deformed. Switch levers are bent and torn off (fig. 30). The housings of the onboard batteries are deformed. Some cells became unsealed.

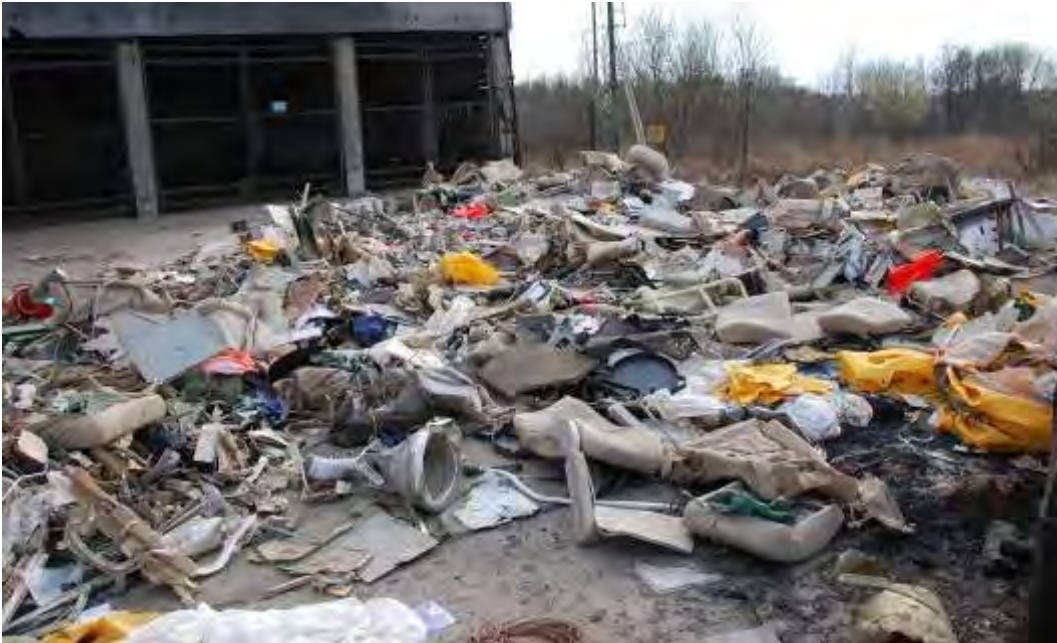
Fig. 31. The remnants of the passenger compartment equipment

The passenger seats have been torn away from their mountings and fragmented into pieces. The inner wall covering panels in the passenger compartment broken into small pieces (fig. 31). Safety belts have been scattered at the aircraft crash site.

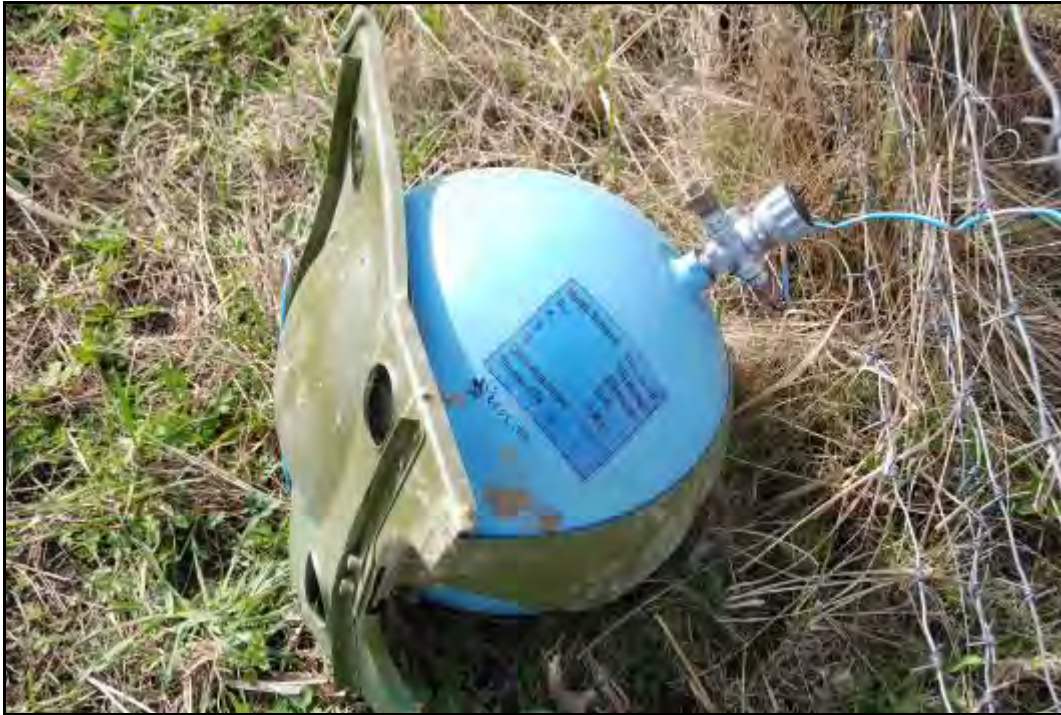
Fig. 32. УВШ-25/150М bottle with a part of its mount and oxygen lines

At the scene of accident only УВШ-25/150М bottle, no. 1100477, was found; the bottle was not disrupted but torn away (together with a part of the mount to which it was attached) when the aircraft's structure was being damaged.

The bottle was fitted with a cylinder top with a manometer and inlet and outlet connections. There is a longer section of the oxygen line attached to the inlet connection of the bottle; the outlet oxygen line was torn away at the very connection. The bottle bore neither traces of fire, nor any deformations caused by other elements of the aircraft.

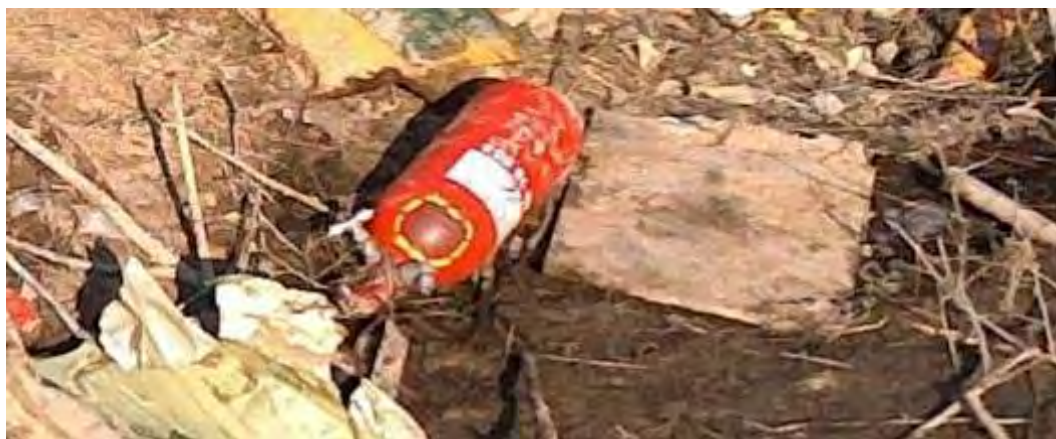
Fig. 33. OCY-5II-01 bottle

At the scene of accident one bottle OCY-5II-01 no. 08056 was found; the bottle was not disrupted but torn away when the aircraft's structure was being damaged (fig. 33).

The bottle was fitted with a cylinder top with inlet and outlet connections. The bottle bore neither traces of fire, nor any deformations caused by other elements of the aircraft.

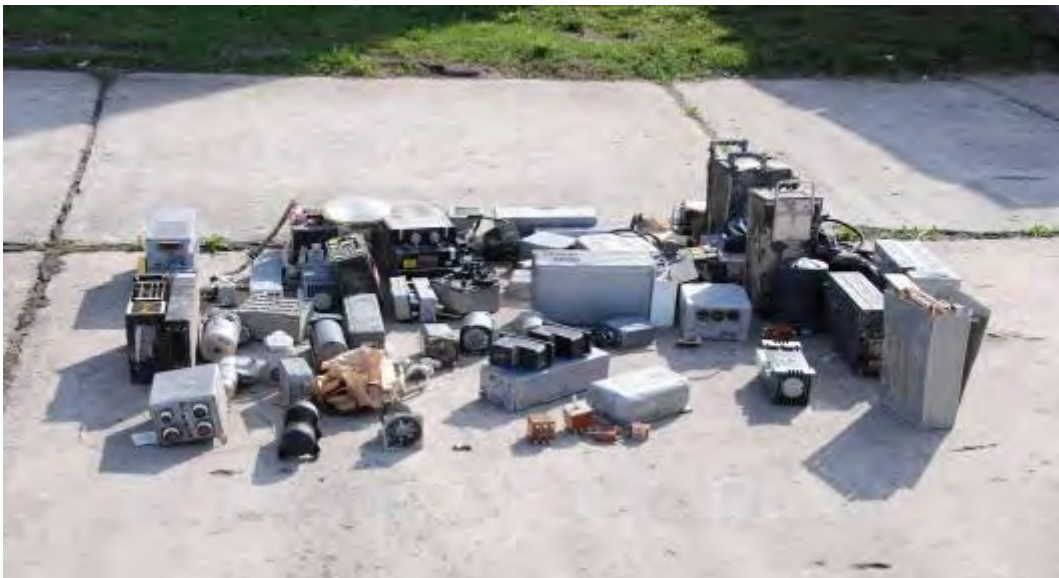
Fig. 35. Spare parts carried in the luggage compartment

The units carried in the luggage compartment (spare parts in so called “technical emergency kit”) survived the crash in the best condition (fig. 35).

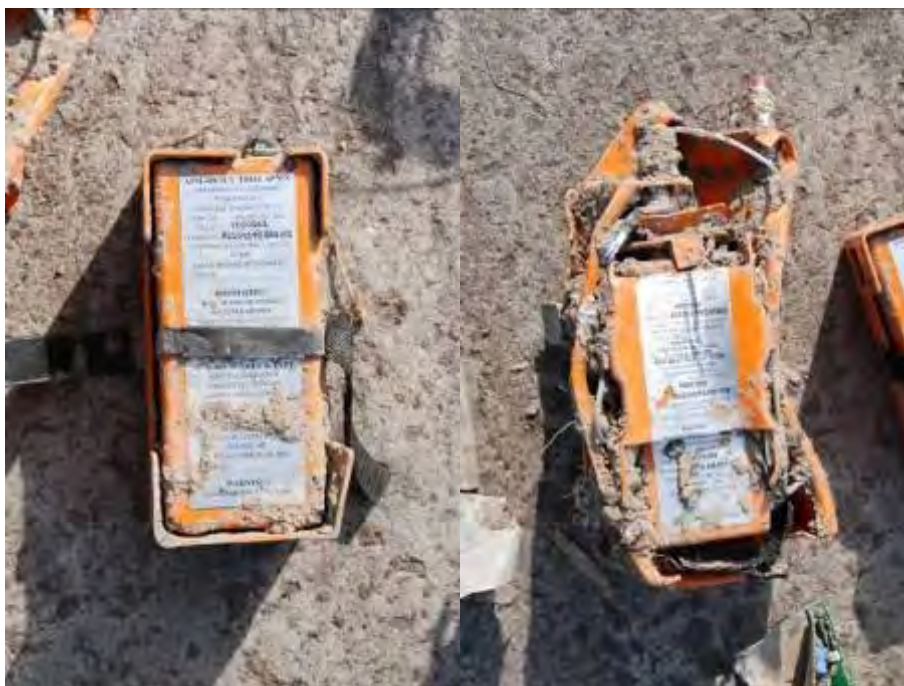
Fig. 36. Emergency radio stations ARM-406AC1 (left) and ARM-406P (right)

Installed during the last overhaul, the ARM-406AC1 (no. 7523242494) and ARM-406 (no. 7524241208) radios and their antenna systems became damaged in the crash to the extent of inoperability.

The ARM-406P radio station (automatically enabled with a G-load switch): the antenna and power cables torn away, the radio station casing crushed. The ARM-406AC1 radio station: slight damage to the casing (in order to use the radio station, the crew has to wire up the antenna and switch on the device).

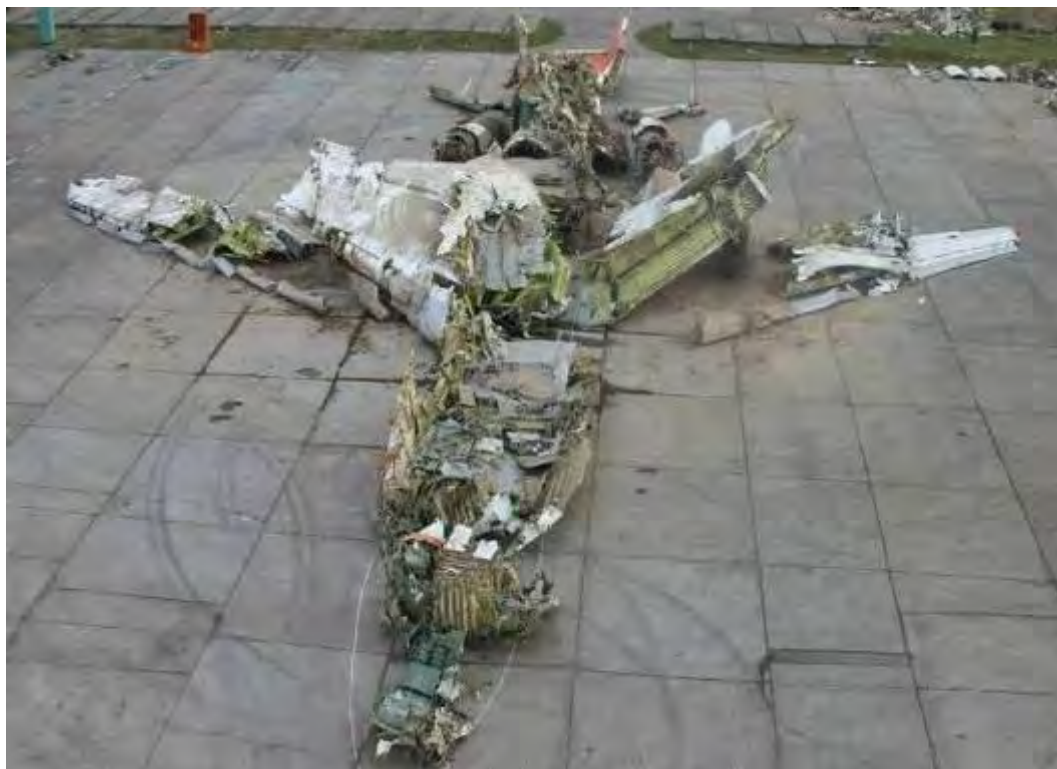
Fig. 37. Parts of the aircraft as arranged on the ground

The remnants of the destroyed aircraft were arranged within its outline on a hard surface on the premises of SMOLENSK “SEVERNY” aerodrome. Elements of individual systems were sorted into separate groups and laid out in the vicinity of the wreckage (fig. 25, 26, 30, 34, 35, 36). A general view of the wreckage is shown in figure 37.
