# **Final Report**

**from the examination of the aviation accident no  
192/2010/11**

**involving the Tu-154M airplane, tail number 101,  
which occurred on April 10<sup>th</sup>, 2010**

**in the area of the SMOLENSK NORTH airfield**

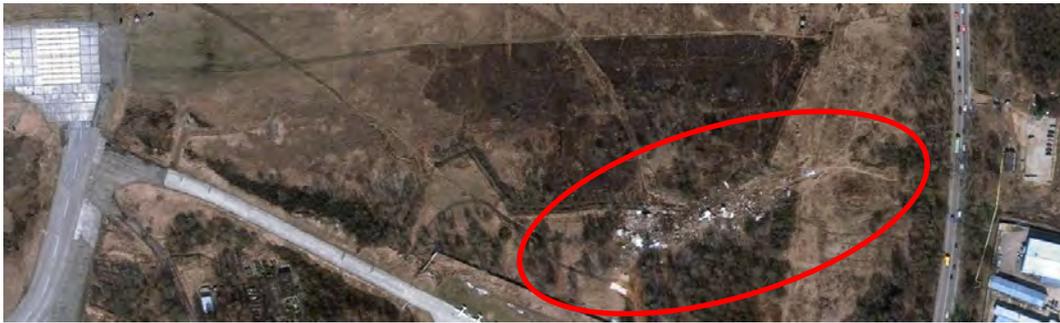
Striking terrain obstacles and impacting the ground, the aircraft caused such damage:

- broken power line,
- many broken trees and shrubs along the final phase of the flight,
- woodland devastation, about 52 m wide and 165 m long on the site of aircraft's fall.

Photo 1. A satellite photo of the site of crash.

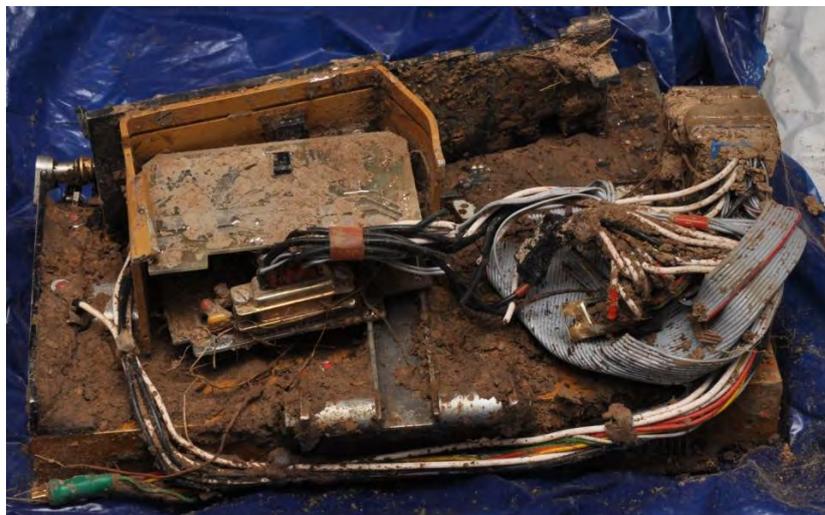
Photo 10.Quick Access Recorder ATM-QAR on the site of crash

The memory cassette of ATM-QAR was found on the site of crash. On 20.04.2010, the data from the memory of the cassette were readout in the Air Force Institute of Technology in Warsaw, in the presence of representative of MAK, the Committee of Aircraft Accident Investigation in National Aviation (henceforth Committee), Polish Prosecutor's Office and the manufacturer's of ATM-QAR representative. The all data were retrieved;

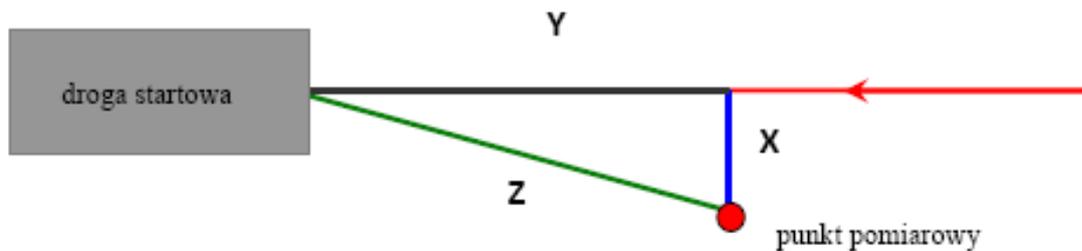
A graphic scheme, which identifies the measurements taken, is depicted in Fig.12. Photo no.14 shows the scatter and identification of aircraft remnants. Fig.13 depicts the scatter of parts (items 14-25), location of terrain obstacles (items 1-13) and places of where the Tu-154M, no.101 impacted the ground (points A and B).

Fig. 12. Graphical scheme which identifies the measurements taken.

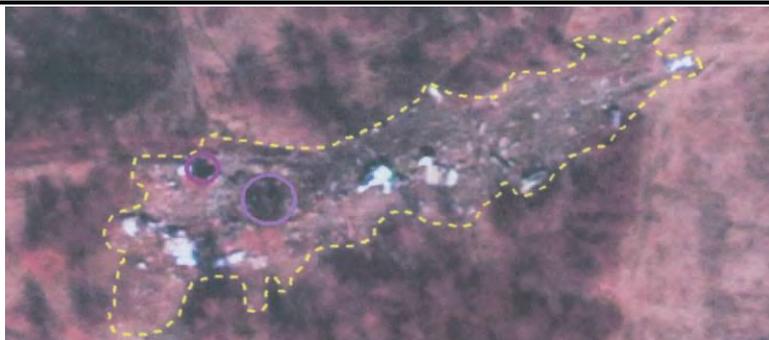
Fig. 14. Probable areas of fire<sup>43</sup>

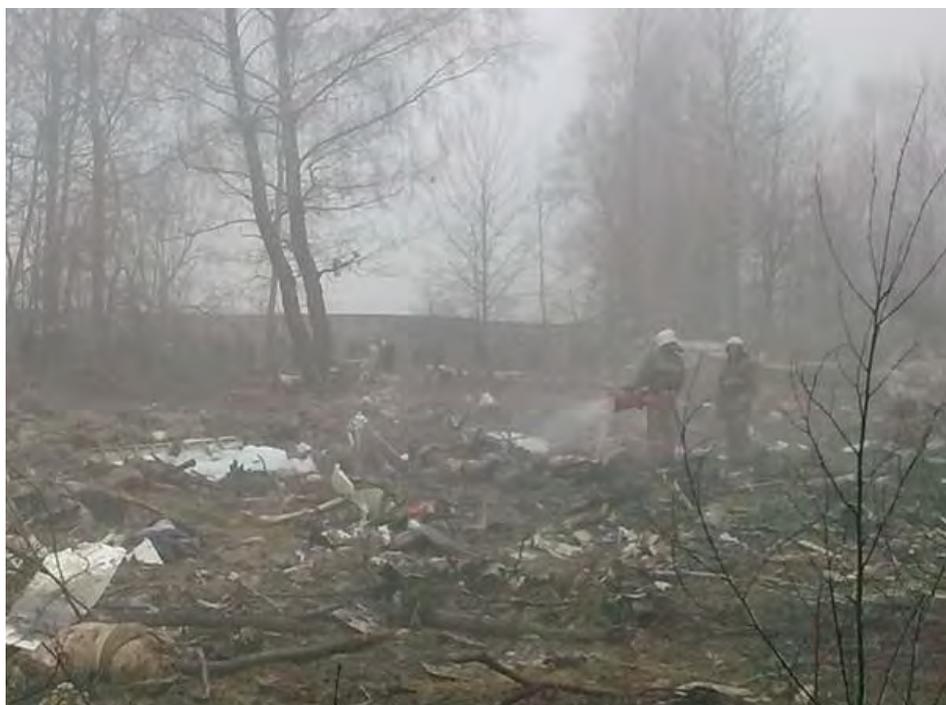
The photographs prove that fire fighting took place. Yet, they make no grounds for assessment of conducting the fire fighting operation.

Photo 15. Fire fighting

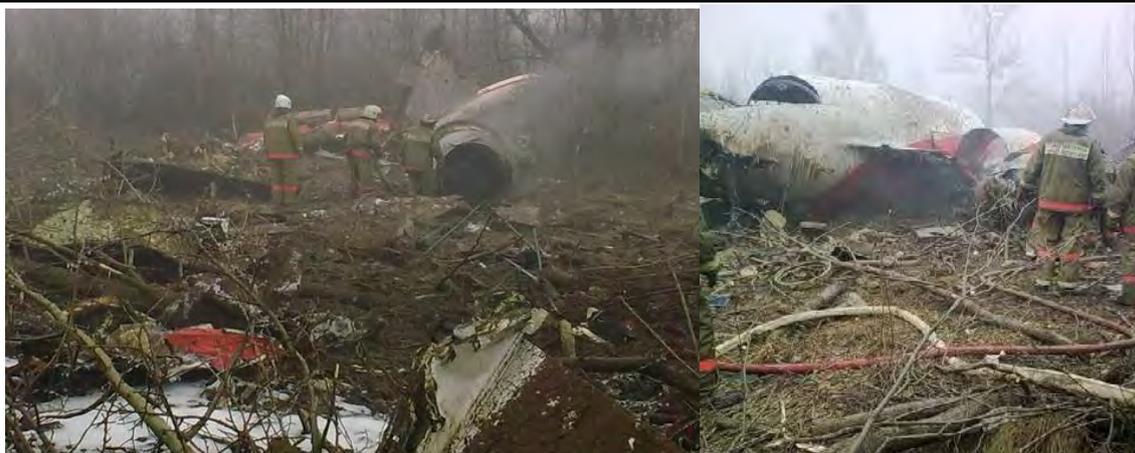
Photo 16. Dumping down operation and securing the site of crash

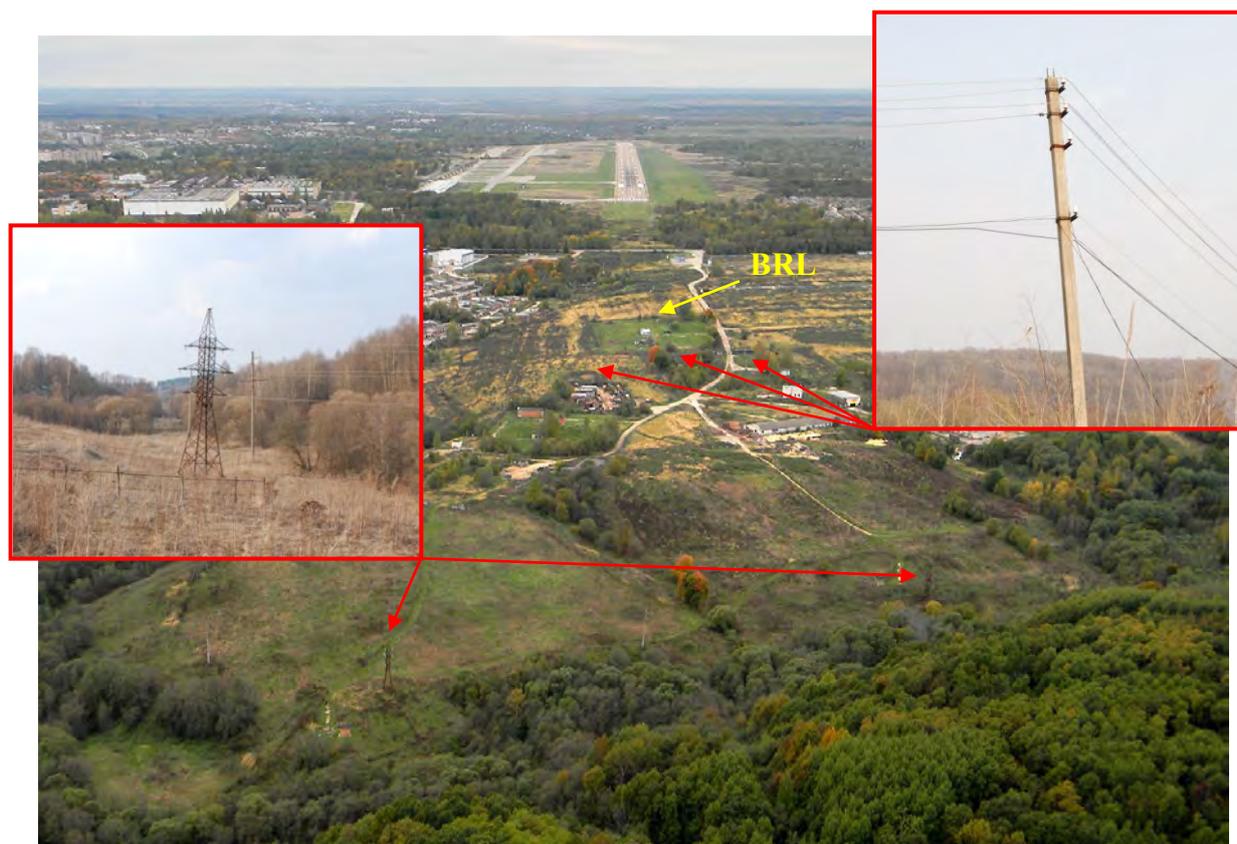
- the overhead power line close to IM,
- the trees in the antenna field, much higher than the post of antenna,
- the depression with a water-course near IM.

Photo 17. Location of power lines and low-voltage lines relative to Inner NDB

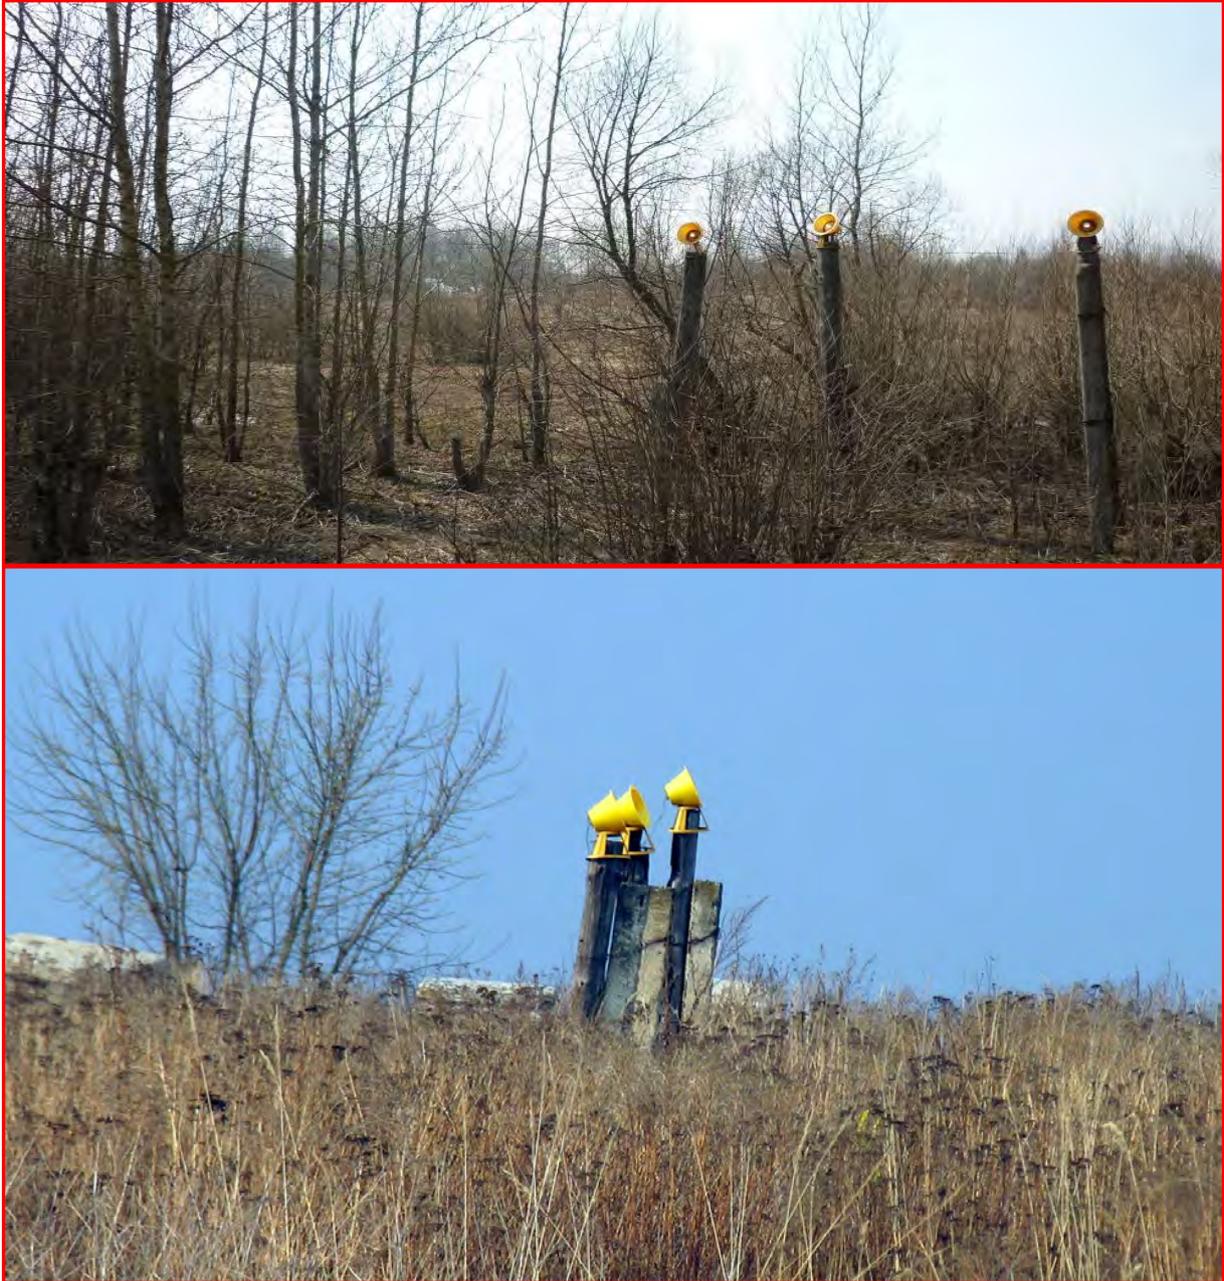
Photo 20. Approach lamps positioning

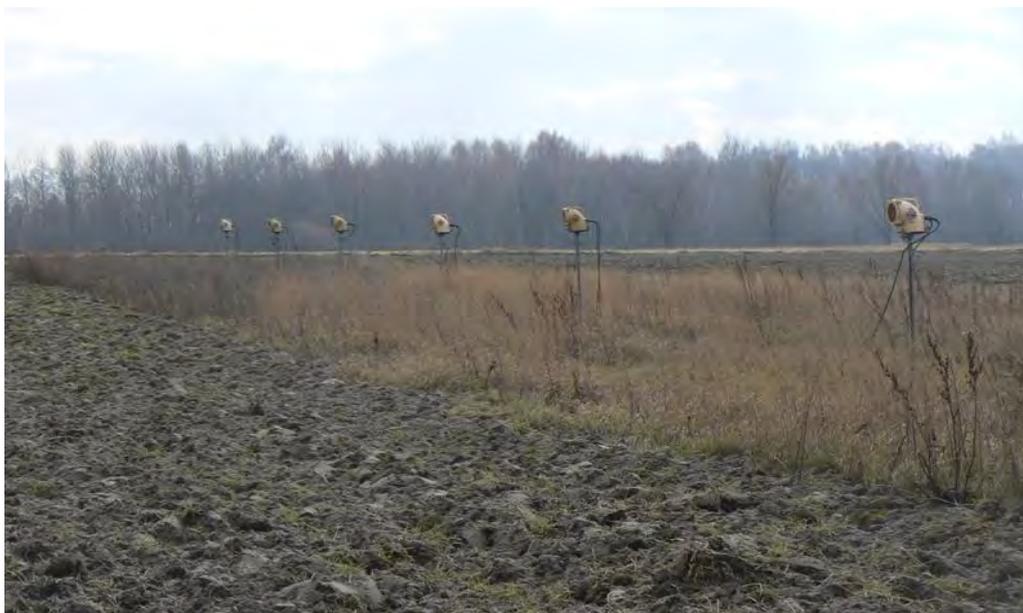
Consecutive photos depict the lamps of ŁUCZ-2MU lighting system with description of differences between them.

Photo 22. Construction of elements and the environs of ŁUCZ-2MU lighting system at the military aerodrome

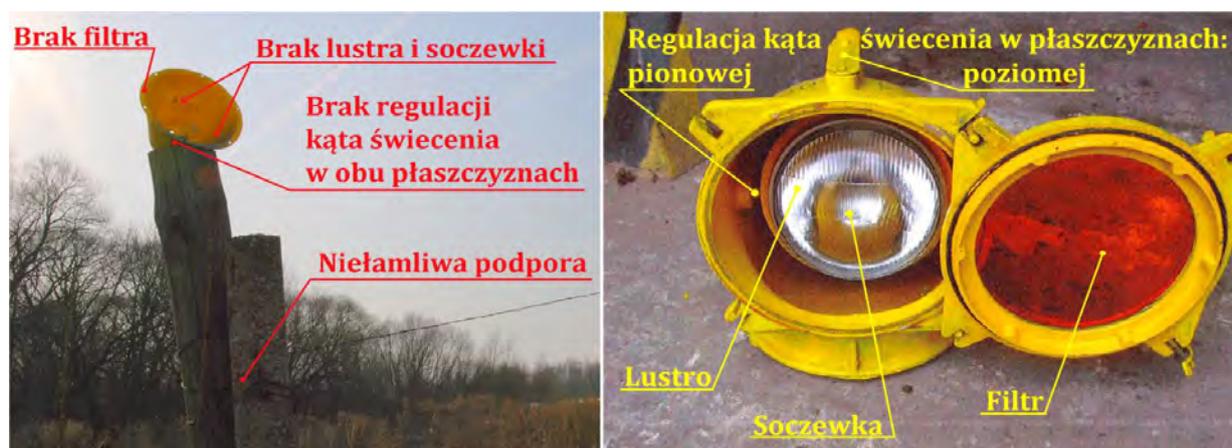
Photo 23. Comparison of lamps of the lighting system

On the left– a lamp of the lighting system at SMOLEŃSK NORTH aerodrome on 10.04.2010.

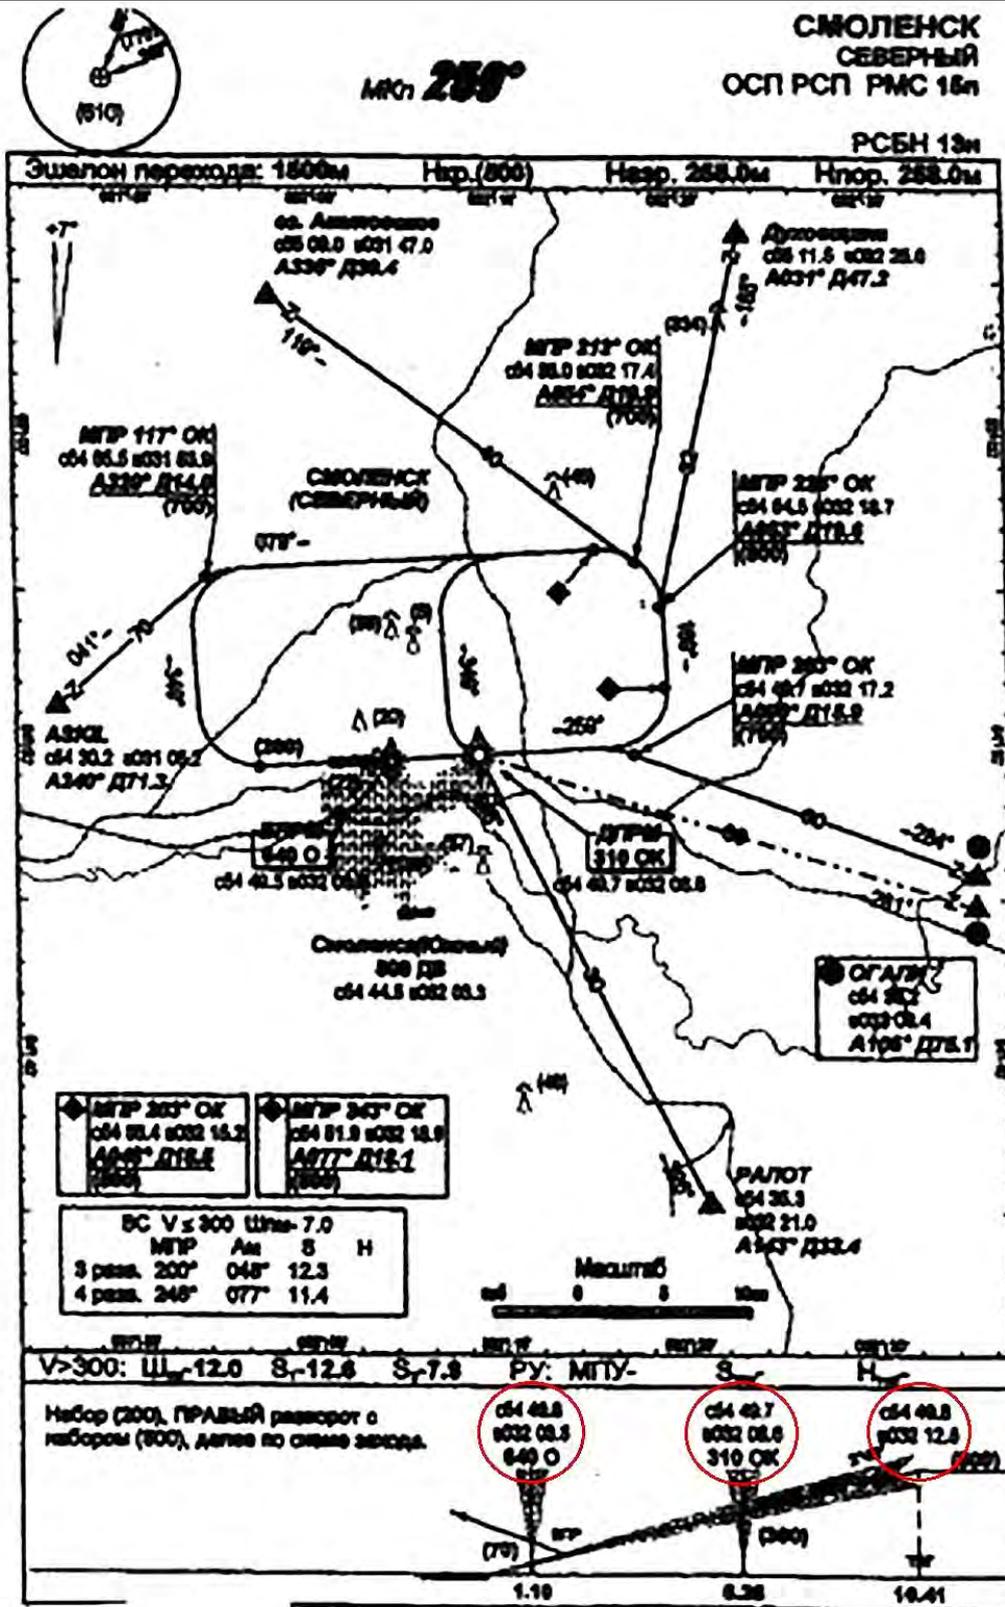
Fig. 16. A copy of the approach chart for the 259° direction

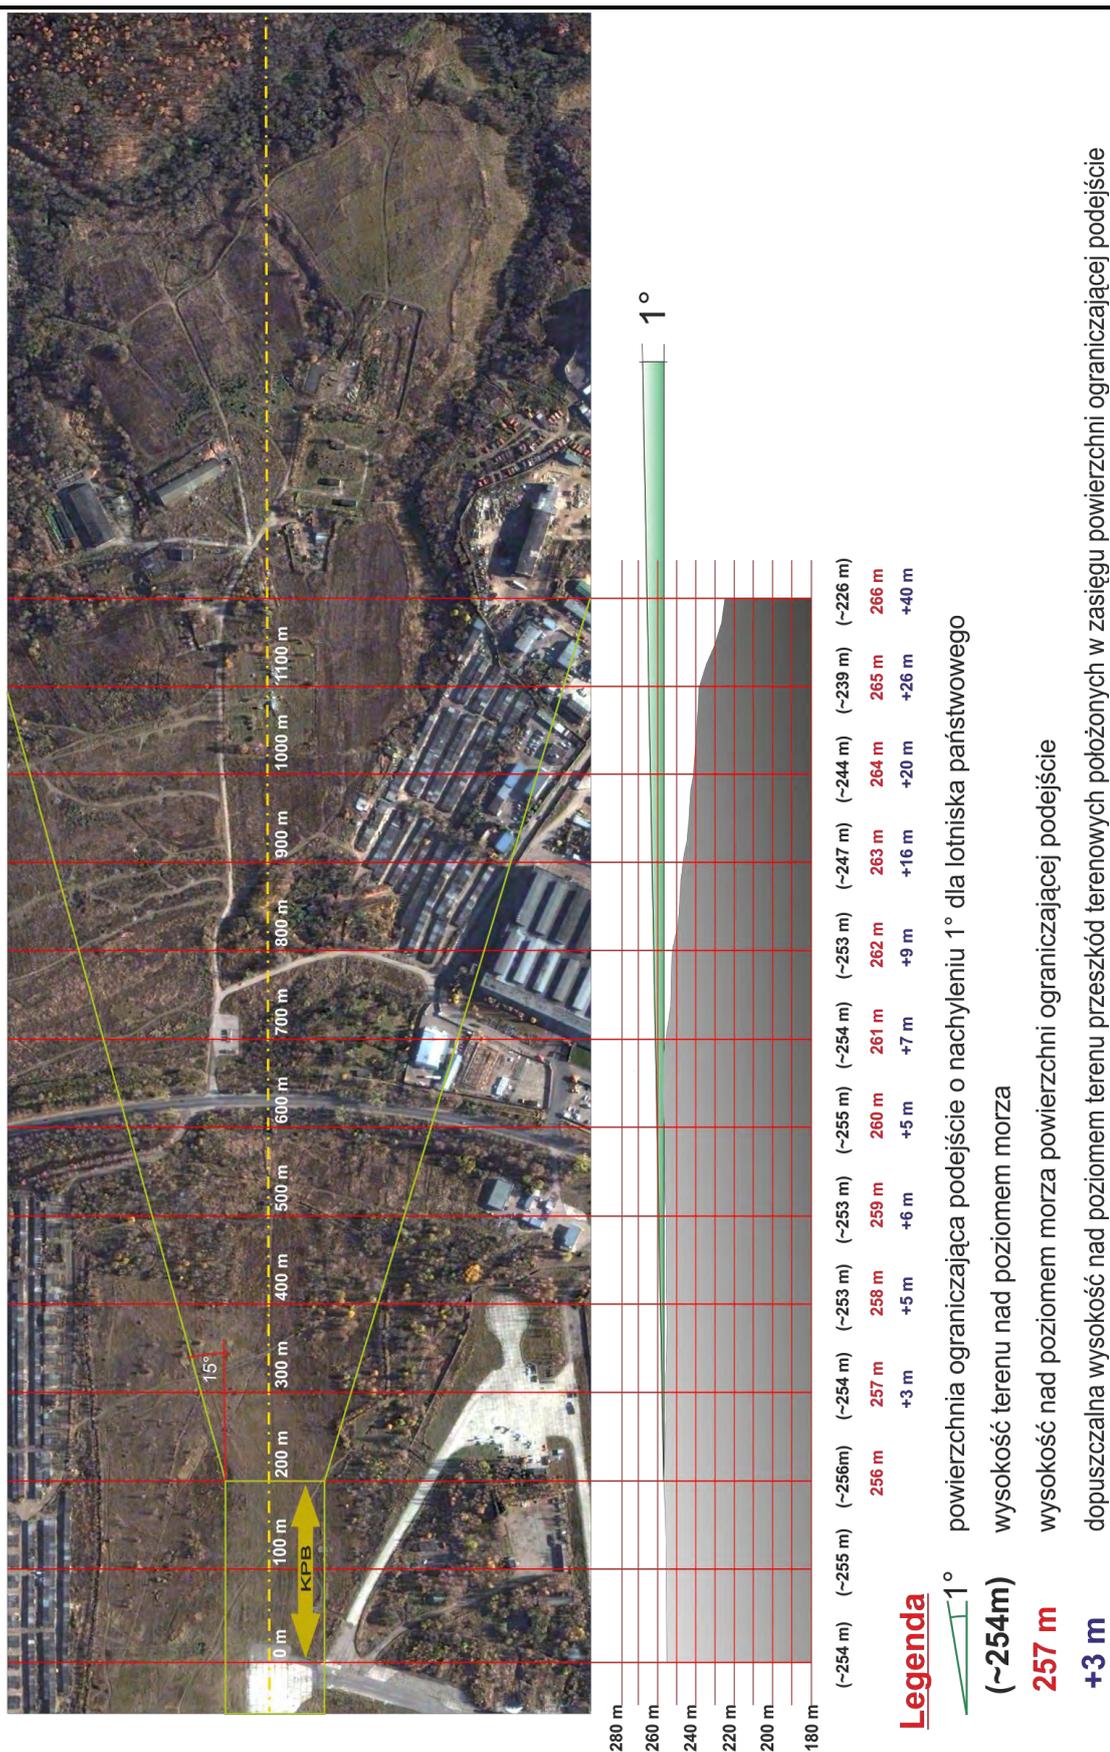
Fig.177. The runway safety area of SMOLEŃSK NORTH  
 (according to Polish regulations for Class I military aerodromes)

Fig.19 shows dislocation of the higher than allowable trees. At 400-600 m from RWY THR 26 sparse trees were about 10 m high, i.e. too high by 5-6 m. In the area of an asphalt road (about 600 m from RWY 26) the trees were too high by allowable 7 m. At 700 m from RWY THR 26, the tree stand was too high by 8 m and, at 800 m – 5-6 m higher than allowable. The tree height limit was mostly abused at 640-690 m from RWY THR 26 where 10-11 m high trees were obstructing the safety area. Terrain elevation in that area is around 256-257 m above sea level.

The above analysis shows that SMOLEŃSK NORTH aerodrome was not properly prepared to receive aircraft.

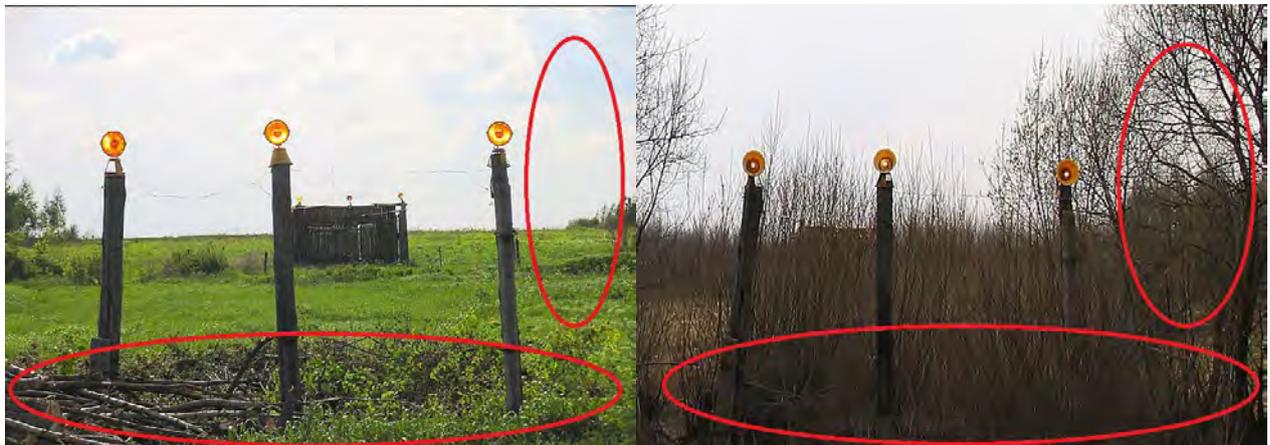
Fig. 21. SMOLEŃSK NORTH – difference in tree stands in „A” area – approach path lamps, about 600 m from RWY THR 26

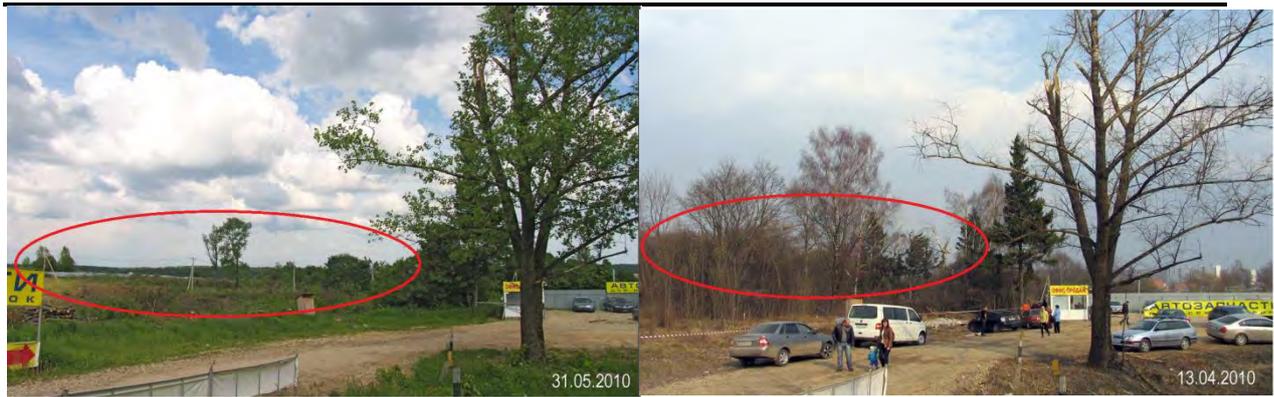
Fig. 22. SMOLEŃSK NORTH – differences in tree stands in the area about 670 m from RWY THR 26

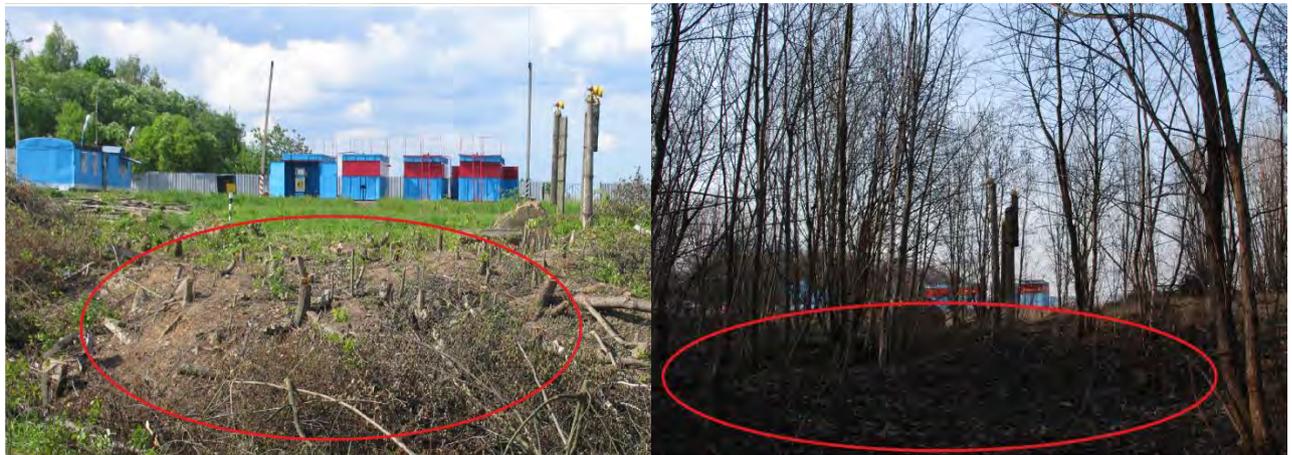
Fig.23. SMOLEŃSK NORTH – difference in tree stands– approach path lamps, about 700 m from RWY THR 26

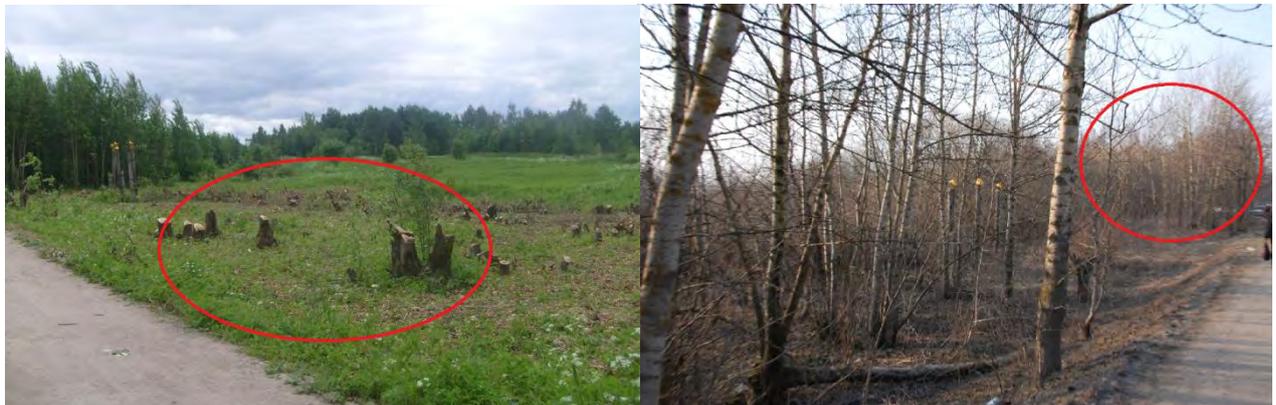
Fig.24 SMOLEŃSK NORTH – differences in tree stands – approach path lamps, about 600 m from RWY THR 26

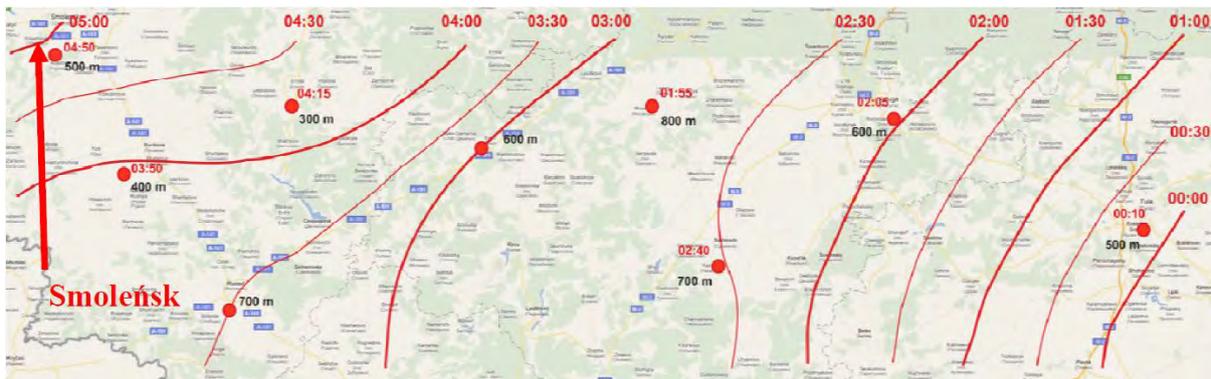
In the Committee's opinion, the TWER forecaster had great difficulties in correct predicting of such unfavourable conditions. His prognoses hardly kept pace with ever worsening weather conditions, never were ahead. It was not only due to big distance between Twer and Smoleńsk, but also because the shift-on-duty at the met office did not consider the occurrence of fog on the direction of advection. As has been proved, it was possible to make a map of isochrones of places of fog occurrence, which would clearly show the advance of the zone of fog towards SMOLEŃSK NORTH aerodrome from SE.

Fig.21. A map of isochrones of fog spots as well as visibilities watched – prepared on the basis of STORM messages from met stations resided to the east and south of Smoleńsk

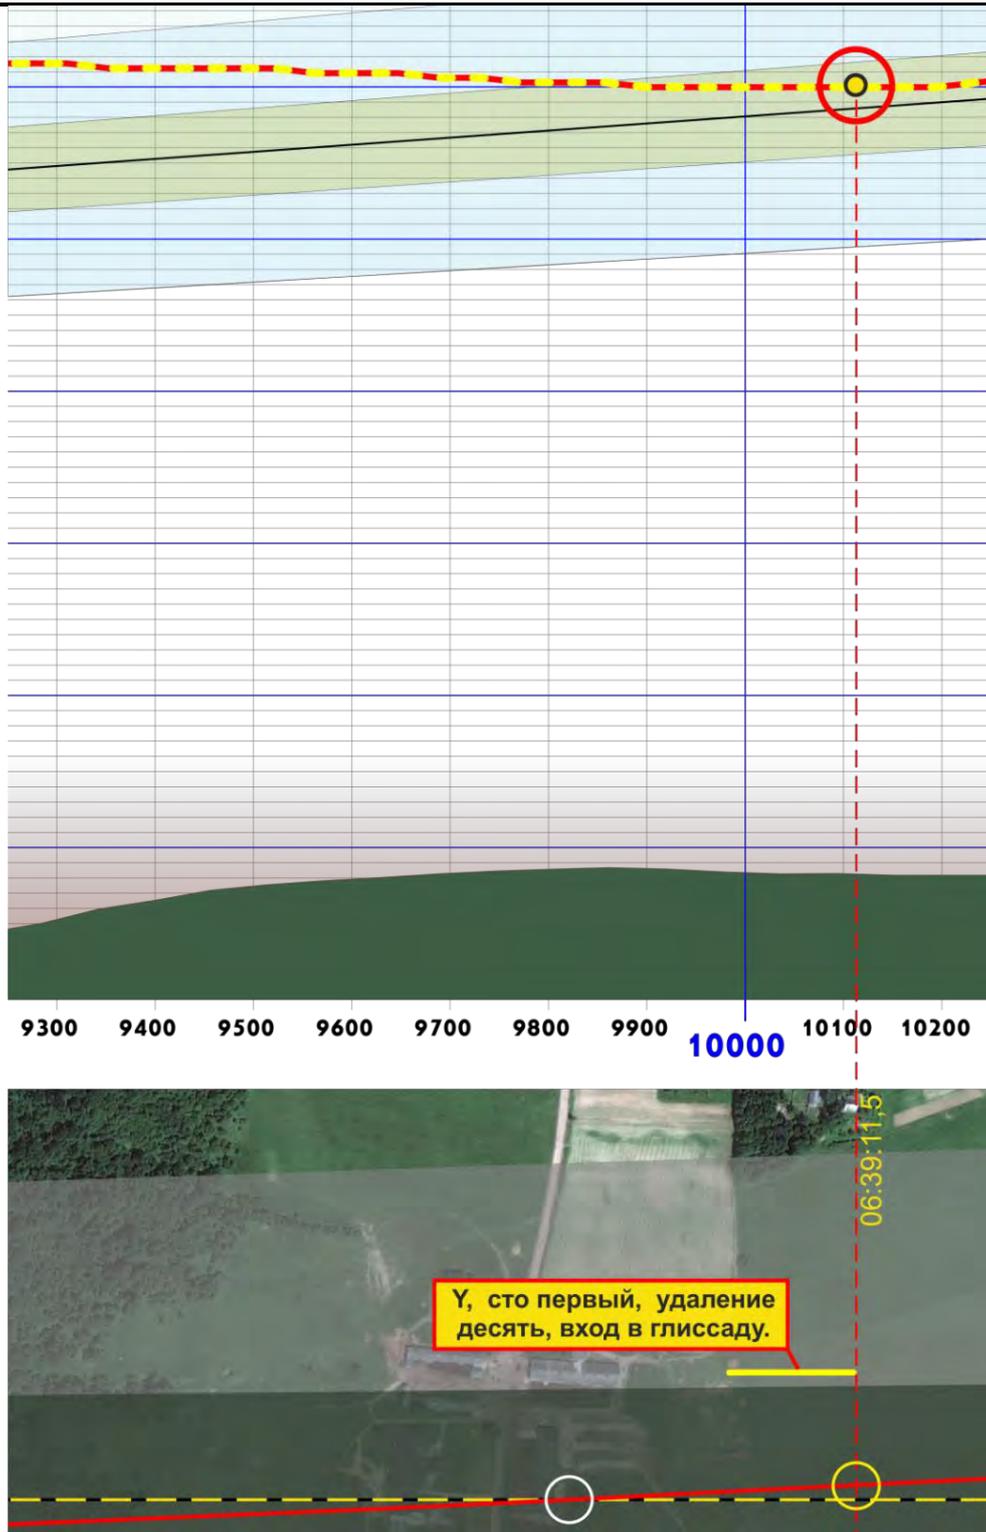
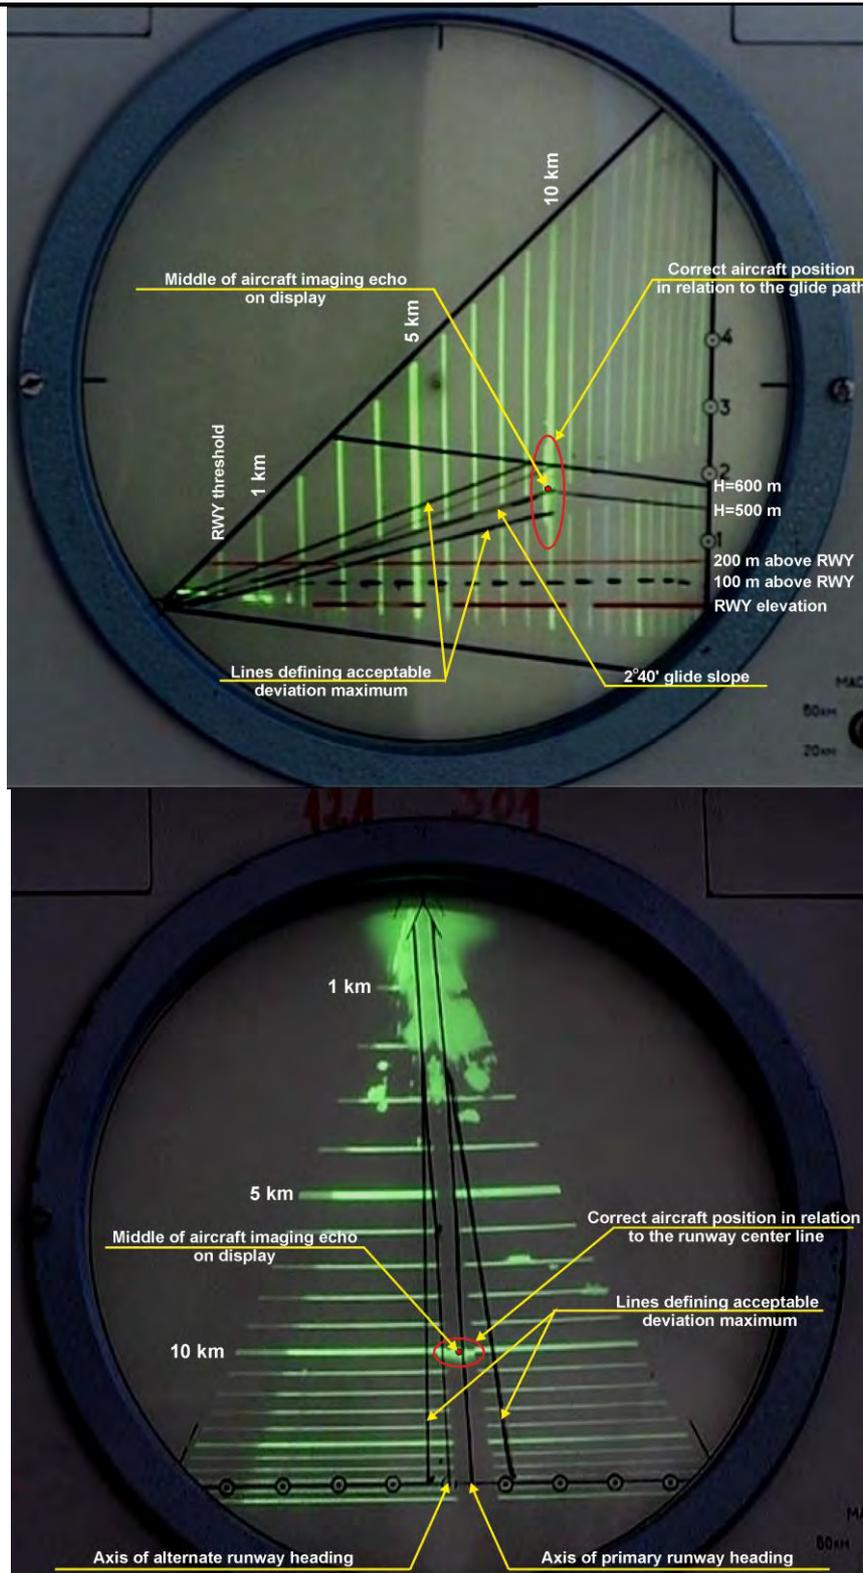
<sup>149</sup> Of the four aircraft approaches on April 10<sup>th</sup>, 2010, LZC did not confirm distance at initiation of final approach for the Tu-154M only.

Fig. 24. Location of the aircraft at the moment of command: „Сто первый, удаление десять, вход в глиссаду”  
(One zero one, distance ten, entry into glide path)

Image 25. Imaging of aircraft position in relation to the glide path an RWY center line on WISP-75 displays

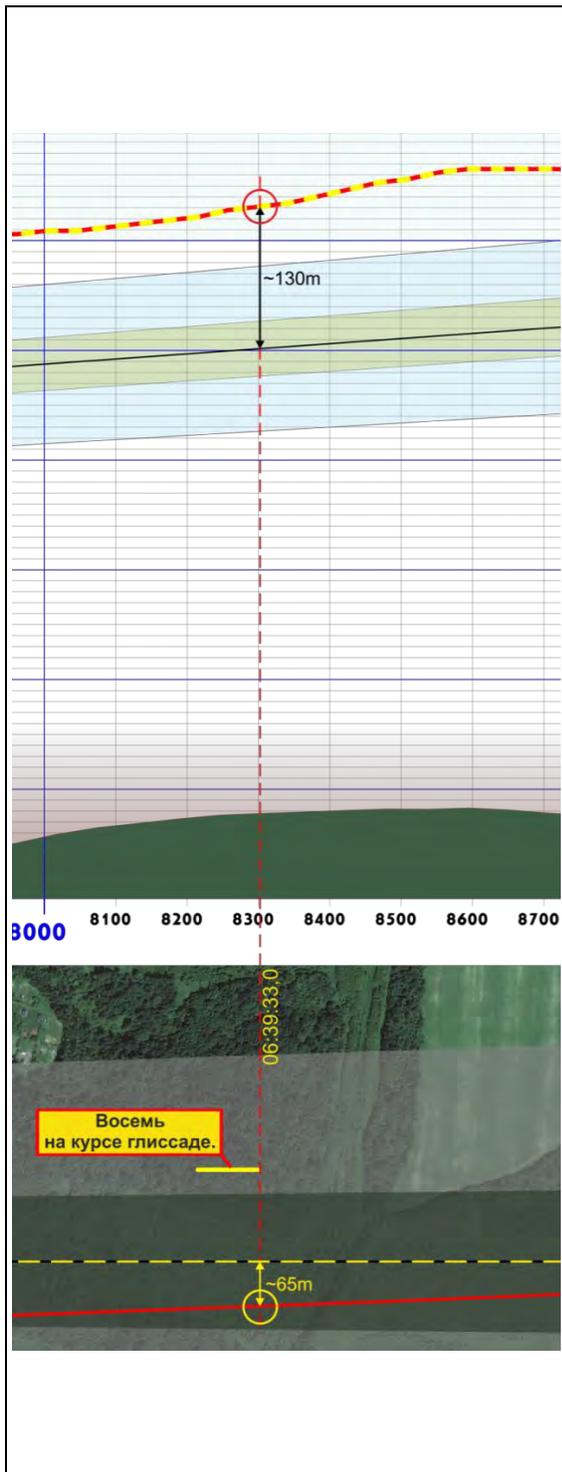
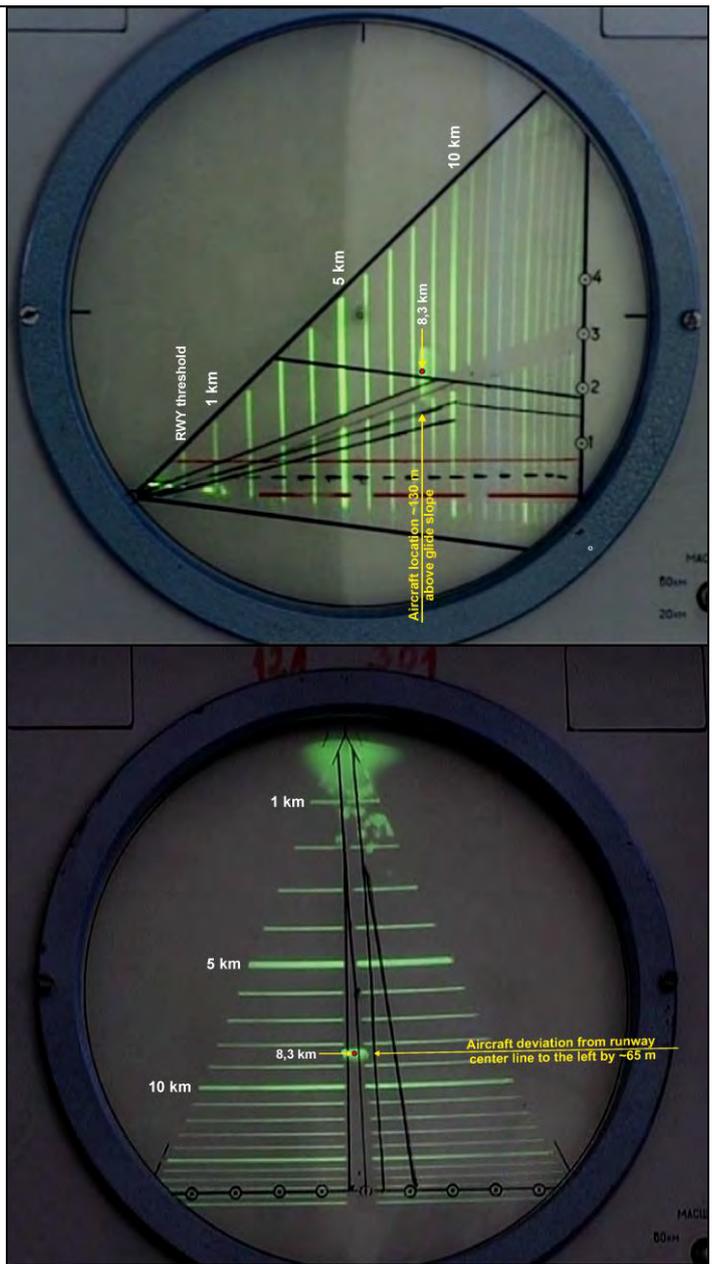
Fig. 25. Location of the aircraft at the moment of command: „Восемь, на курсе, глиссаде” („Eight on course, glide path”)

Image 26. Imaging of aircraft position in relation to the glide path and RWY center line on WISP-75 displays

Subsequent communication on the distance and correct location on the glide path<sup>153</sup> was given issued by LZC after 20 s. That was inconsistent with the actual position, as it was actually at 120 m above glide path at the time, 115 m left of RWY center line (444 m above airfield level, 6,649 m from RWY 26 threshold), i.e. outside of the border of maximum acceptable linear deviation ( $\pm 30'$ ) from the glide slope as instructed ( $2^{\circ}40'$ ). Commander of the Tu-154M aircraft incorrectly confirmed the distance from the RWY 26 threshold as „cztery” (*four*) instead of six. The mistake went unnoticed by LZC and ATC.

In the opinion of the Committee, given the weather conditions on site, and incorrect position of the aircraft (excessive deviation from glide path and course, small distance from RWY 26 threshold) LZC should have asked the crew for their decision regarding continued approach, or recommend that it be discontinued.

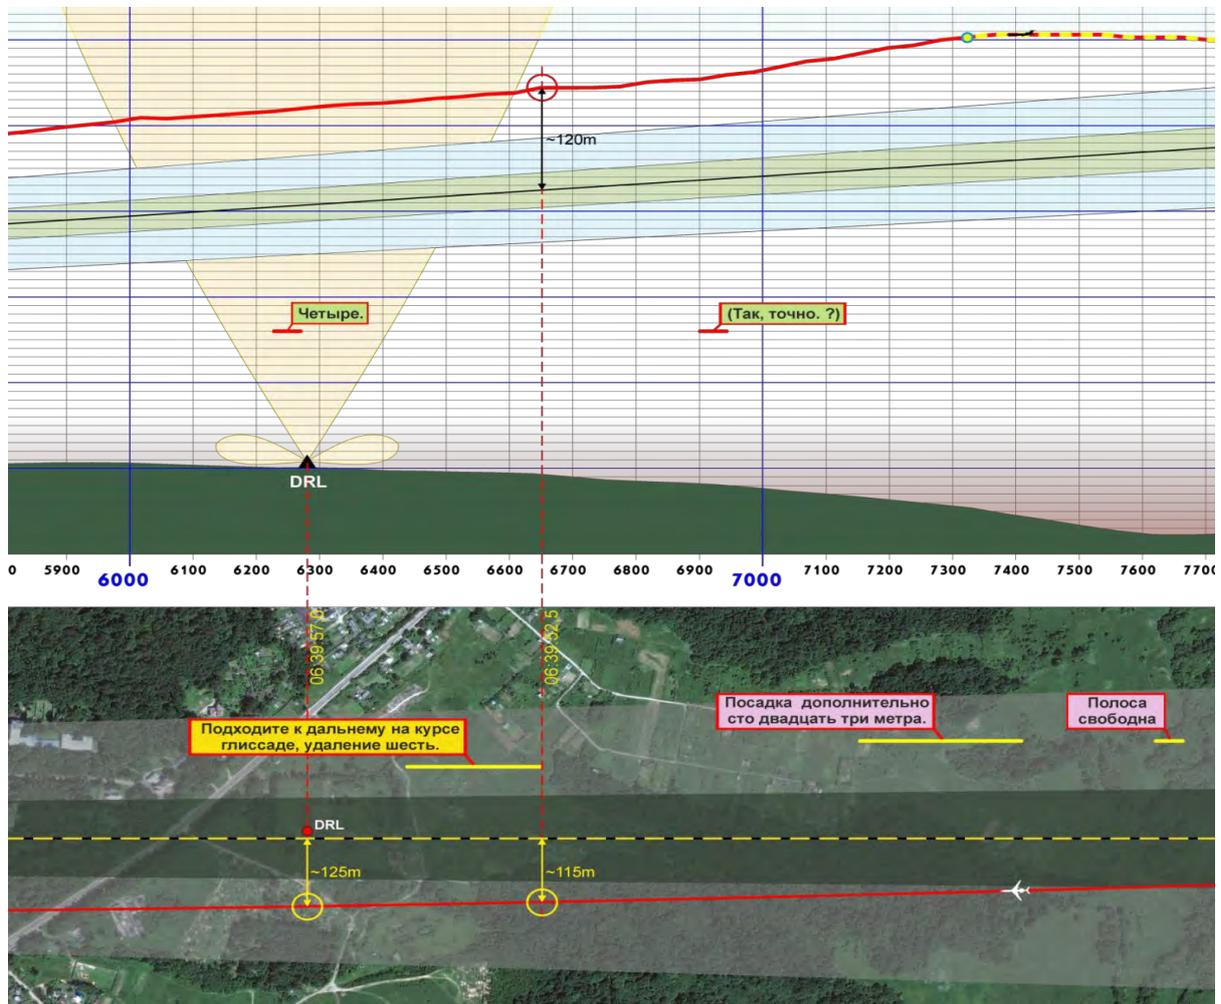
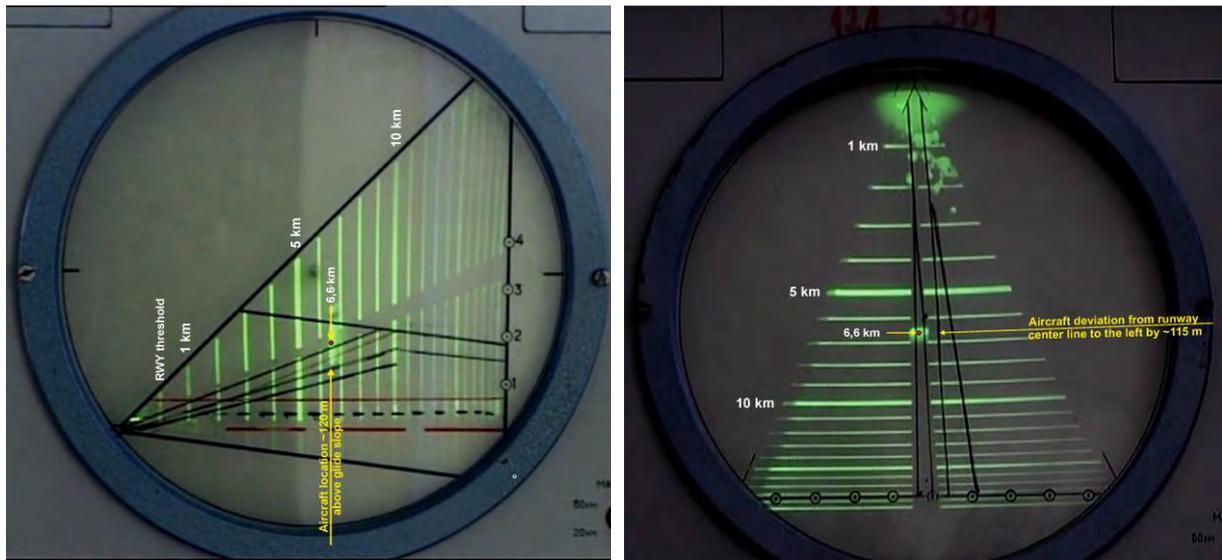
Fig. 26. Aircraft location at the time of the command: „Подходите к дальнему, на курсе глиссаде, удаление шесть” (*You are approaching the outer, on course, on glide path, distance six*)

Image 27. Imaging of aircraft position in relation to glide path and RWY center line on WISP-75 displays

Subsequent communication was issued by LZC after 24 s<sup>154</sup>, at a distance of ca. 4,600 m from RWY 26 threshold. LZC was still issuing communication to the crew about correct aircraft position, even though the aircraft was 60 m above glide path, 130 m left of RWY center line (at the altitude of 287 m above airfield level, 4,591 m from RWY 26 threshold).

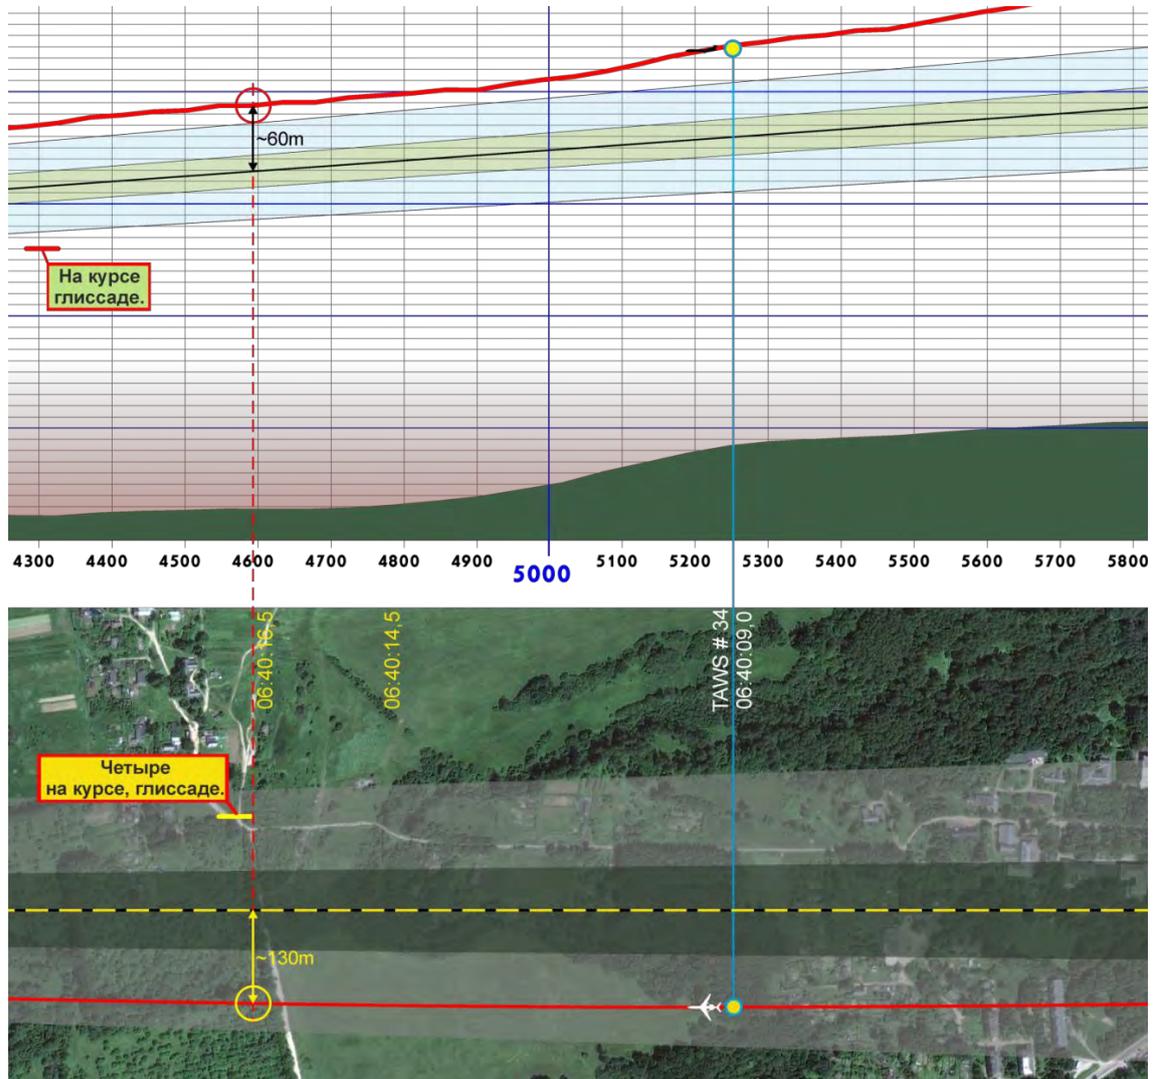
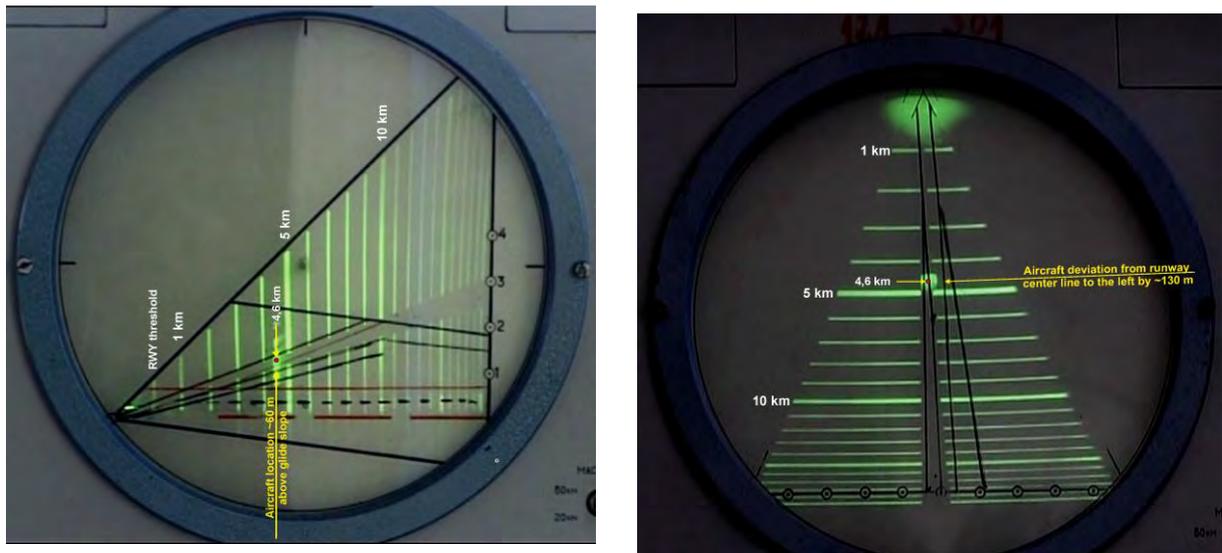
Fig. 27. Aircraft location at the time of the command given: „Четыре на курсе, глиссаде” (*Four on course, on glide path*)

Image 28. Imaging of aircraft position in relation to glide path and RWY center line on WISP-75 displays

Subsequent communication by <sup>155</sup> LZC was issued after 13 s (3460 m from RWY 26 threshold). LZC kept informing the crew of correct plane position on course and glide path, while in reality the aircraft was at the upper limit of acceptable linear deviation (+30′) from the commanded glide path, and 100 m left of RWY center line.
