# **Final Report**

**from the examination of the aviation accident no  
192/2010/11**

**involving the Tu-154M airplane, tail number 101,  
which occurred on April 10<sup>th</sup>, 2010**

**in the area of the SMOLENSK NORTH airfield**

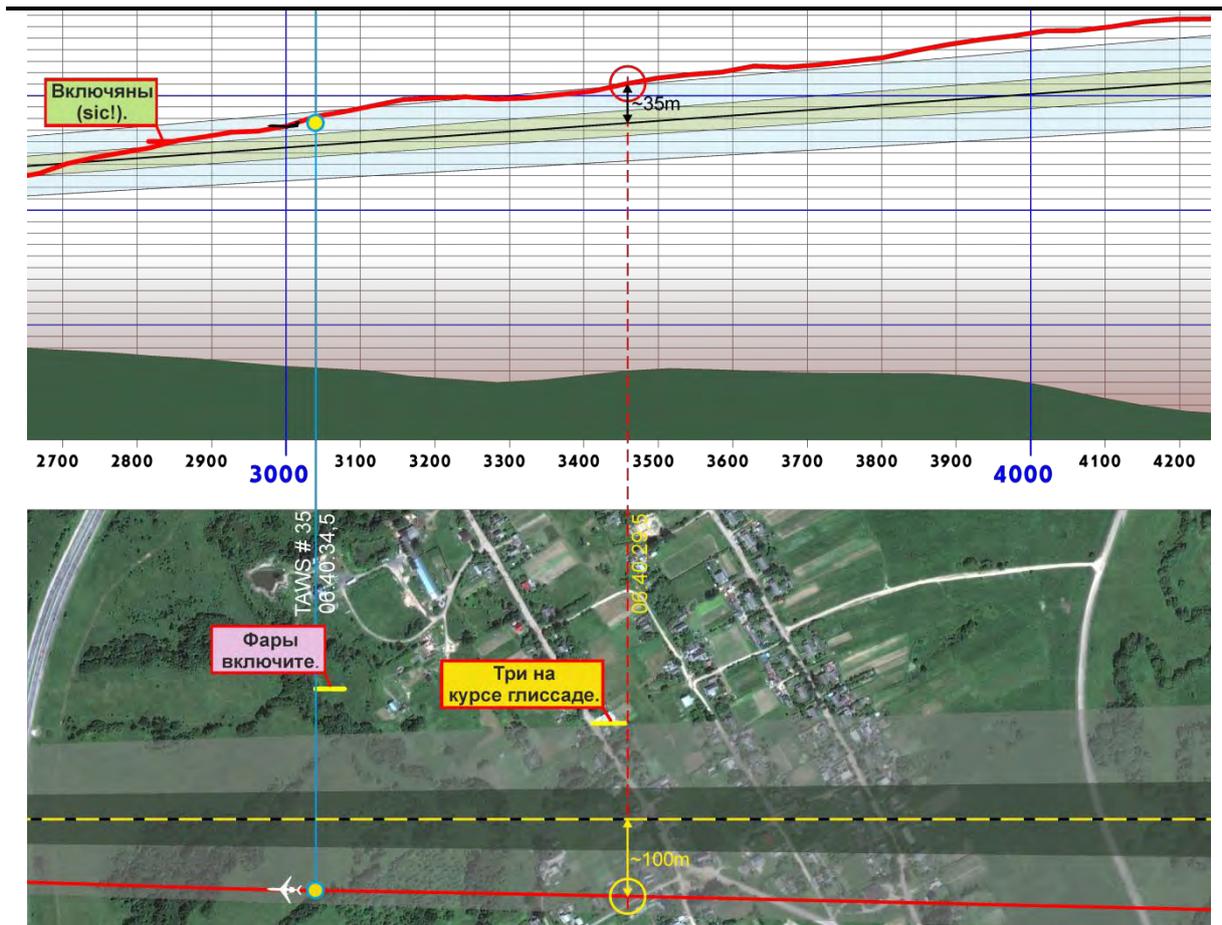
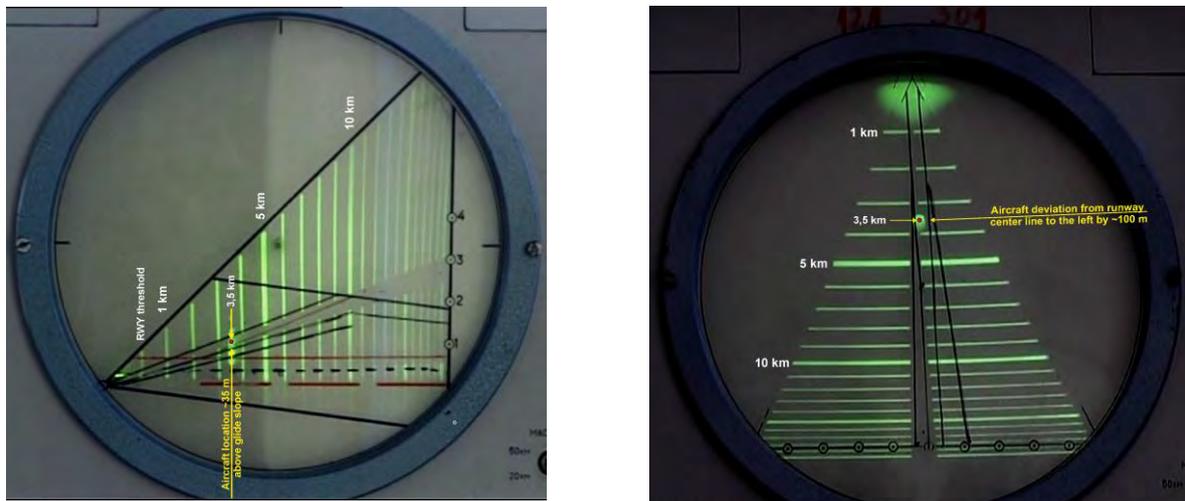
Fig. 28. Location of aircraft at the time when command was given: „Три на курсе, глиссаде” (*Three on course, on glide path*)

Image 29. Imaging of aircraft position in relation to glide path and RWY 26 center line on WISP-75 displays

At a distance of 2,700 m from RWY 26 threshold, the aircraft “crossed” the glide slope downwards, and the crew continued descent below the required glide path, to which LZC did not react in any way.

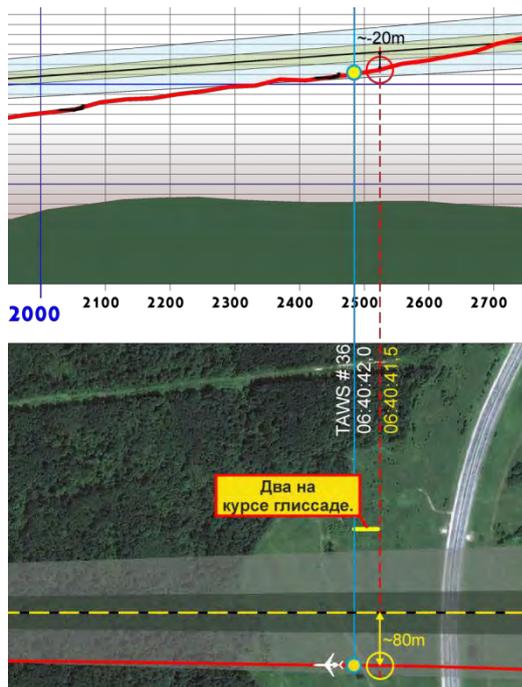
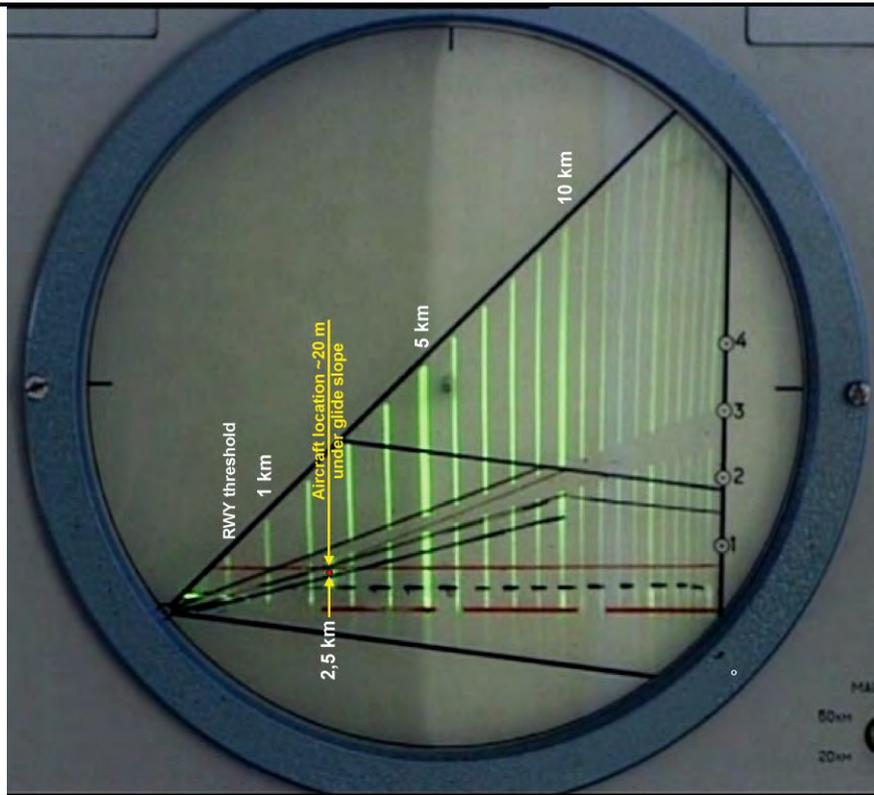
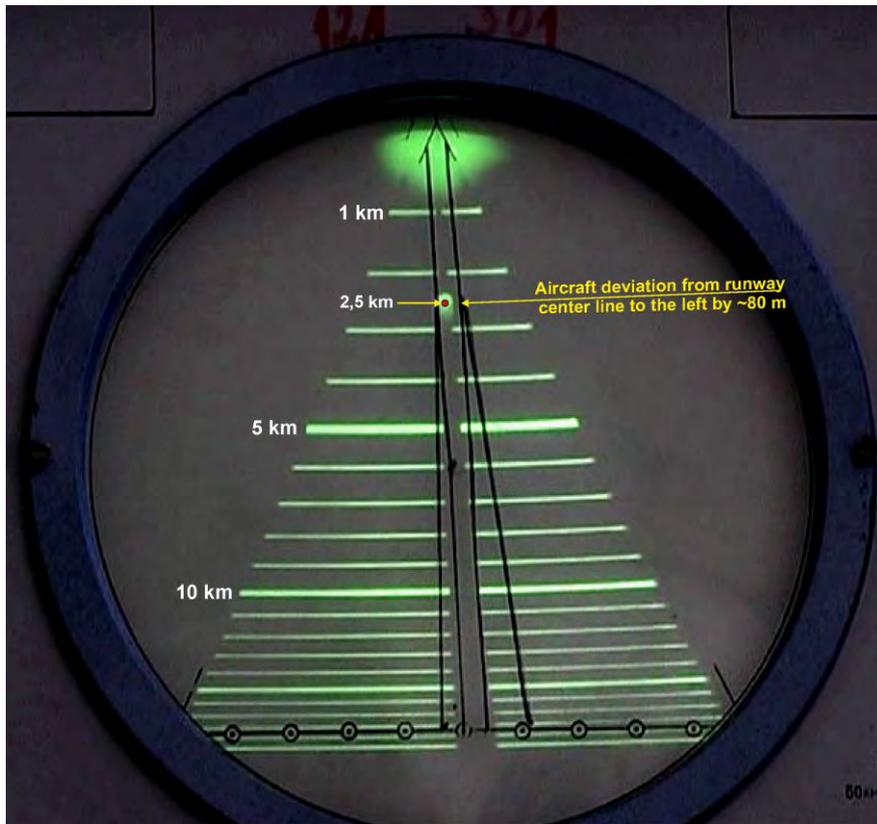
Fig. 29. Location of aircraft at the time command was given: „Два на курсе, глиссаде” („Two on course, on glide path”)

Image 30. Imaging of aircraft position in relation to glide path and RWY 26 center line on WISP-75 displays

The command ordering change to horizontal flight „Горизонт, сто один” („Horizon, 101”) was issued by LZC after 13.5 s as of the communication “Two on course, on glide path”. At the time, the aircraft was at an altitude of about 14 m above airfield plane and **could not be seen on radar displays anymore**. Two seconds before the „Horyzont 101” (Horizon 101) command, the aircraft commander made the decision to go around (altitude above airfield level 39 m).

According to the Committee’s findings, the command „Горизонт, сто один” (*Horizon, one zero one*) should have been issued 10 s sooner (0640:44.5), i.e. when the aircraft was well below the glide path, at the lower limit of acceptable minimum deviation from glide path (-30°).

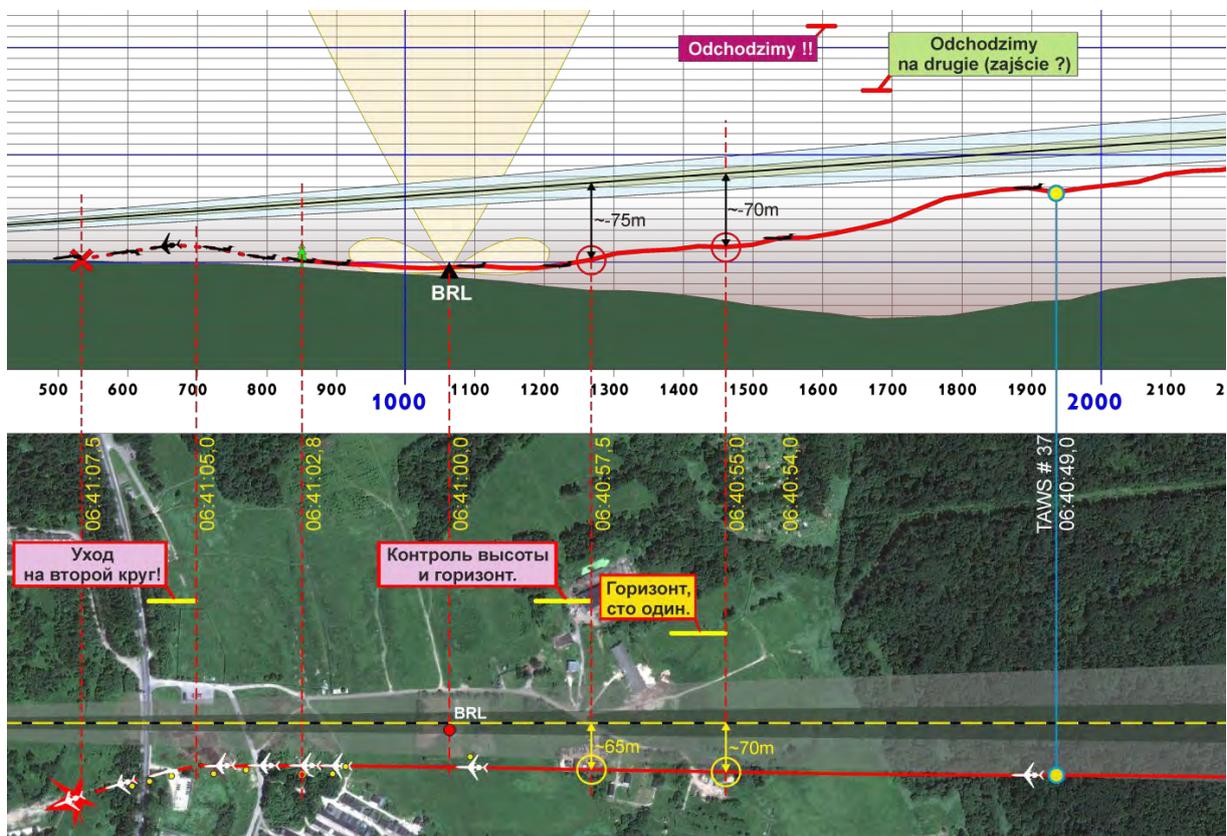
“Odchodzimy !!”; “Odchodzimy na drugie (zajscie ?)” (*Going around !!; Going around for a second (approach?)*); BRL = inner NDB

Fig. 30. Imaging of the last phase of flight of the Tu-154M
